North Jersey Transportation Planning Authority

# Concept Development Report

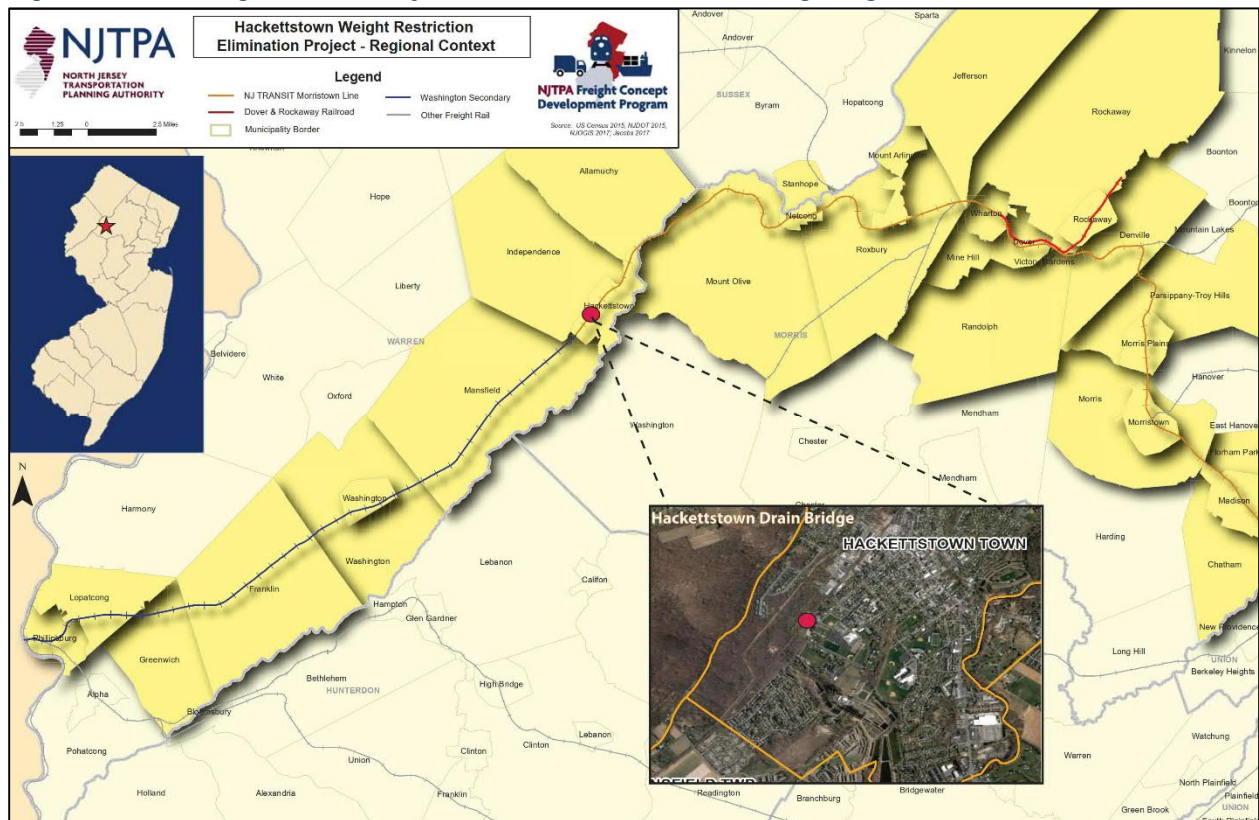
In addition to weight constraints, there are also height constraints along the corridor that limit the rail line's utility and ability to effectively serve the freight rail-served businesses located along the corridor and the connecting branch lines. The industry standard is Plate F or 17 feet in height. This report documents the study process, alternatives considered, public and stakeholder outreach, and coordination and recommendation of a preferred alternative that best meets the project purpose and need for advancement into design and construction at the drain bridge.

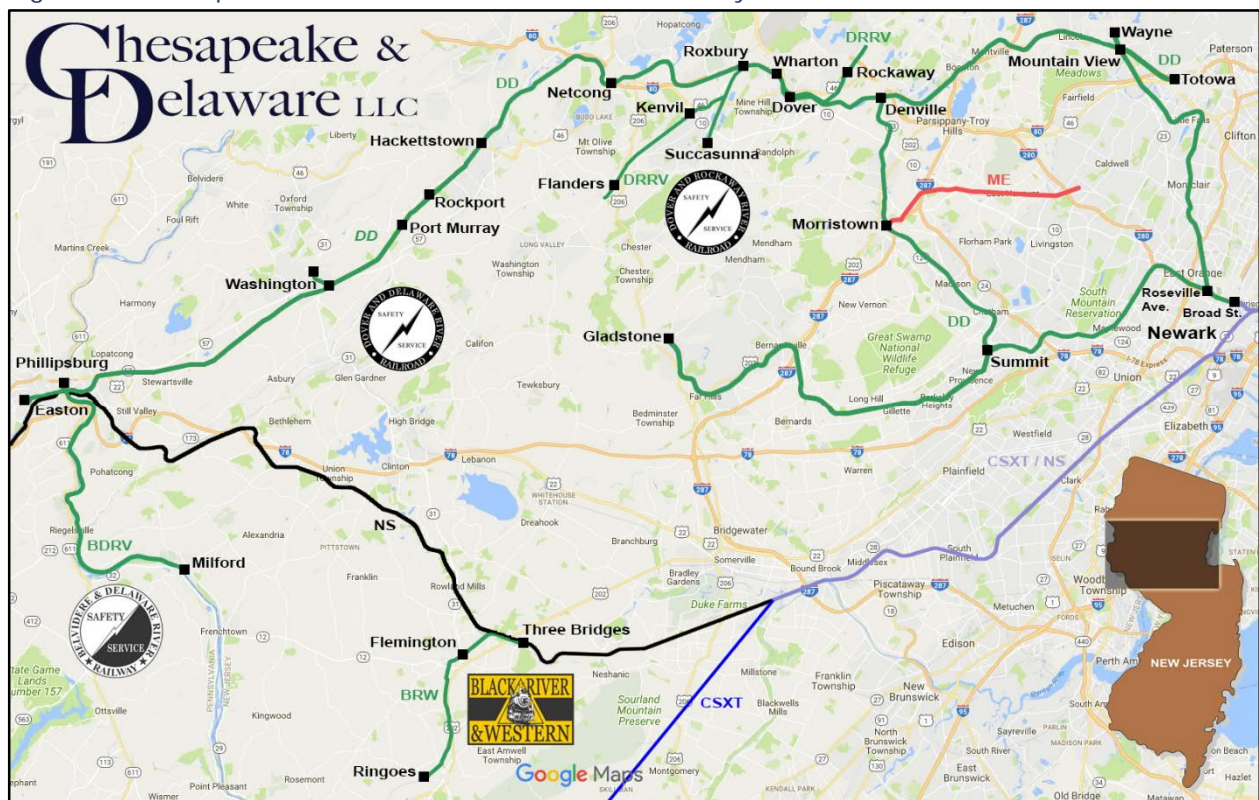
Source: [http://www.chesapeakeanddelaware.com/Railroads\\_DRRV.html](http://www.chesapeakeanddelaware.com/Railroads_DRRV.html)

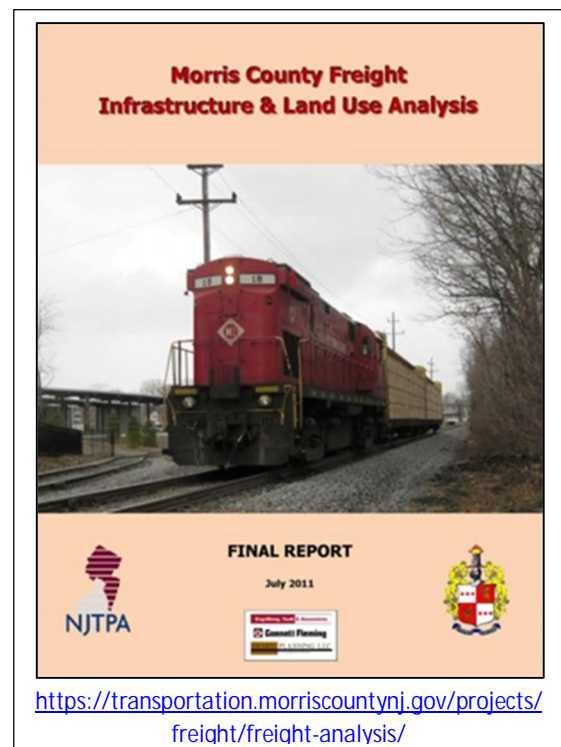
In response to the additional constraints identified, the NJTPA, again in collaboration with Morris County, undertook the Morris/Warren County Rail Corridor Study. Completed in 2013, this study built upon the findings of the Morris County Freight Infrastructure and Land Use Analysis study and more closely examined the infrastructure and operational improvements necessary to accommodate industry standard 286K, Plate F rail services along the Washington Secondary. The study documented impediments, such as low overpasses that limit the height of railcars and aging bridges that cannot accommodate the 286K railcars, that minimize the competitive advantage of industries served by the corridor and its branch lines, hampering the region's ability to retain existing and attract new rail-served industries.

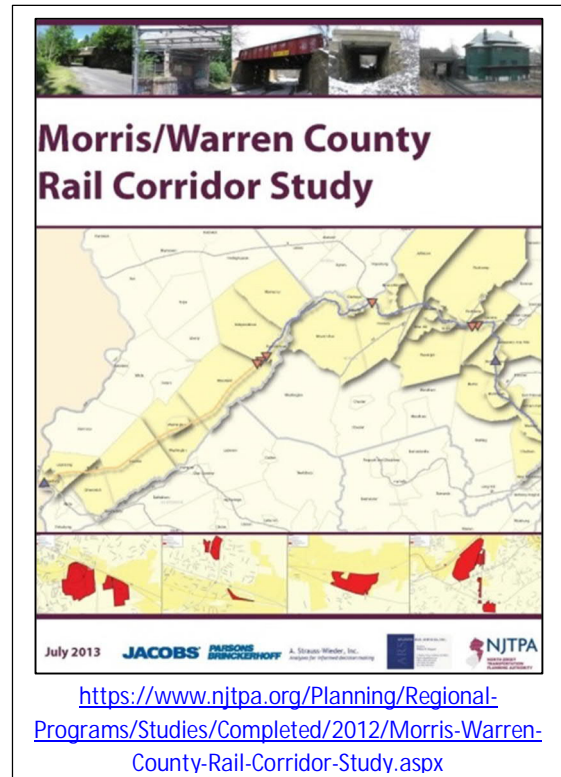
### 1.3 Existing Conditions

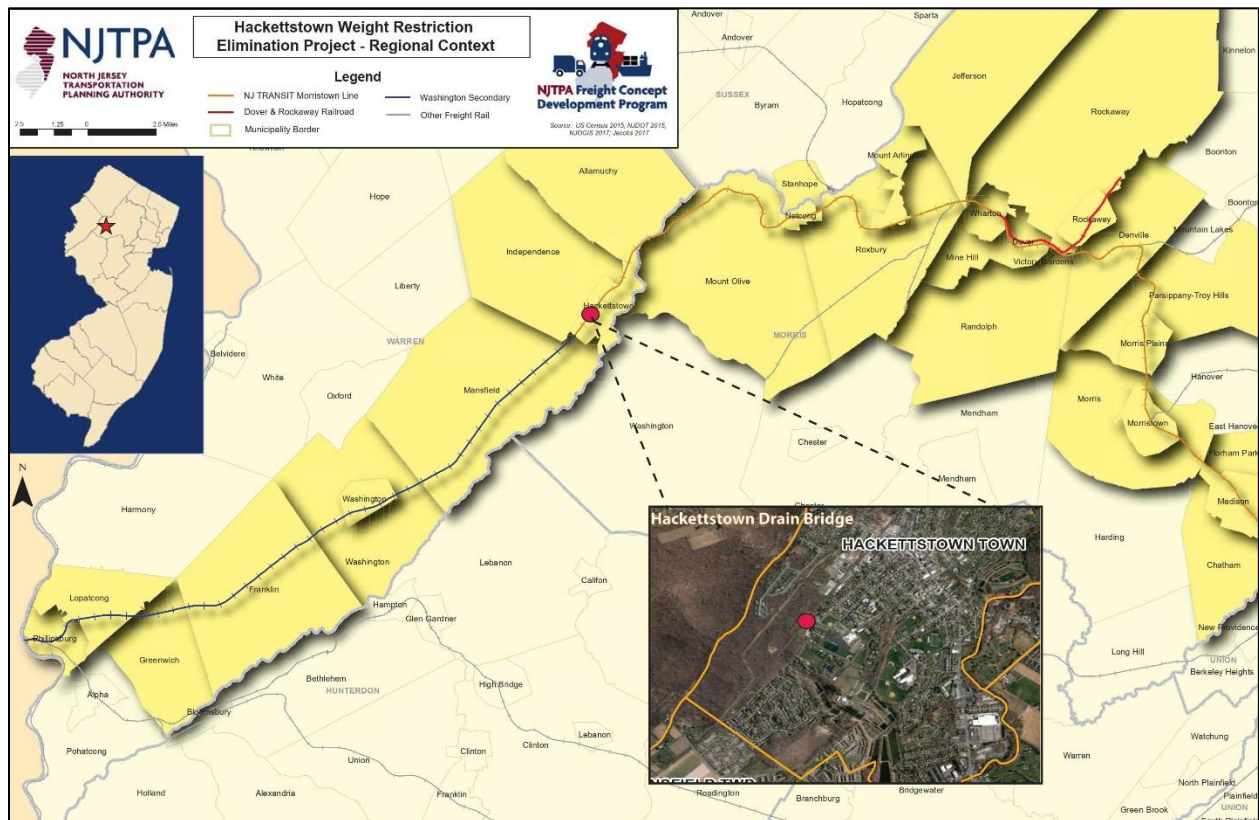
In addition to weight constraints, there are also height constraints along the corridor that limit the rail line’s utility and ability to effectively serve the freight rail-served businesses located along the corridor and the connecting branch lines. The industry standard is Plate F or 17 feet in height. This report documents the study process, alternatives considered, public and stakeholder outreach, and coordination and recommendation of a preferred alternative that best meets the project purpose and need for advancement into design and construction at the drain bridge.

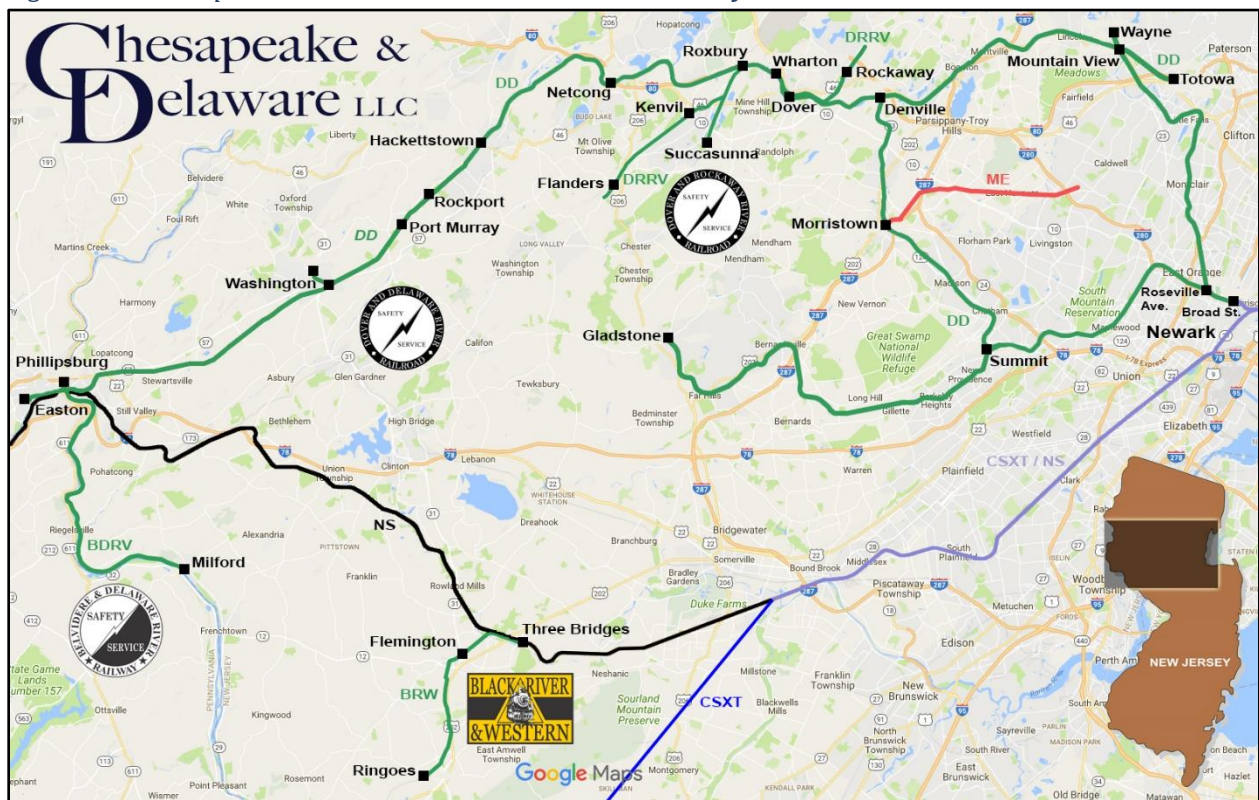
Source: [http://www.chesapeakeanddelaware.com/Railroads\\_DRRV.html](http://www.chesapeakeanddelaware.com/Railroads_DRRV.html)

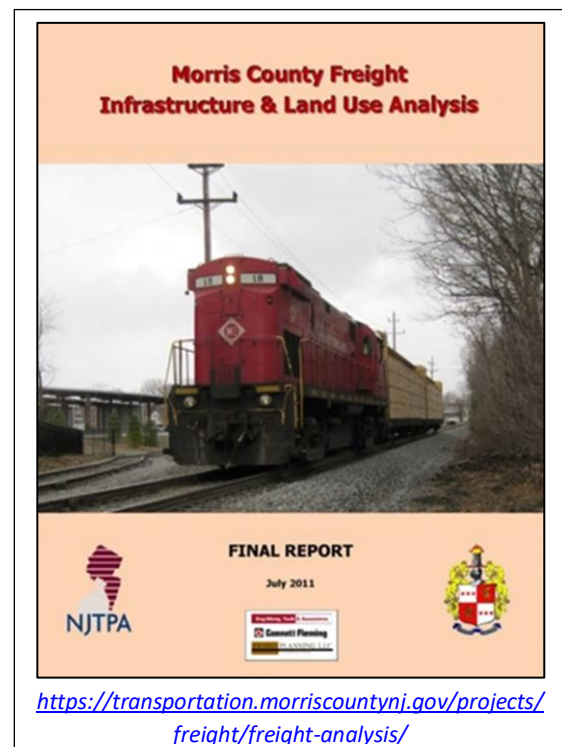
In response to the additional constraints identified, the NJTPA, again in collaboration with Morris County, undertook the **Morris/Warren County Rail Corridor Study**. Completed in 2013, this study built upon the findings of the Morris County Freight Infrastructure and Land Use Analysis study and more closely examined the infrastructure and operational improvements necessary to accommodate industry standard 286K, Plate F rail services along the Washington Secondary. The study documented impediments, such as low overpasses that limit the height of railcars and aging bridges that cannot accommodate the 286K railcars, that minimize the competitive advantage of industries served by the corridor and its branch lines, hampering the region's ability to retain existing and attract new rail-served industries.

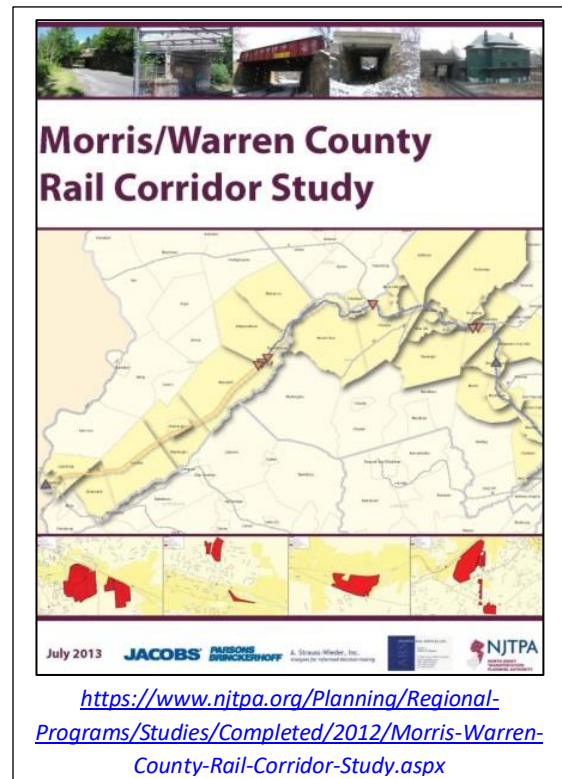
### 1.3 Existing Conditions

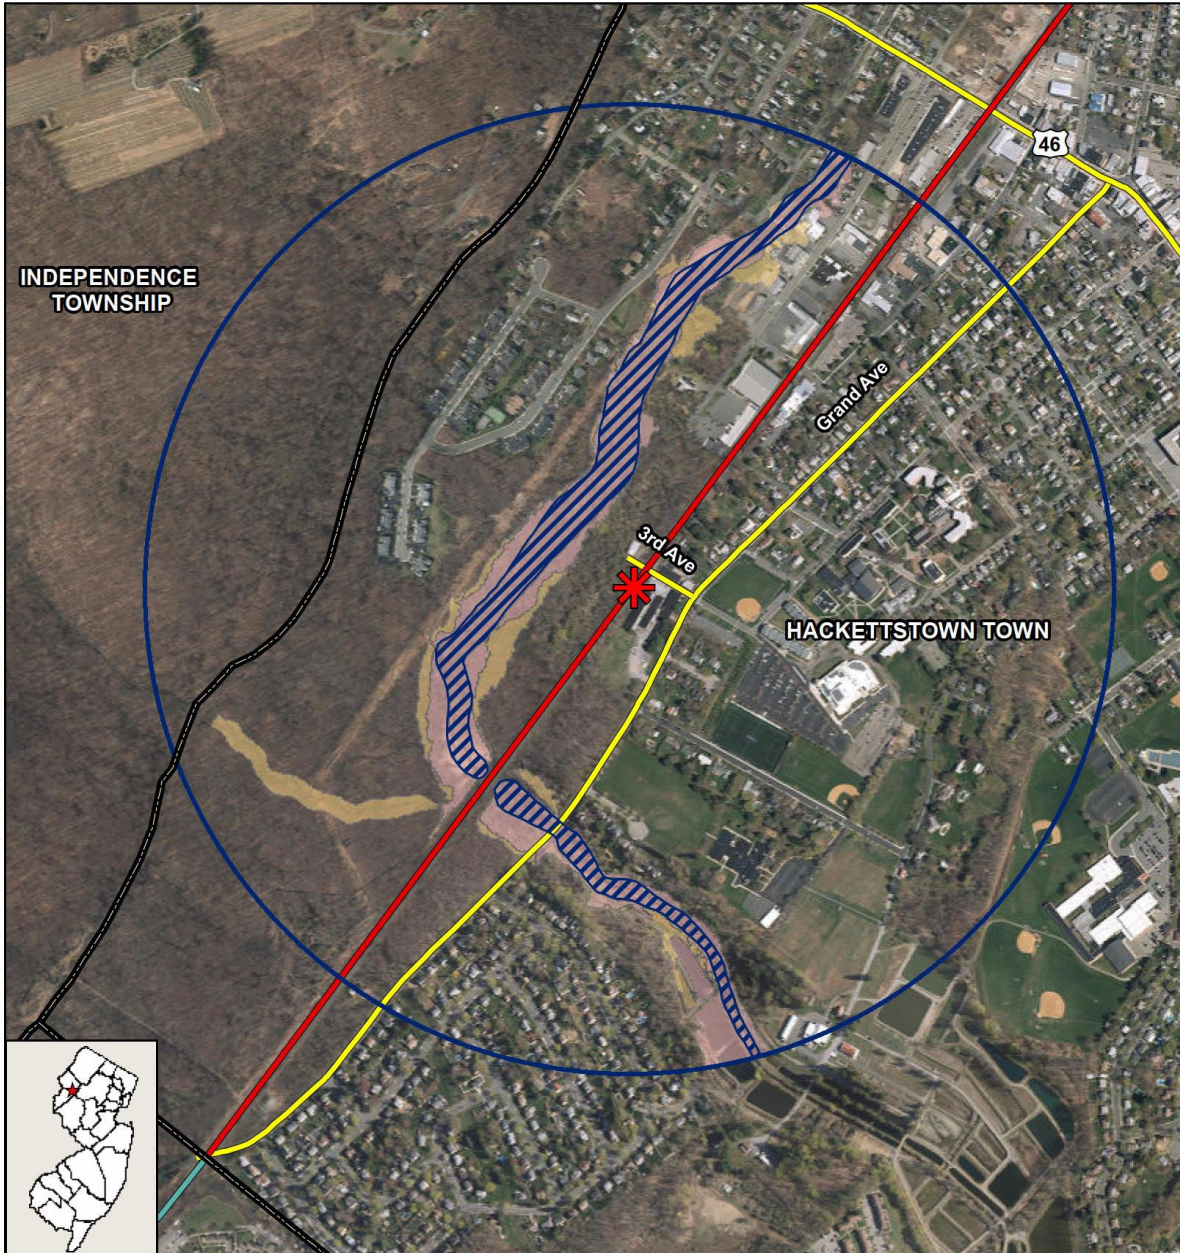
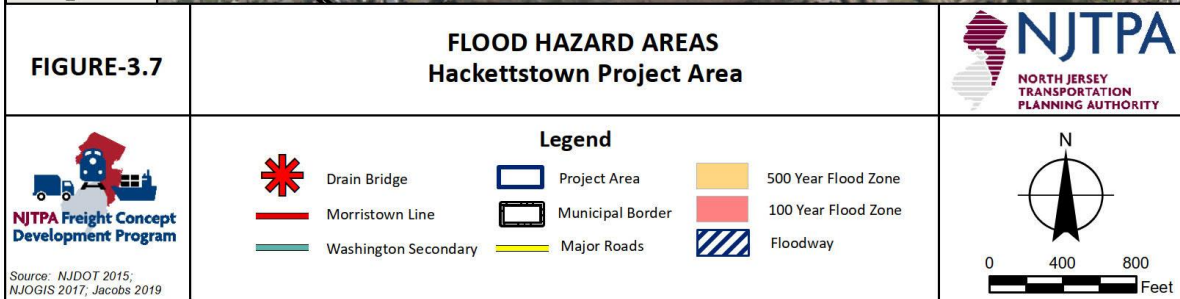
## 3.8 Threatened and Endangered Species

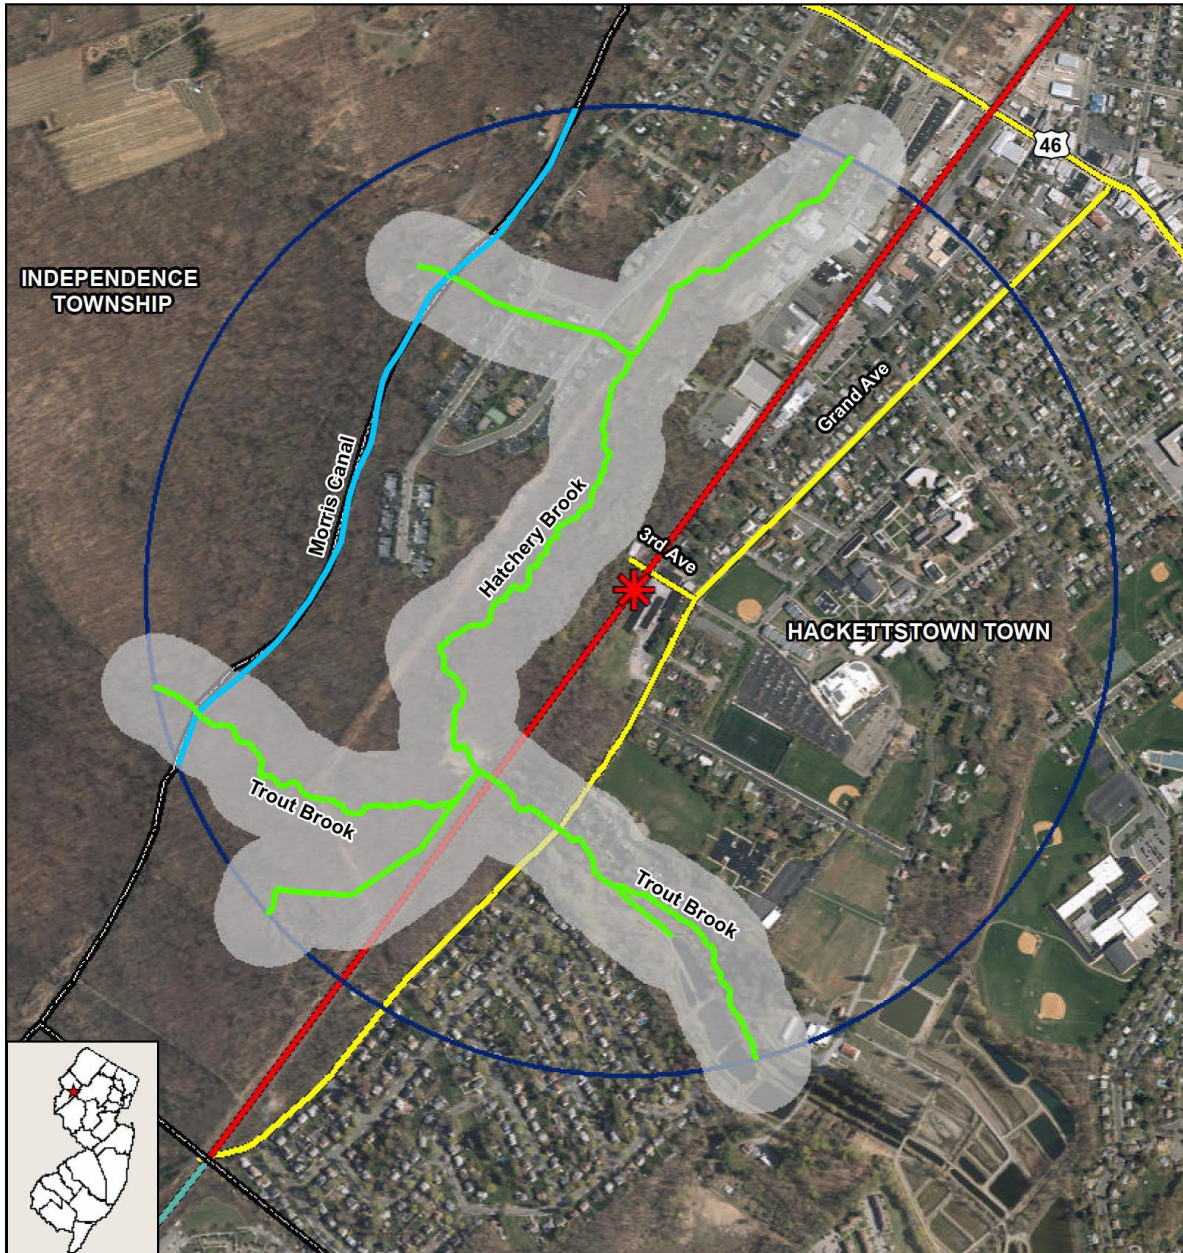
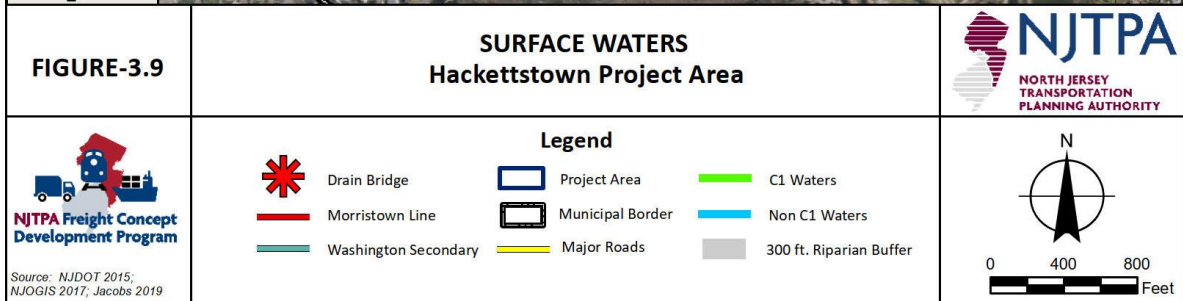
## 3.10 Hazardous Materials

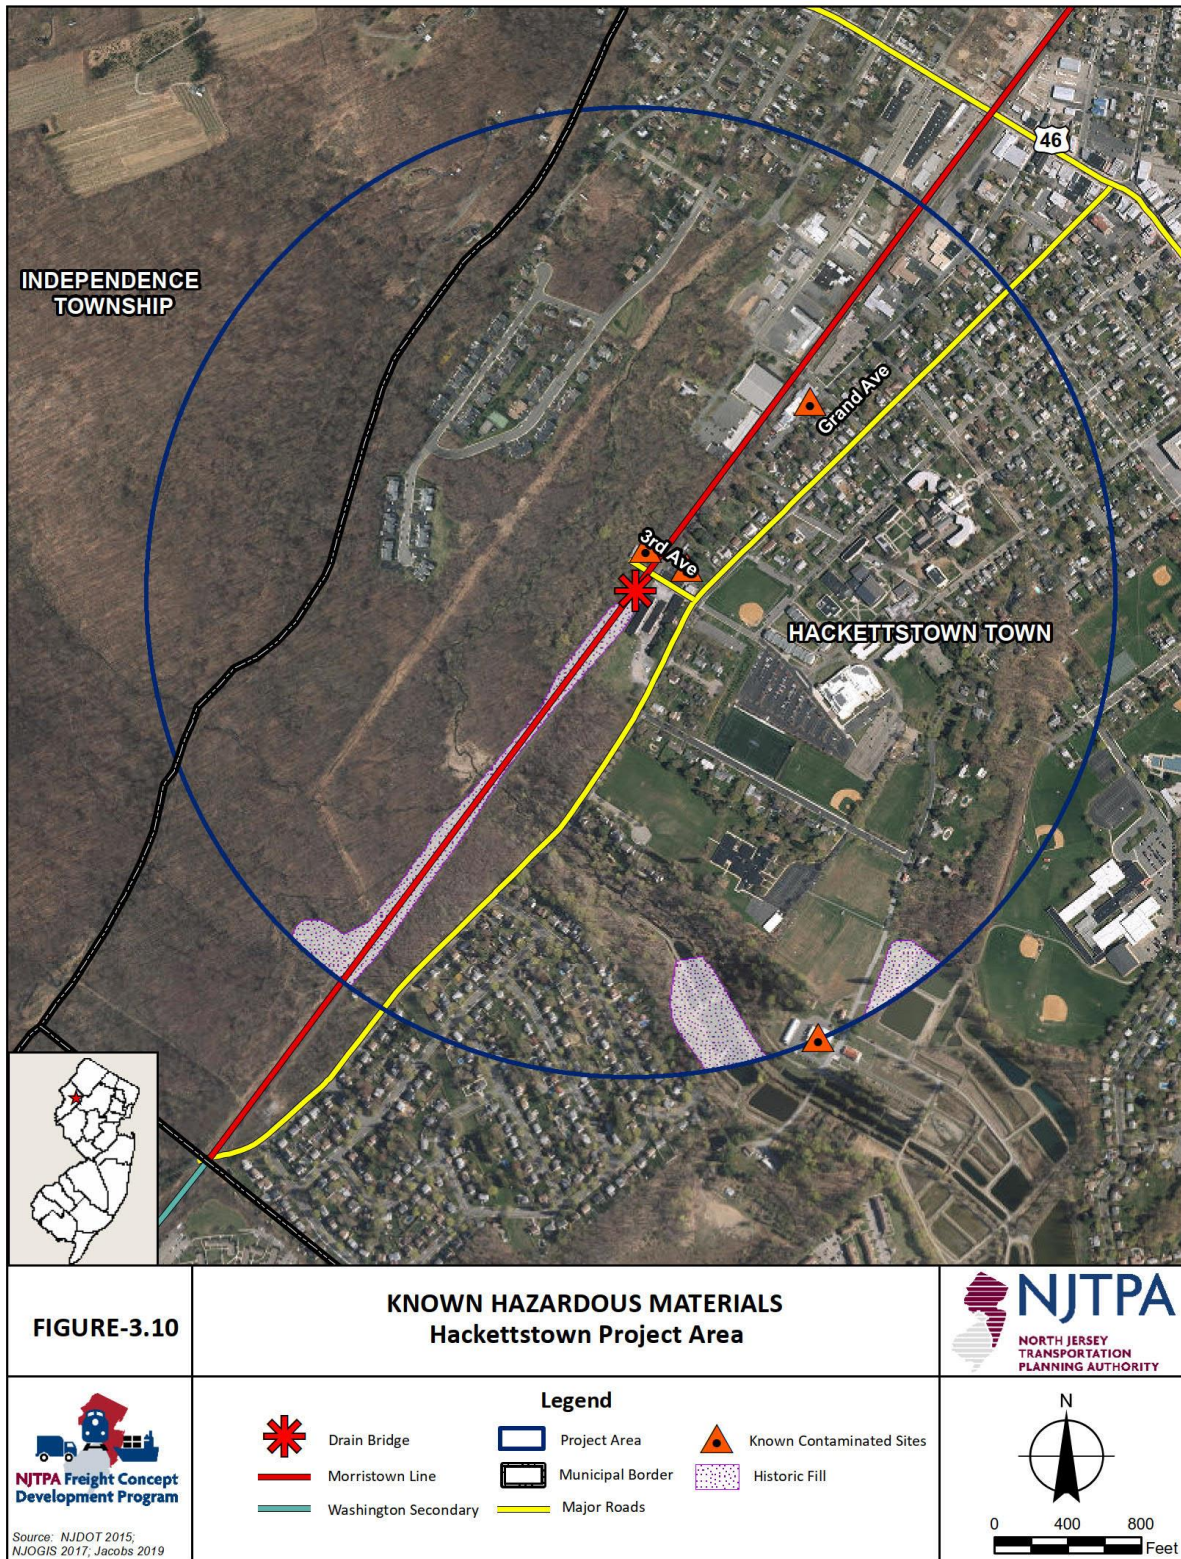
## 4. Infrastructure Analysis

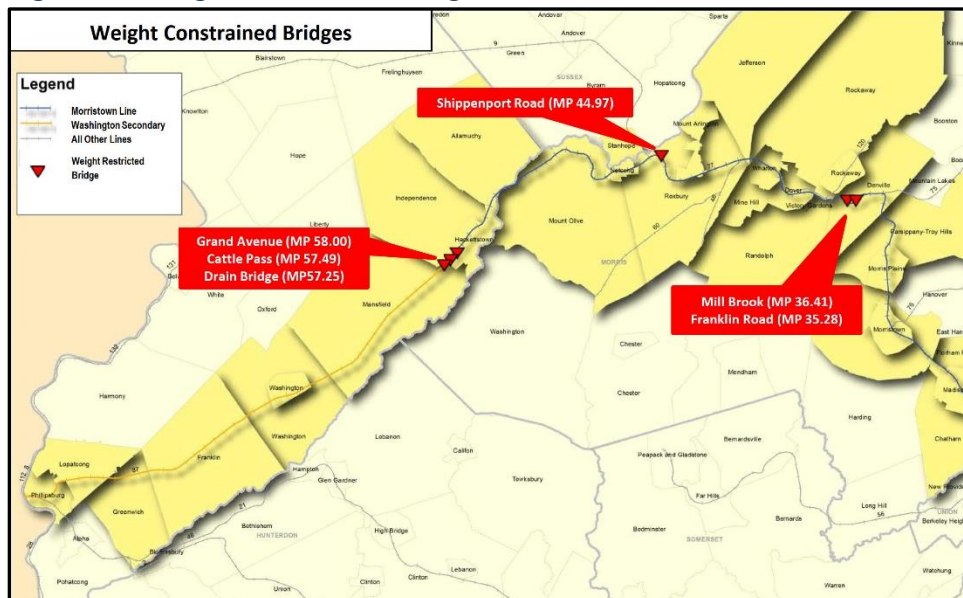
Figures 4.2 through 4.11 depict the existing condition of the bridge surface, abutments, wing walls, and headwall.

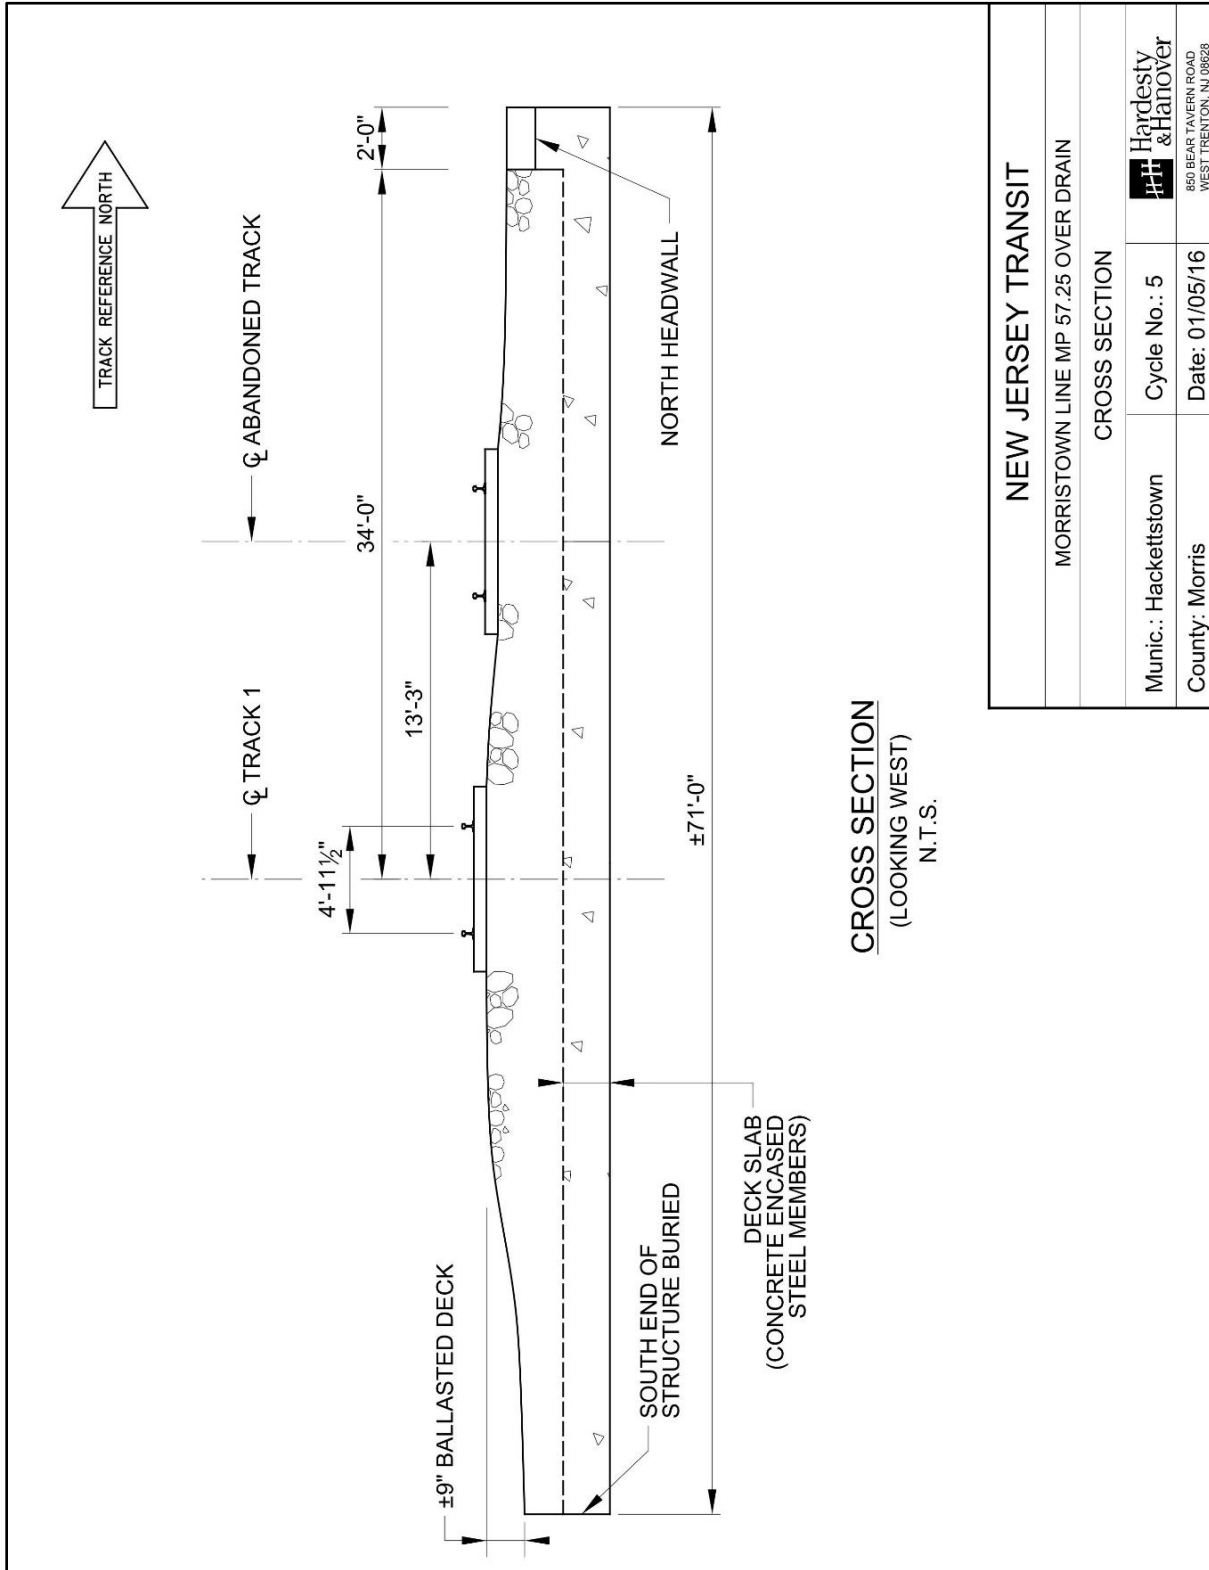
Figure 4.3: Elevation - Looking South

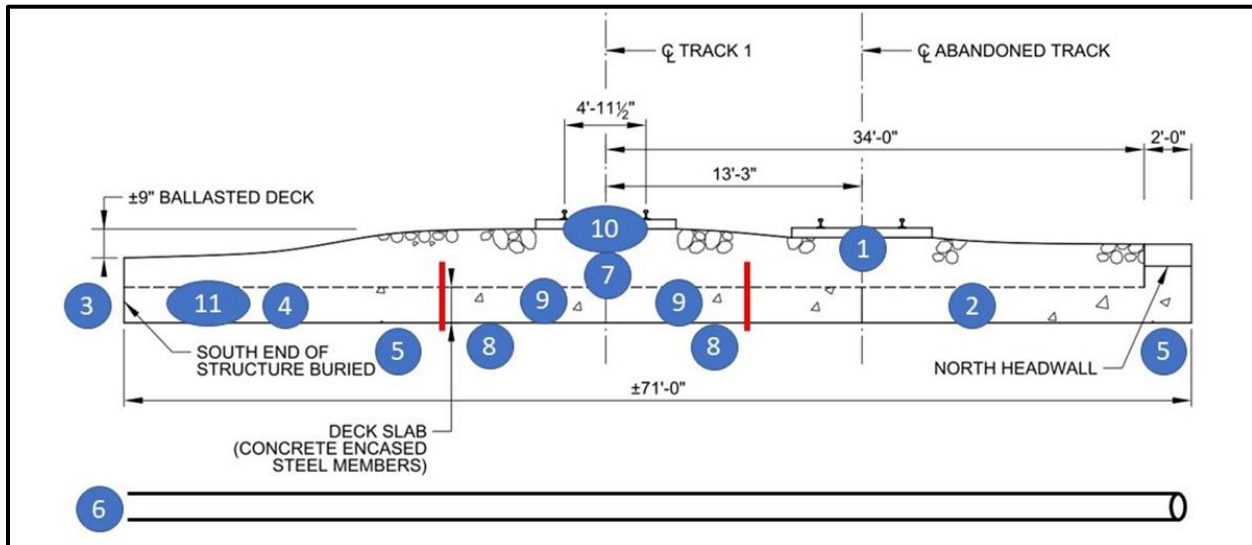
Following are the steps anticipated to replace the existing concrete slab while minimizing the duration of deactivating rail movements along this portion of the Washington Secondary.

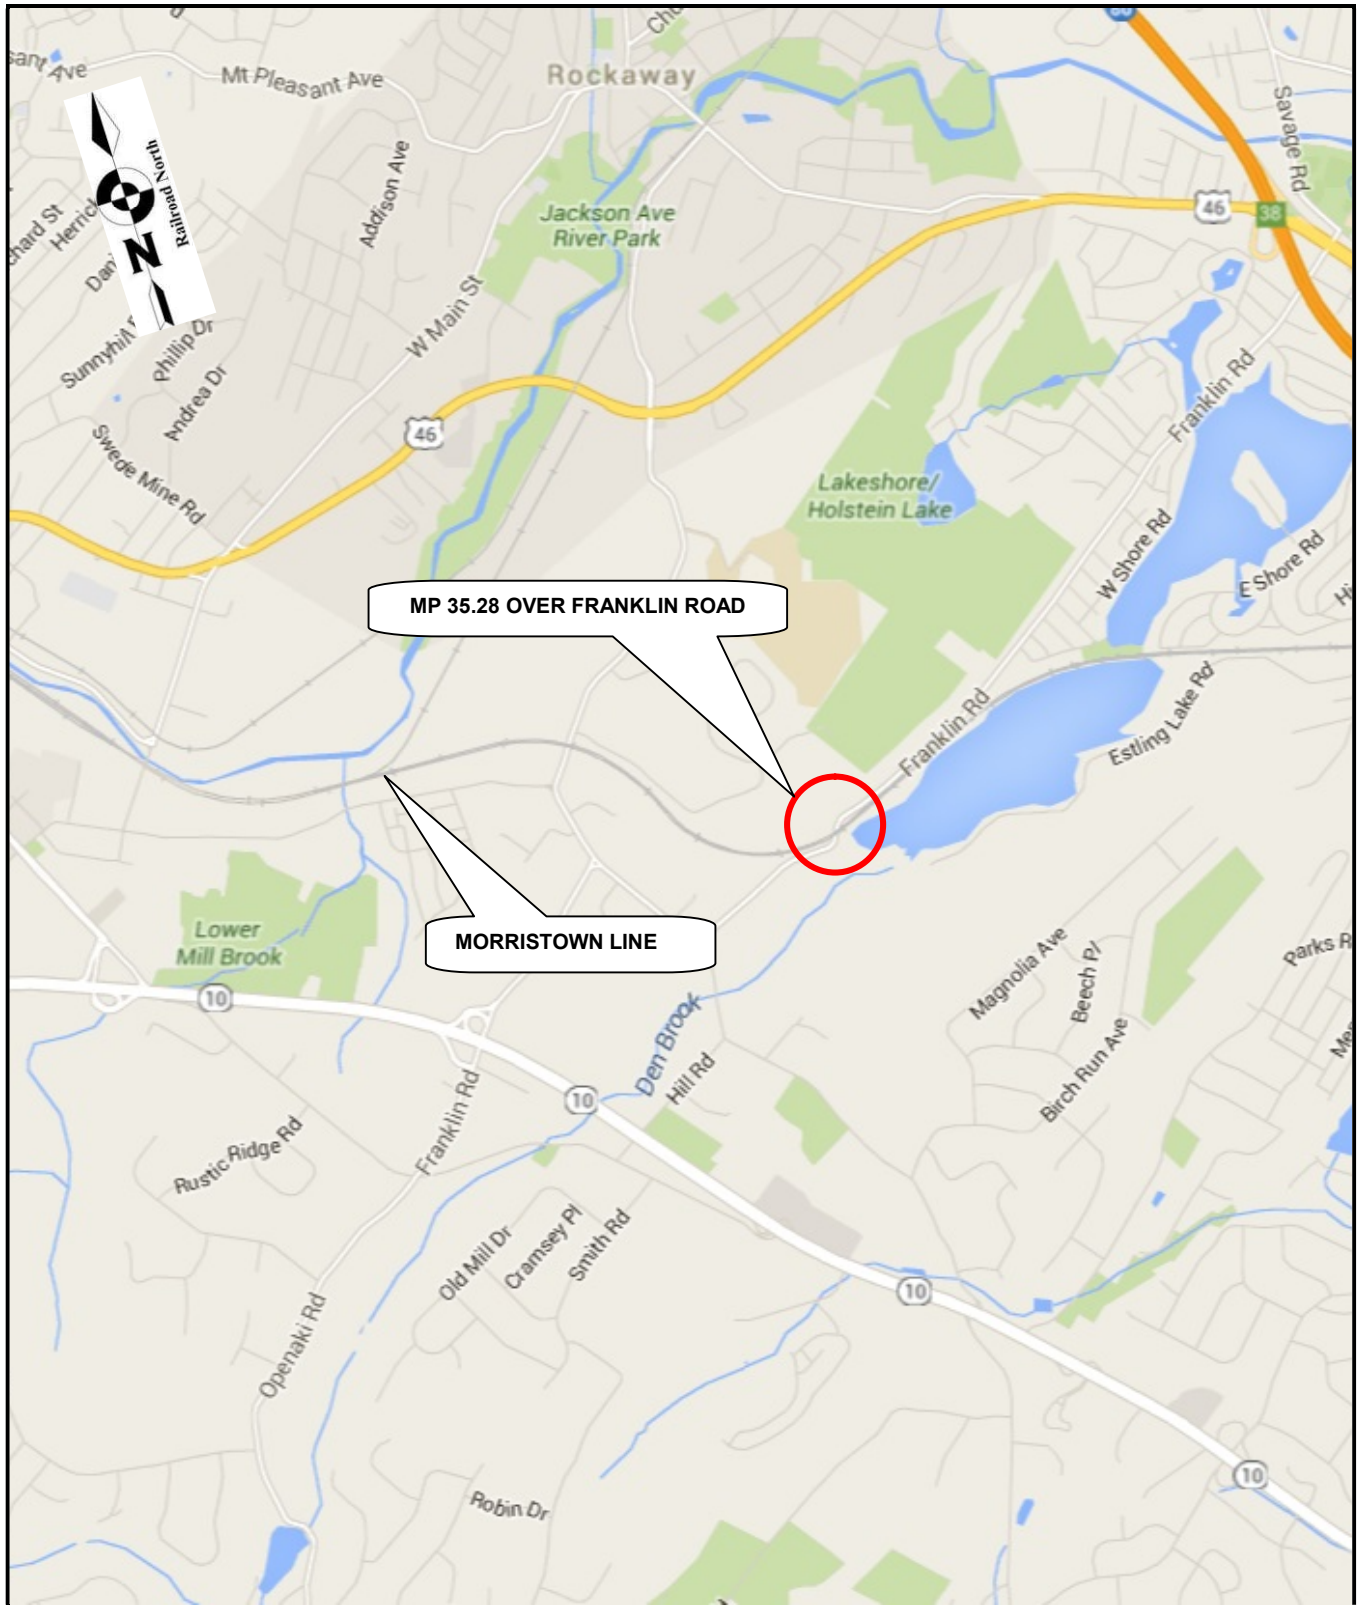
**TRANSIT**  
The Way To Go.

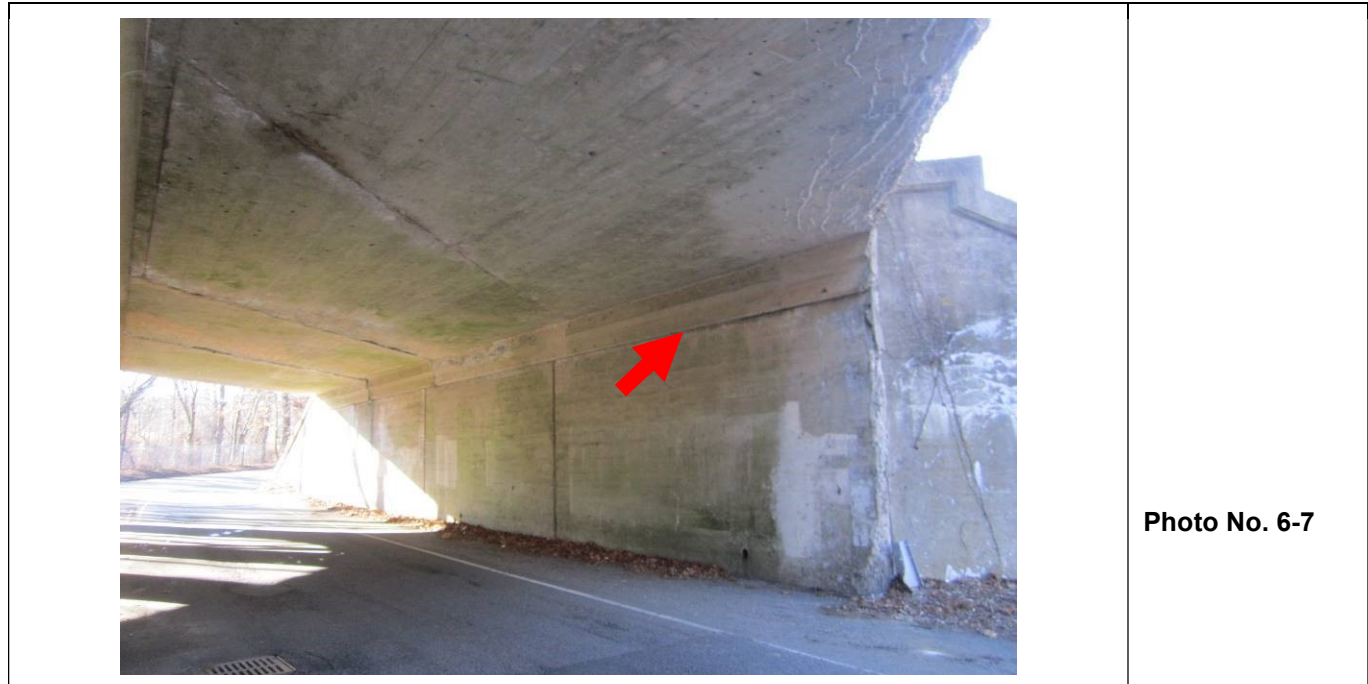
<b>Location:</b>	Underside of deck at Span 2, looking southwest.
<b>Description:</b>	General view.

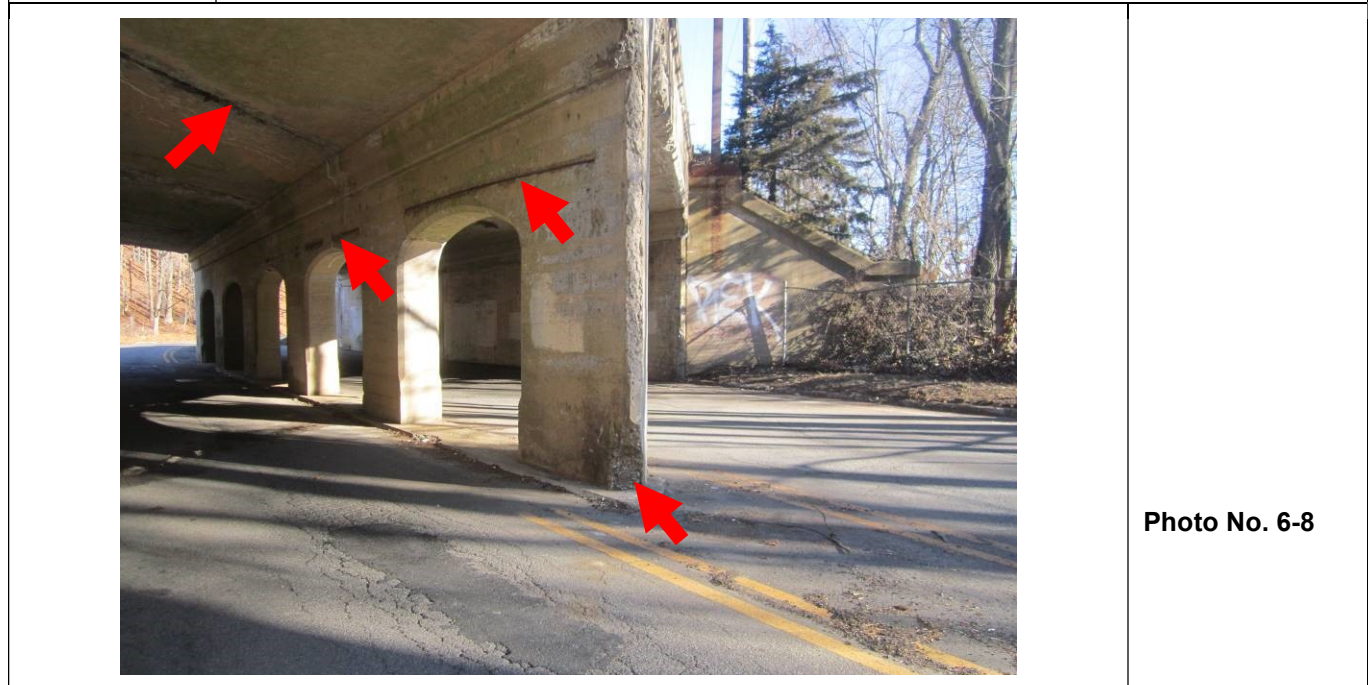
<b>Location:</b>	West abutment, looking southwest.
<b>Description:</b>	General view. Lack of guiderail along northwest wingwall. Moderate crack along the entire length of the abutment breastwall.

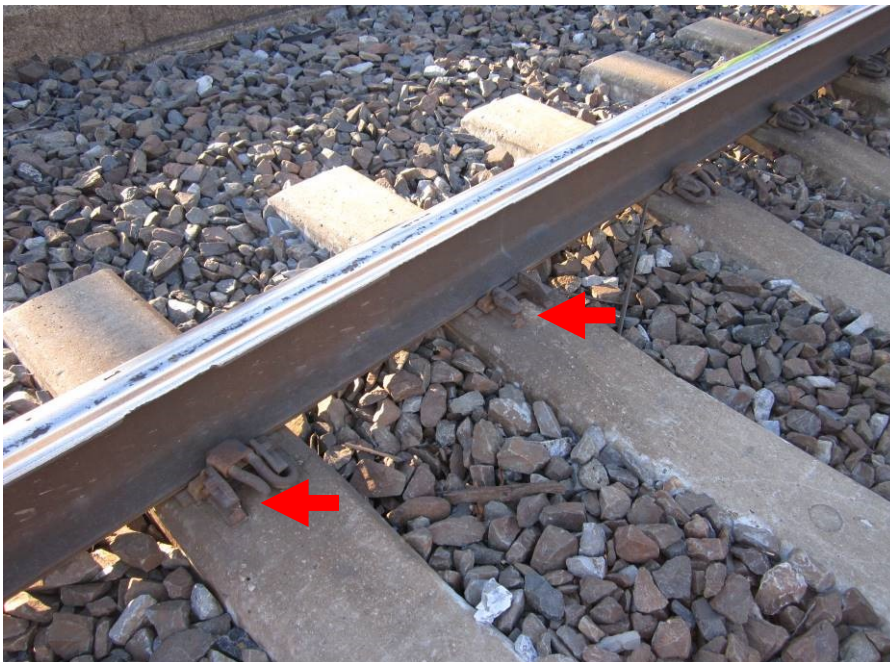
<b>Location:</b>	Span 2, west face of pier, looking east.
<b>Description:</b>	General view. Note spall at bottom of pier at south end. Spall with exposed reinforcement on top of pier. Active water leak mark at first joint.

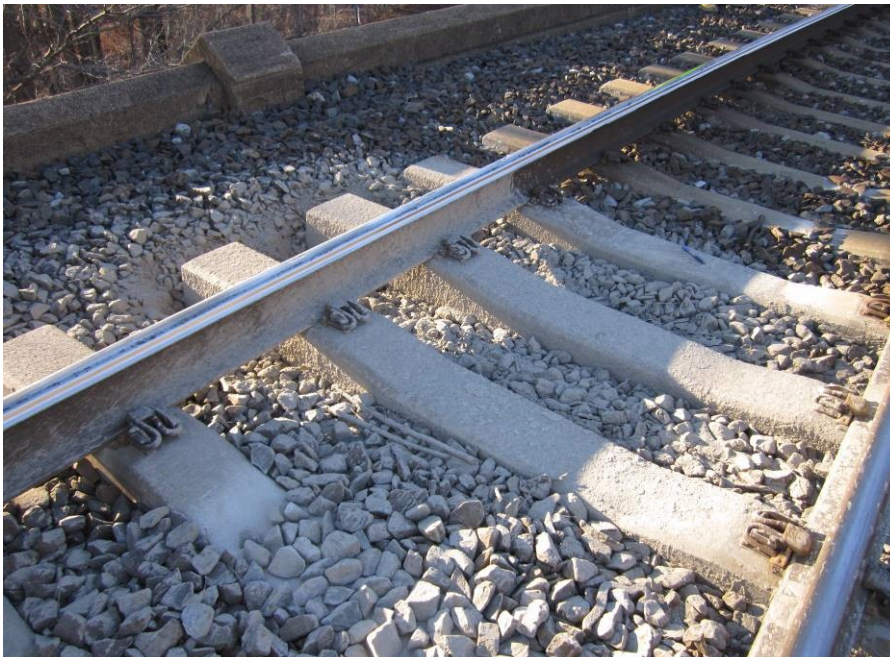
**Description:** Missing and broken pandrol clip.

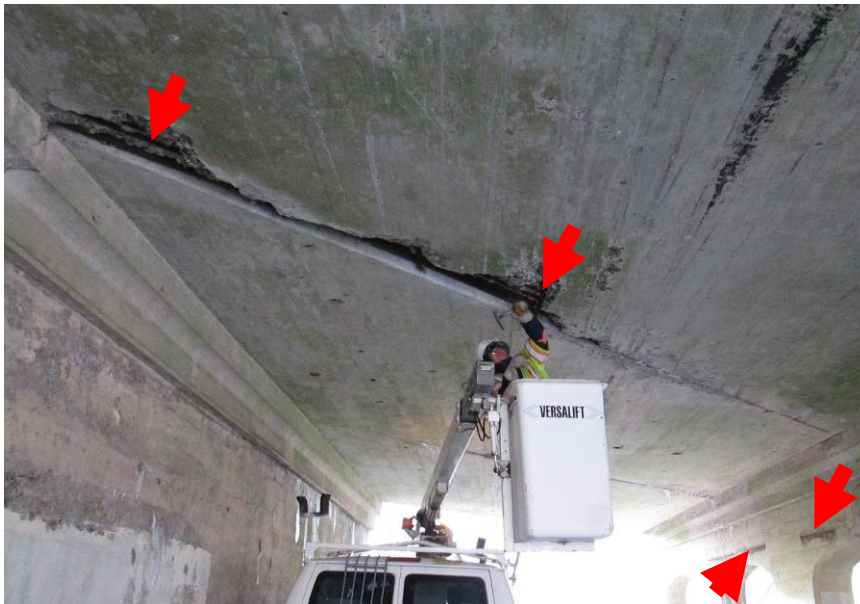
**Description:** Spall on top of parapet.

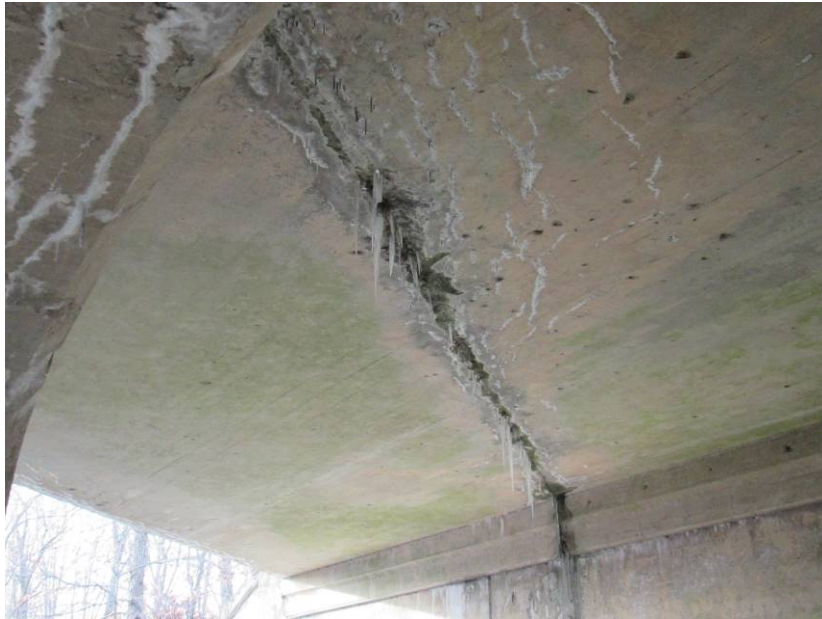
**Description:** Large spall with exposed reinforcement at the underside of slab at joint. Spall with exposed reinforcement at east face of pier.

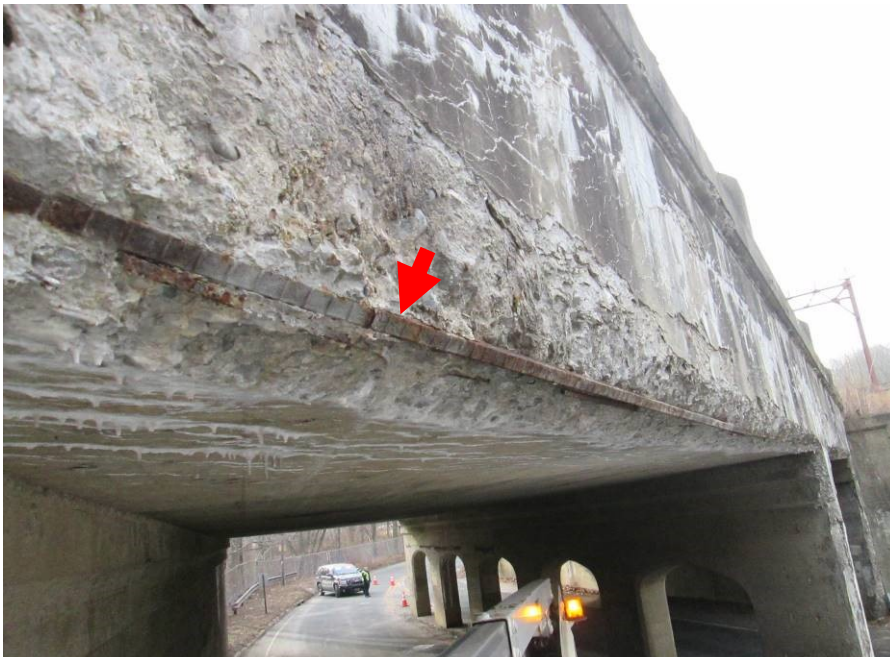
**Description:** Active water leakage at joint.
