North Jersey Transportation Planning Authority

# Concept Development Report

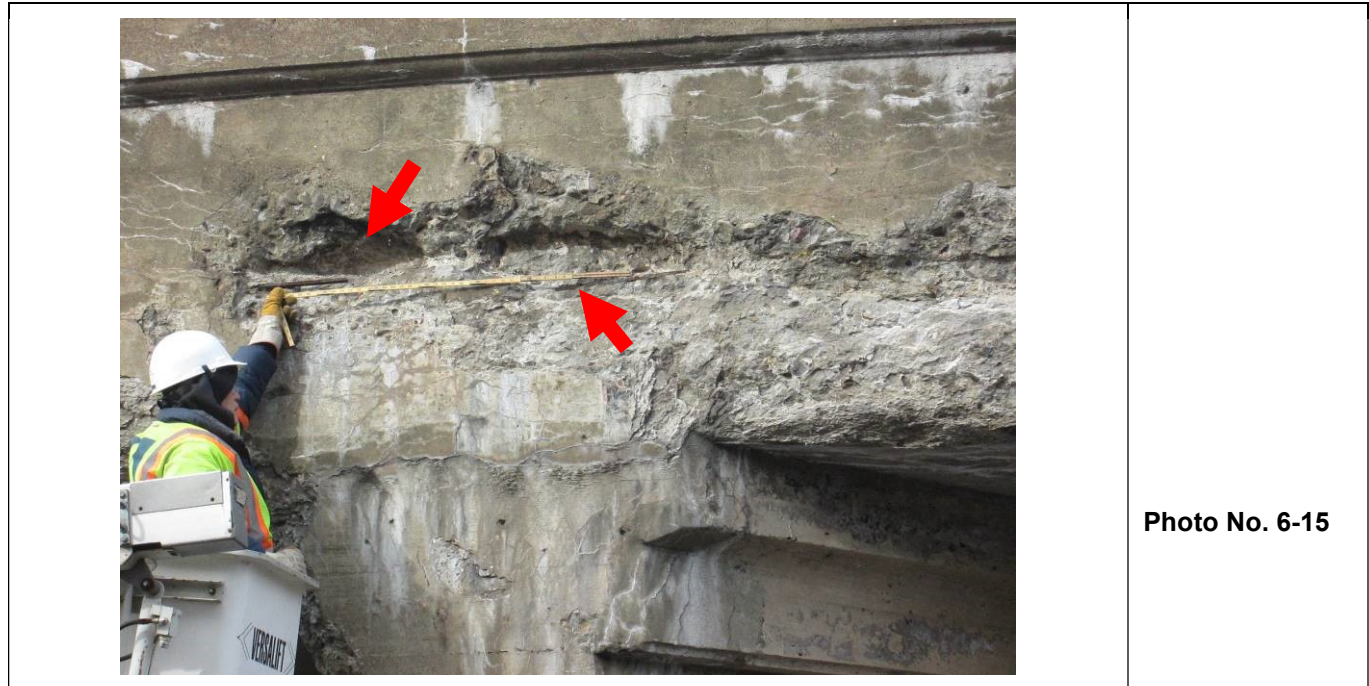
**Description:** Large spall with exposed reinforcement at the underside slab and north fascia. Heavy efflorescence and map cracking adjacent to the spall.

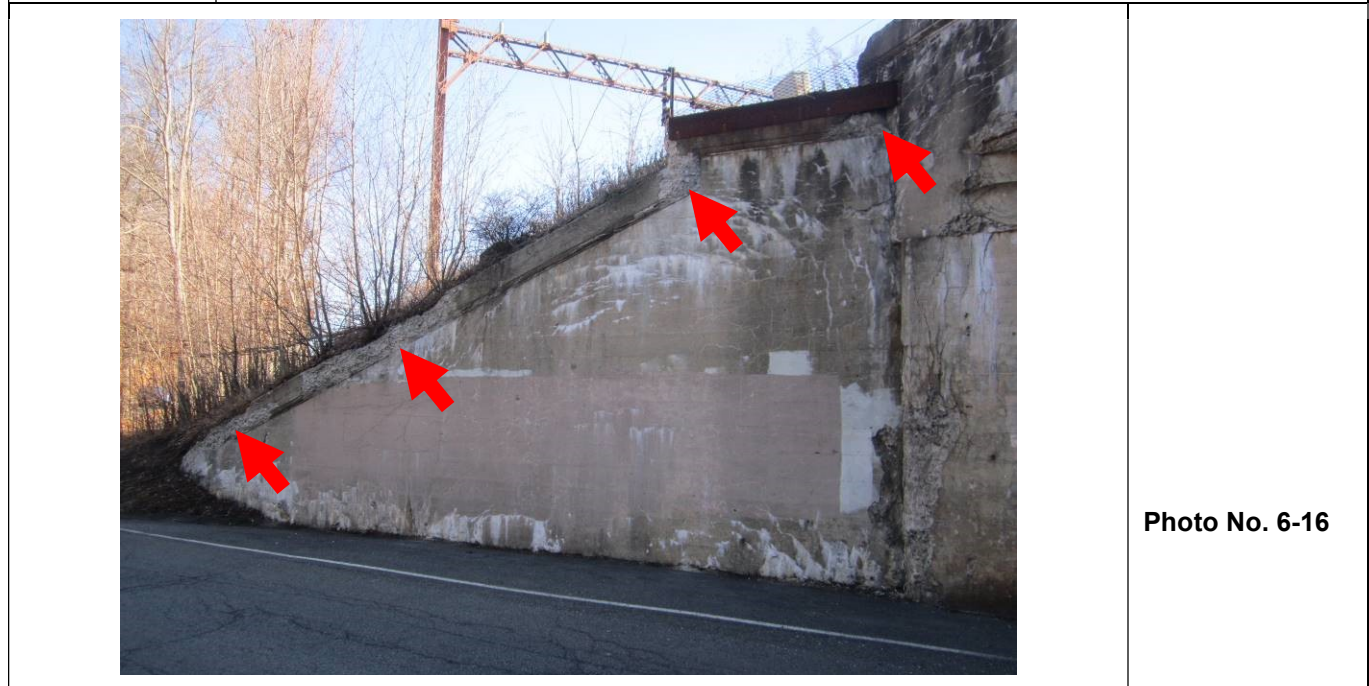
<b>Location:</b>	Top of pier at south fascia, looking northwest.
<b>Description:</b>	Large spall at top of pier at south fascia with exposed reinforcement.

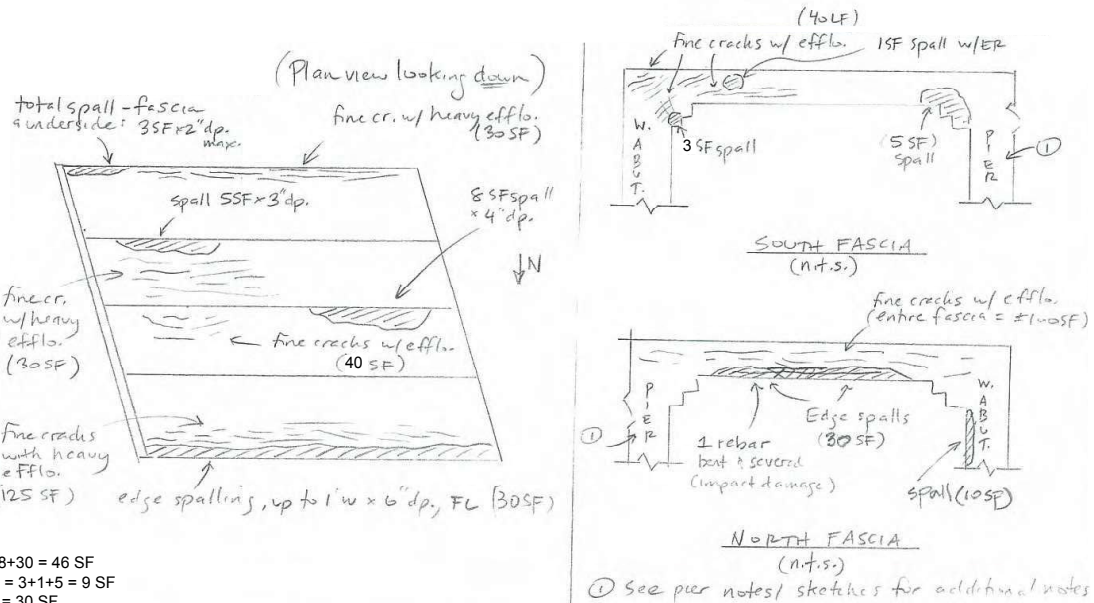
**NJ TRANSIT UNDERGRADE BRIDGE INSPECTIONS – FIELD NOTES**

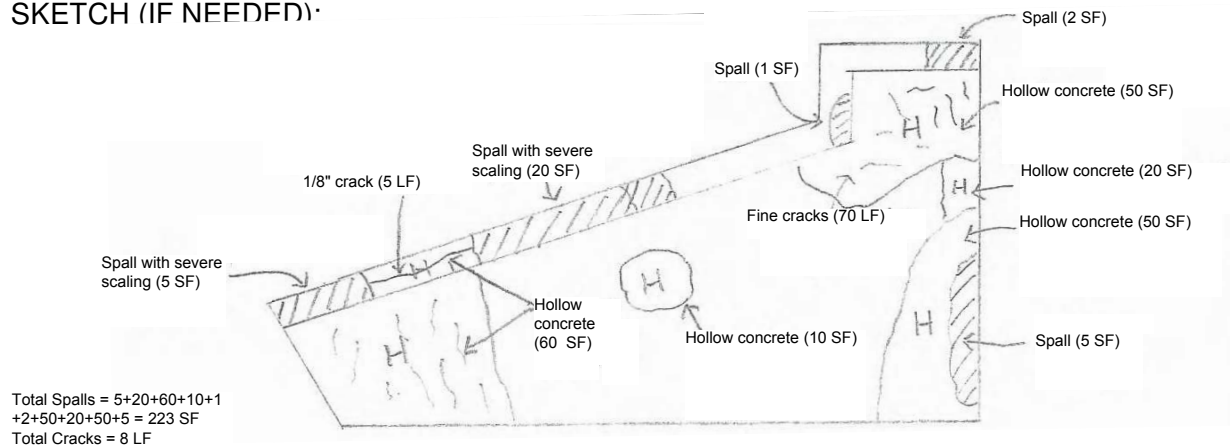
Total Spalls = 5+20+60+10+1  
+2+50+20+50+5 = 223 SF  
Total Cracks = 8 LF

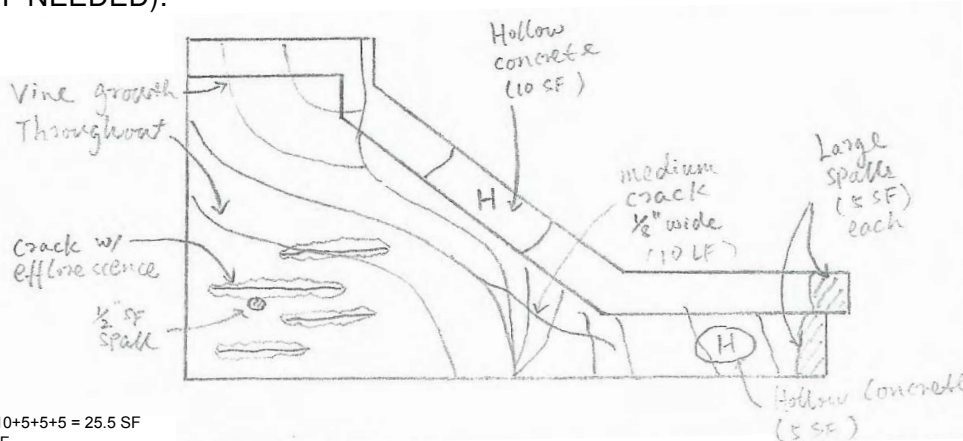
Total Spalls = 0.5+10+5+5+5 = 25.5 SF  
Total Cracks = 10 LF

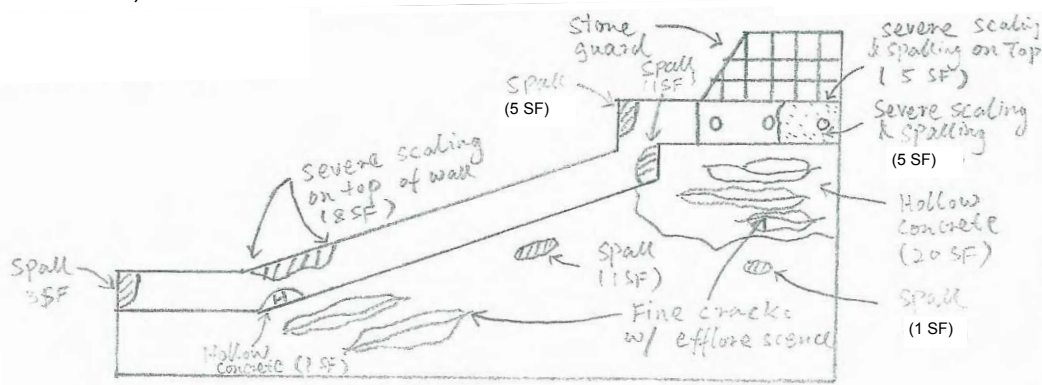
Total Spalls = 3+8+1+1+5+1+5+20+1 = 50 SF

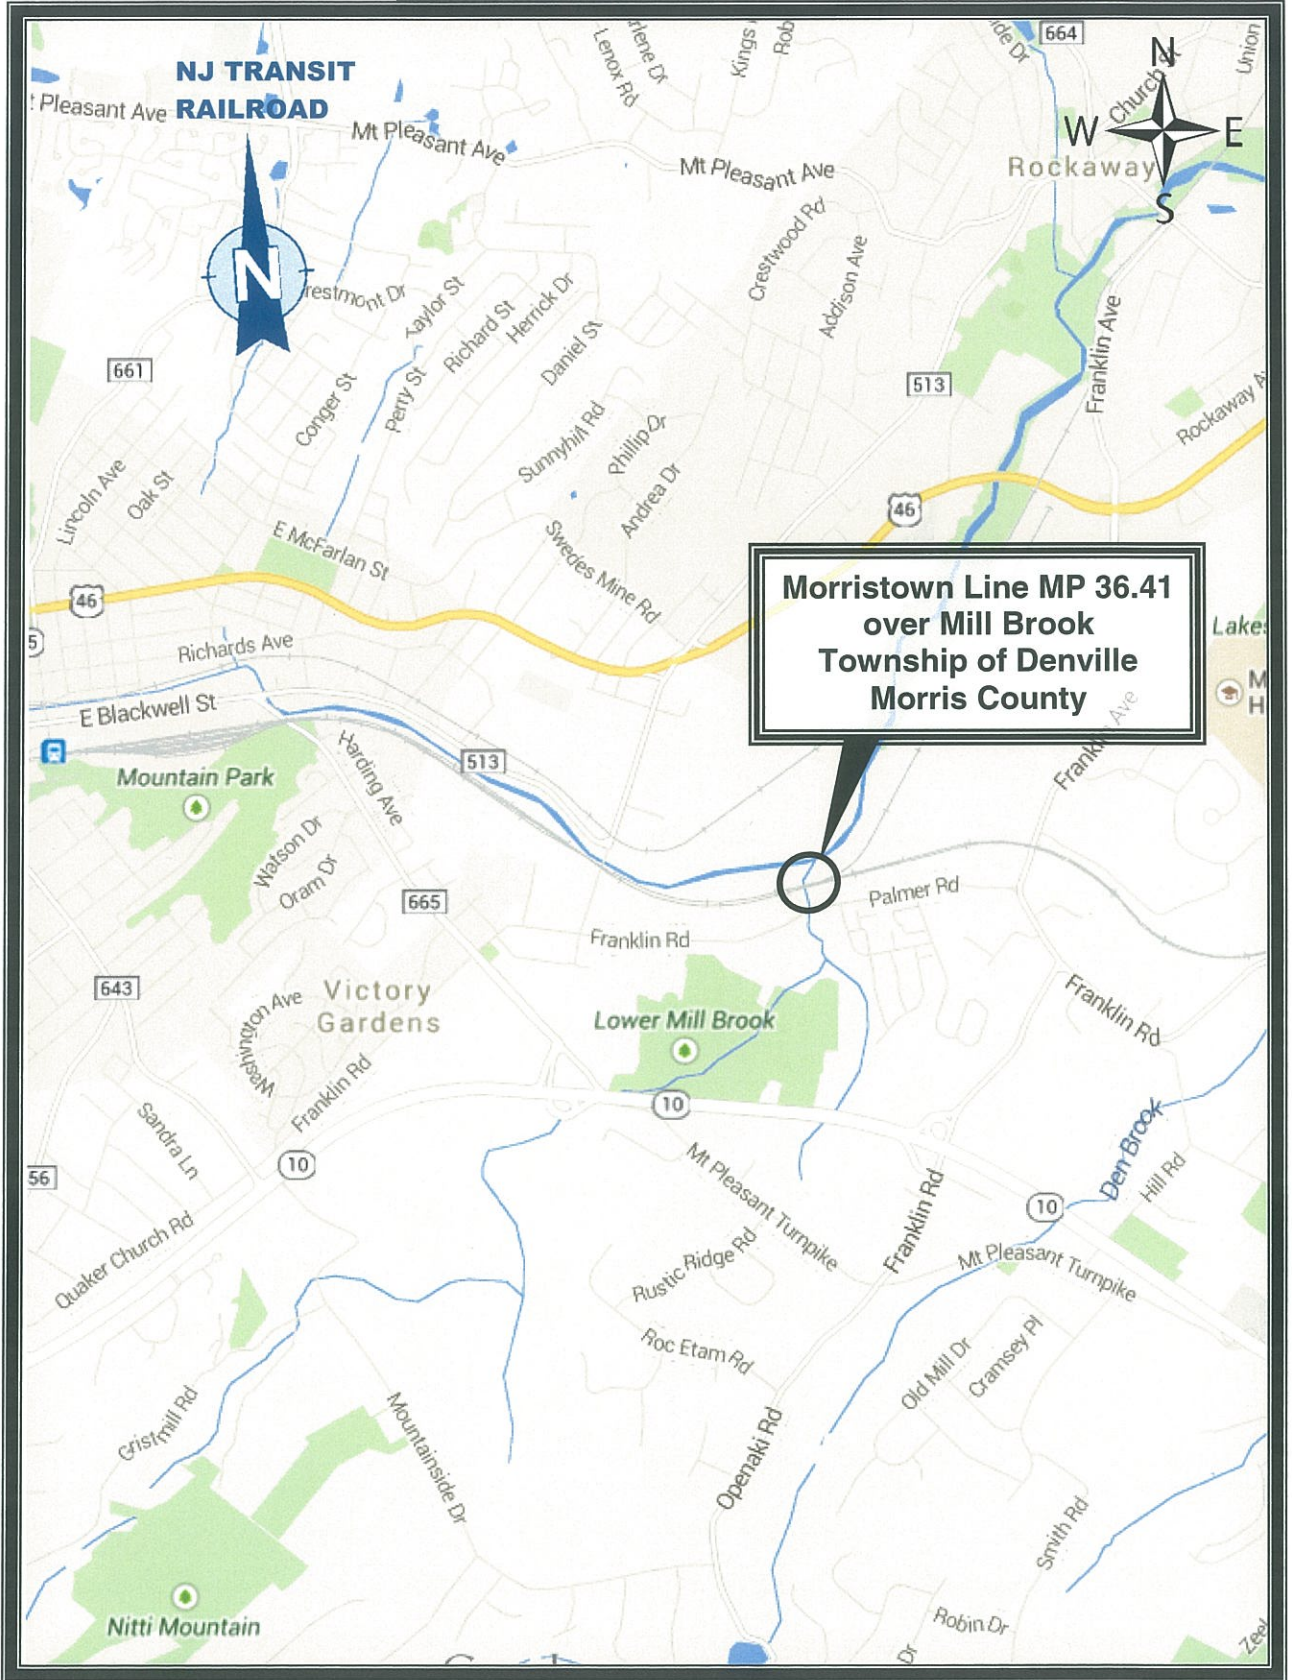
# NEW JERSEY TRANSIT INFRASTRUCTURE ENGINEERING – STRUCTURES BRIDGE EVALUATION SURVEY REPORT CYCLE NO. 5

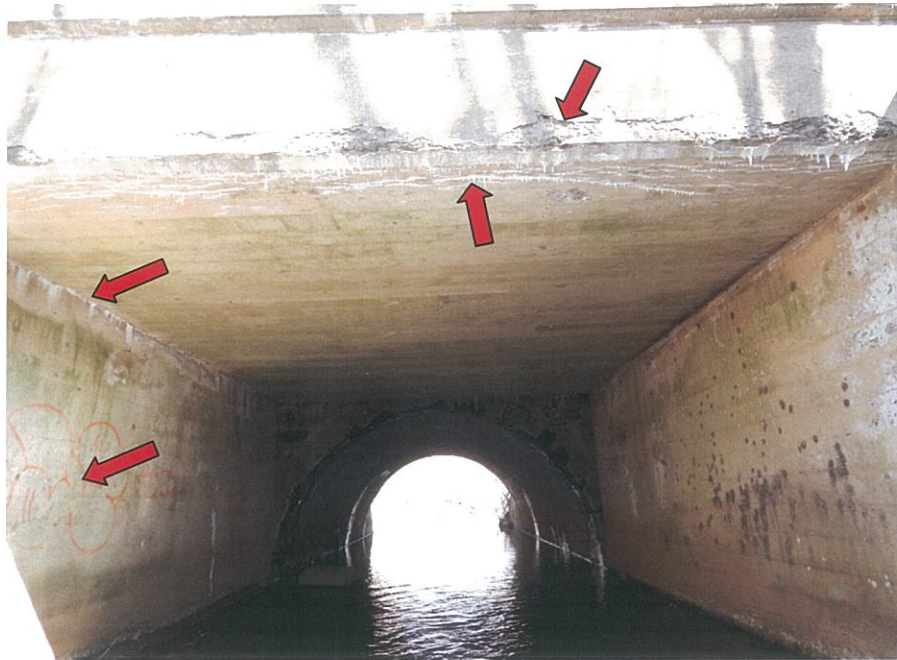
**PHOTO 5-6:** General view of underside of the reinforced concrete deck slab, looking north. Note spalled/ delaminated concrete and fine cracks with efflorescence at the south fascia and underside of the concrete slab. Note also, moderate to heavy efflorescence between slab/ west abutment interface and graffiti at the west abutment breastwall.

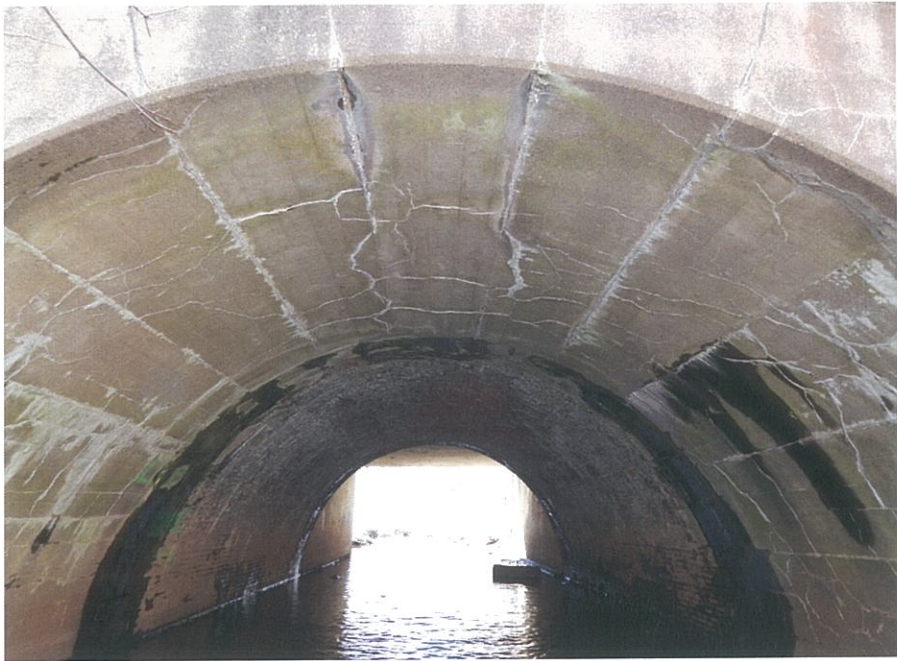
**PHOTO 5-7:** General view of intrados of concrete and brick arches, looking south. Note several fine cracks with efflorescence, water staining and active water leakage at the concrete arch intrados. Note also, heavy efflorescence throughout the brick arch.

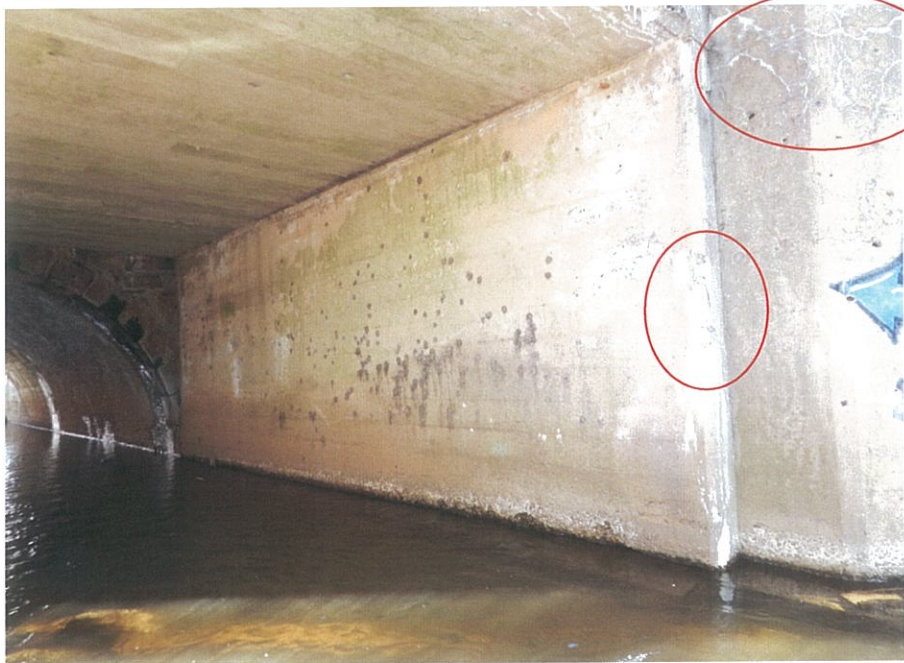
**PHOTO 5-8:** General view of the east abutment breastwall of concrete slab, looking northeast. Note fine cracks with efflorescence at top of the southeast wingwall. Note also, small spall with heavy efflorescence along the south edge, approximately located at mid height of the breastwall.

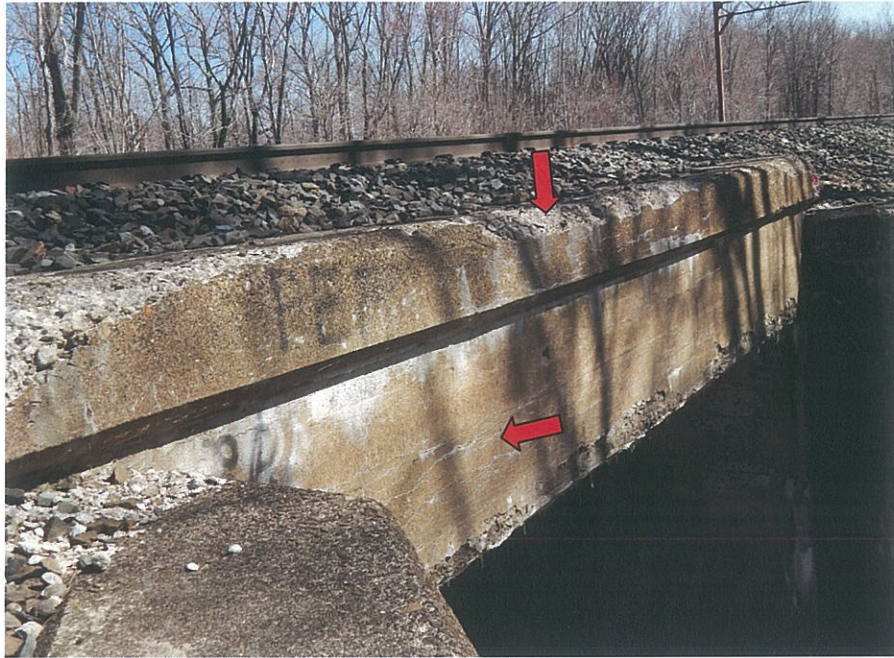
**PHOTO 5-9:** Spalled and or delaminated concrete throughout the top of south headwall, looking northeast. Note fine cracks with efflorescence at random locations of the headwall.

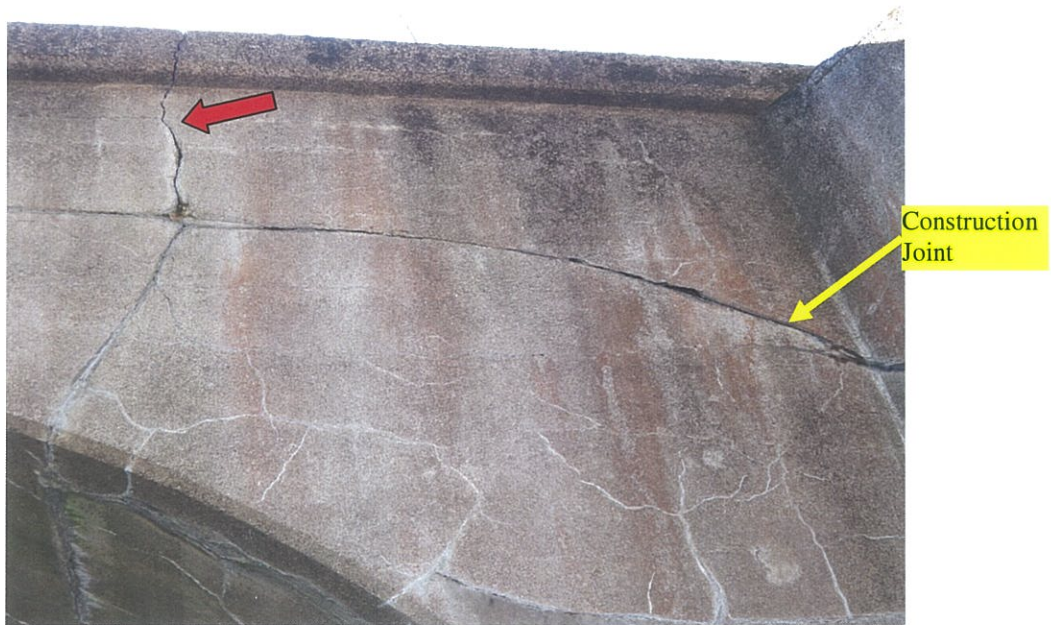
**PHOTO 5-10:** Wide crack at west end of the north spandrel wall, looking south (arrow). Note fine map cracks with efflorescence.

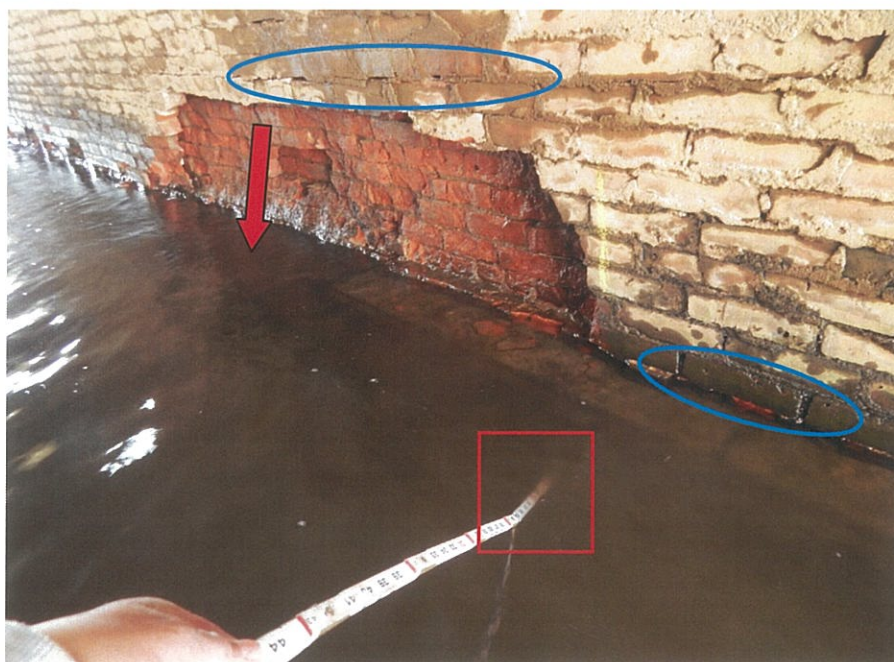
**PHOTO 5-12:** Missing bricks at west side of the brick arch, looking southwest. Note missing section of stone course approximately at center of the brick arch (arrow). Note also, the stone course is undermined throughout the brick arch length (rectangle) and deteriorated pointing at the brick arch intrados (circles).

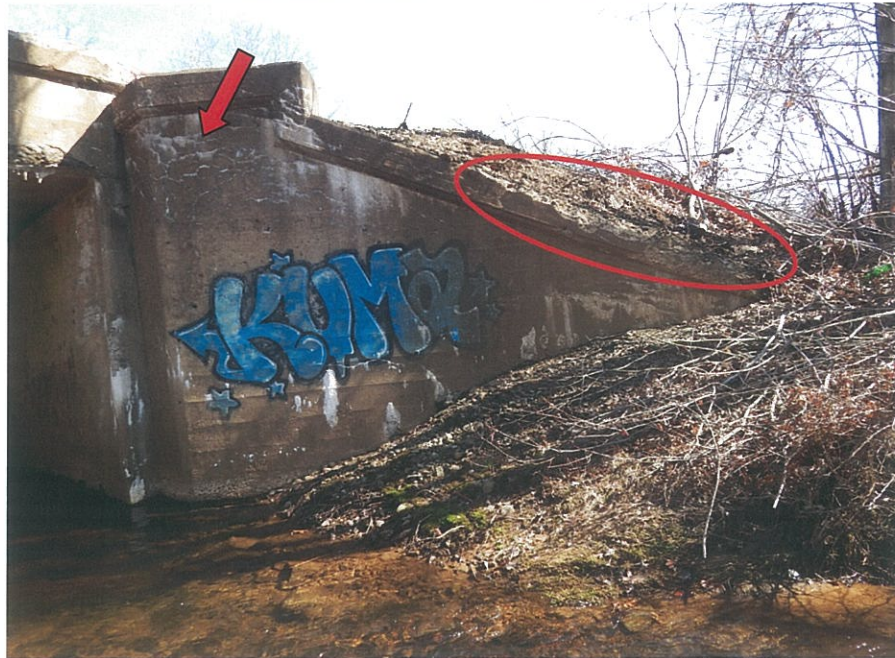
**PHOTO 5-13:** Large spall (circle) along the top face of the southeast wingwall, looking northeast. Note scattered fine cracks with efflorescence (arrow) at the vertical face of the wingwall.

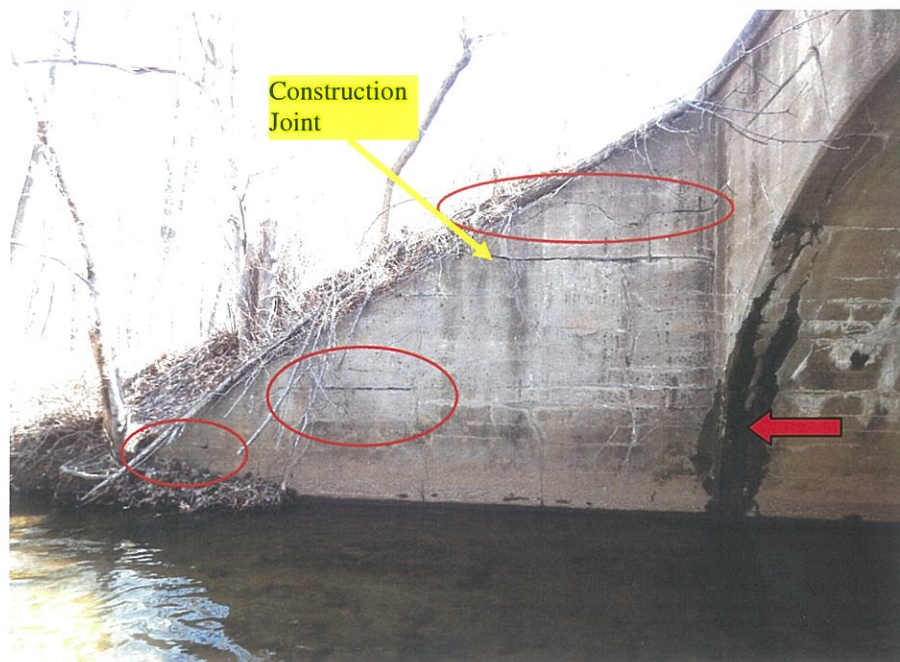
**PHOTO 5-14:** Medium to wide cracks (circles) at isolated locations of the northeast wingwall, looking east. Note tree growth behind the wingwall and active water leakage at northeast corner of the concrete arch (arrow).

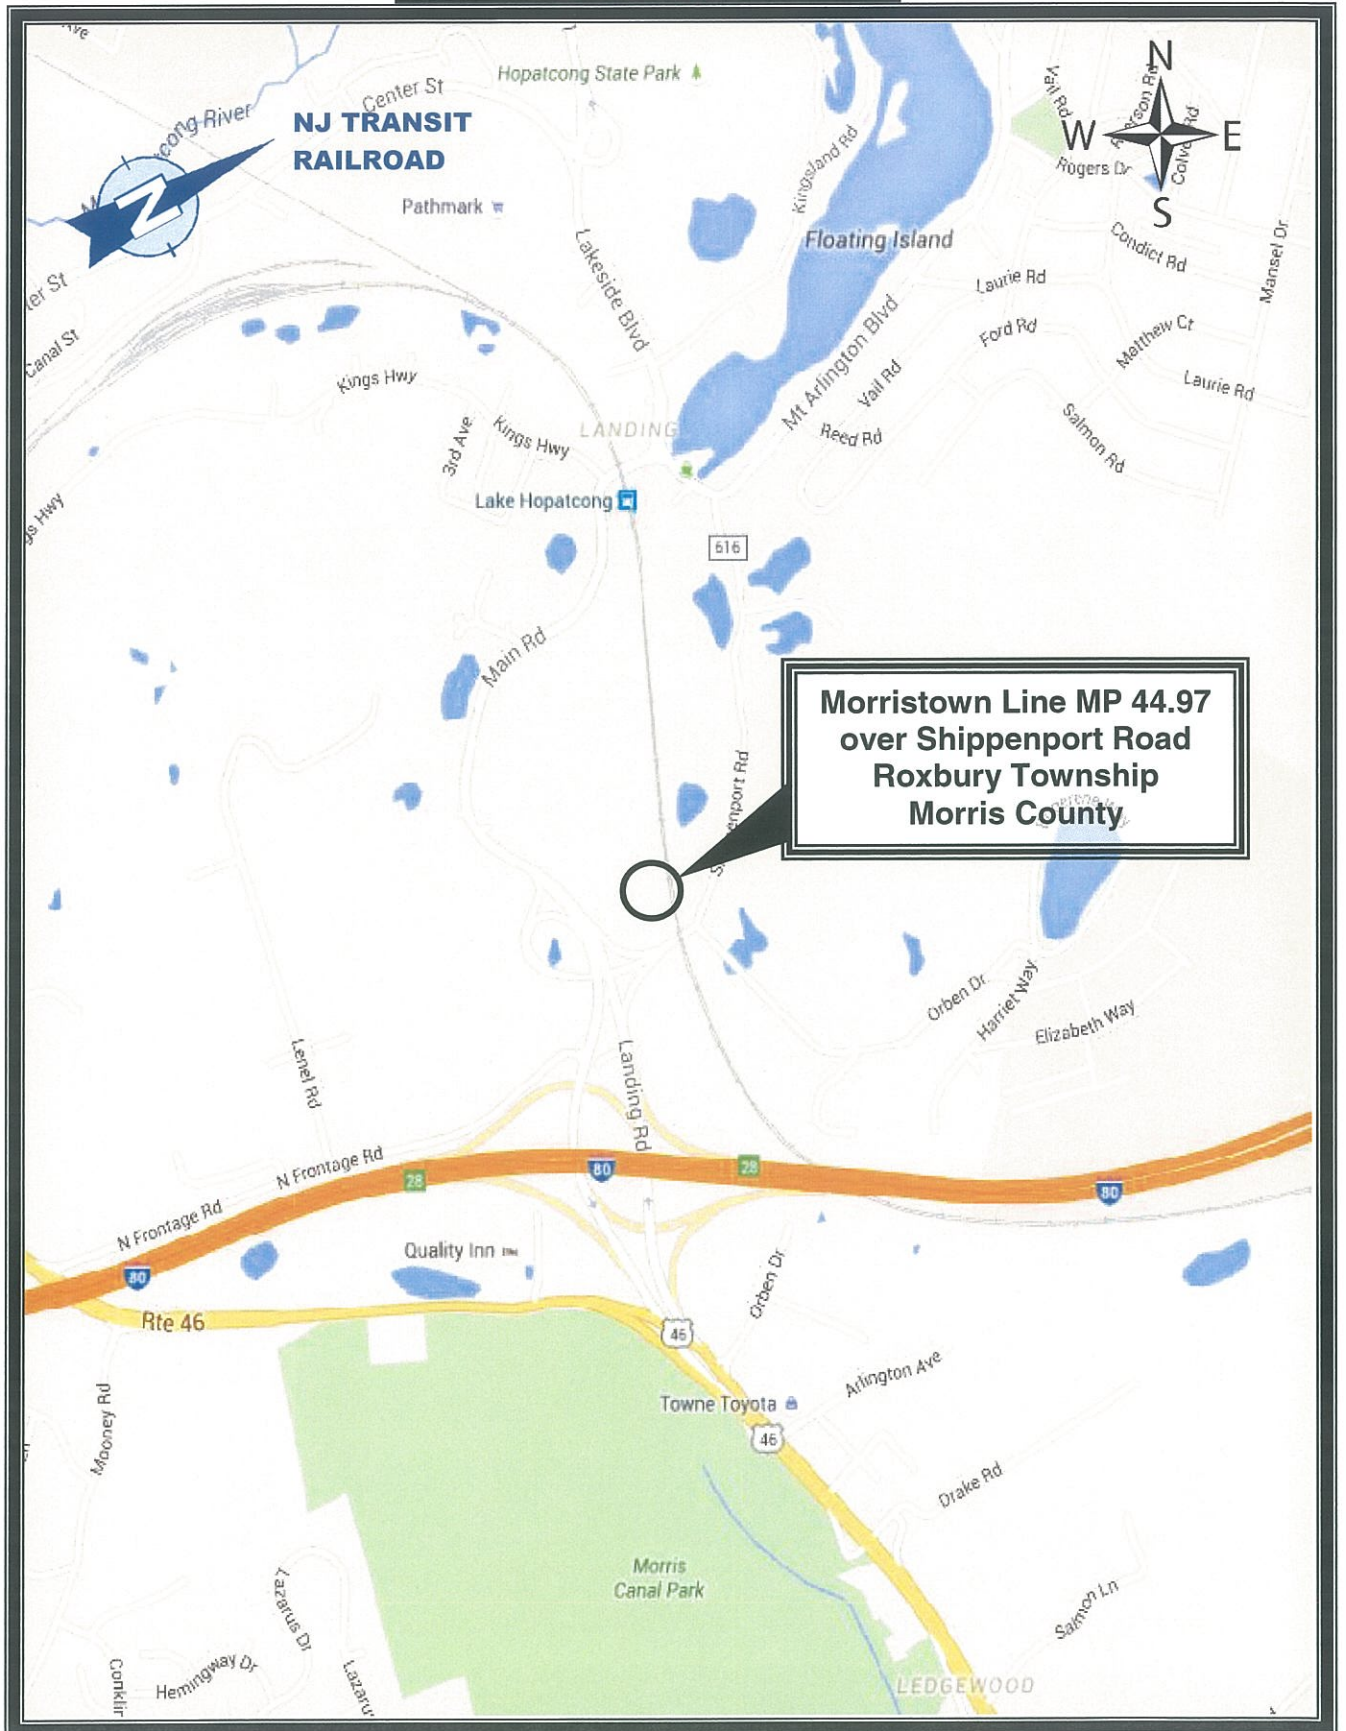
# NEW JERSEY TRANSIT INFRASTRUCTURE ENGINEERING – STRUCTURES BRIDGE EVALUATION SURVEY REPORT CYCLE NO. 5

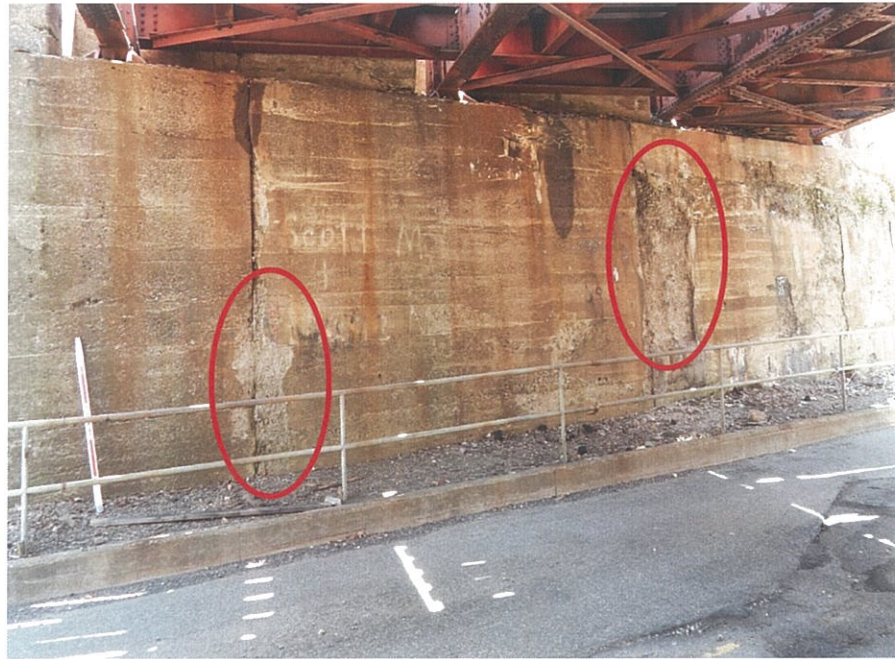
**PHOTO 5-7:** General view of the east abutment, looking east. Note the large spalls and delaminated concrete throughout the abutment (Circles).

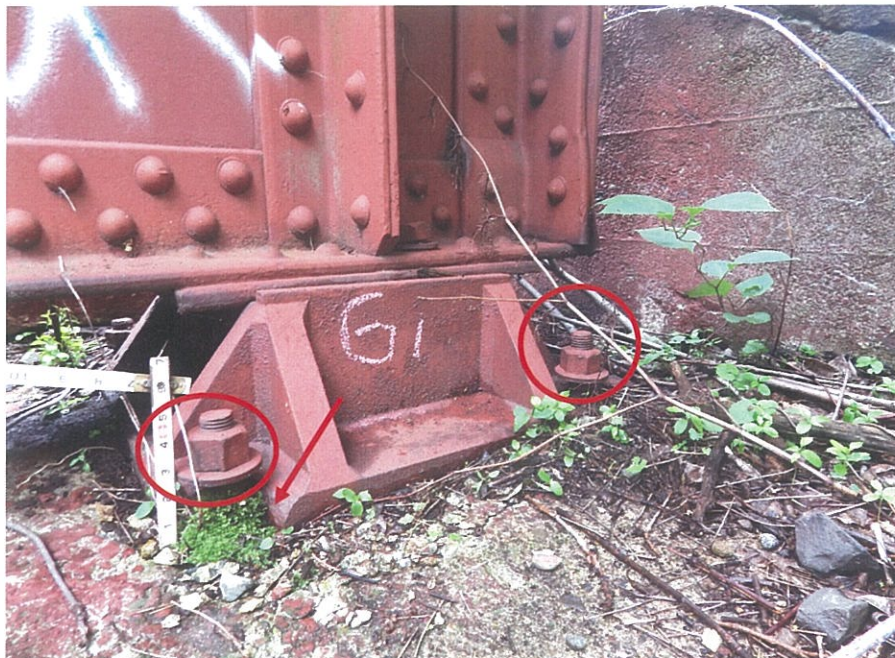
**PHOTO 5-8:** General view of bearing G1 over the east abutment, looking northeast. Note raised anchor bolt nuts (Circles) and broken masonry plate at the southwest corner of the bearing (Arrow).

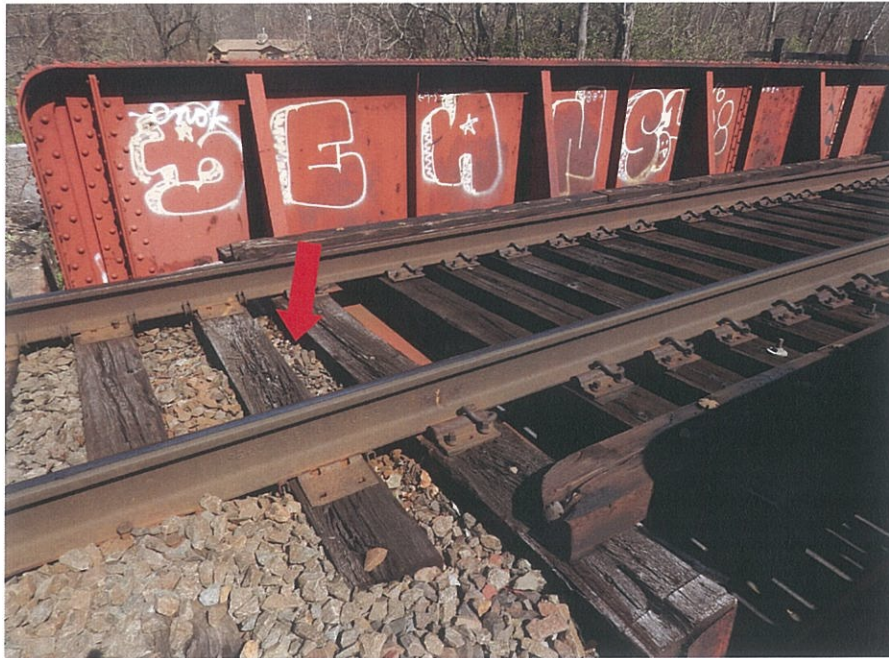
**PHOTO 5-9:** Decayed ties at the west approach on Track #1, looking northeast. Note low ballast adjacent to the bridge (Arrow) and graffiti at the web plate of Girder G4.

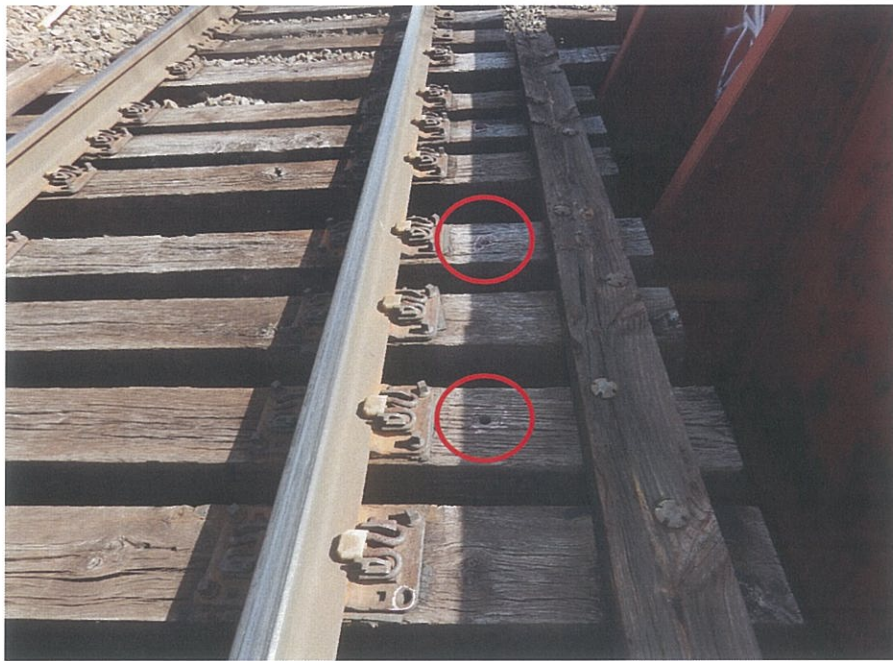
**PHOTO 5-11** Missing J-hook bolts at the south side of Track #2, looking east.

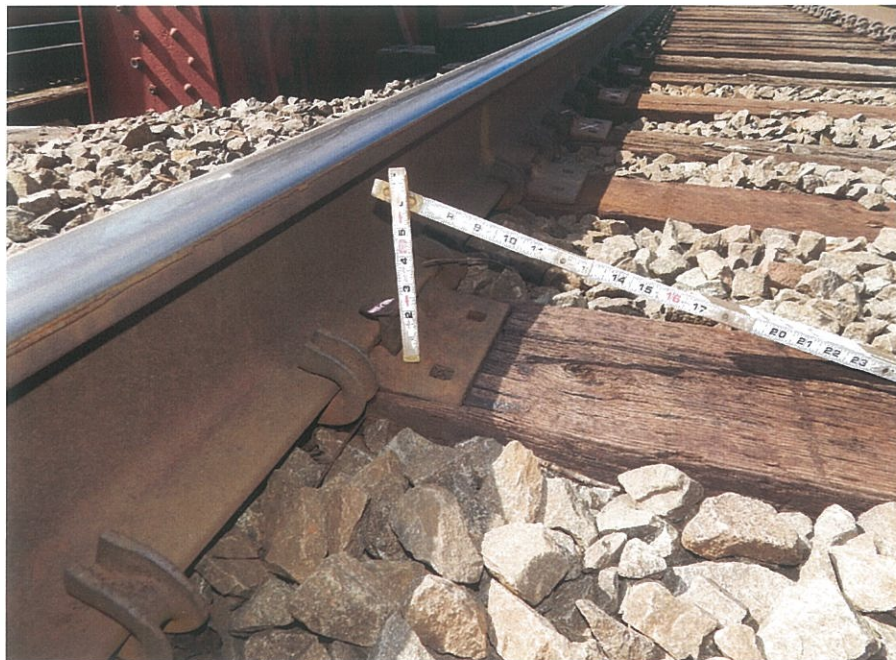
**PHOTO 5-12:** Raised spike at the south rail on Track #1 at the east approach, looking southwest.

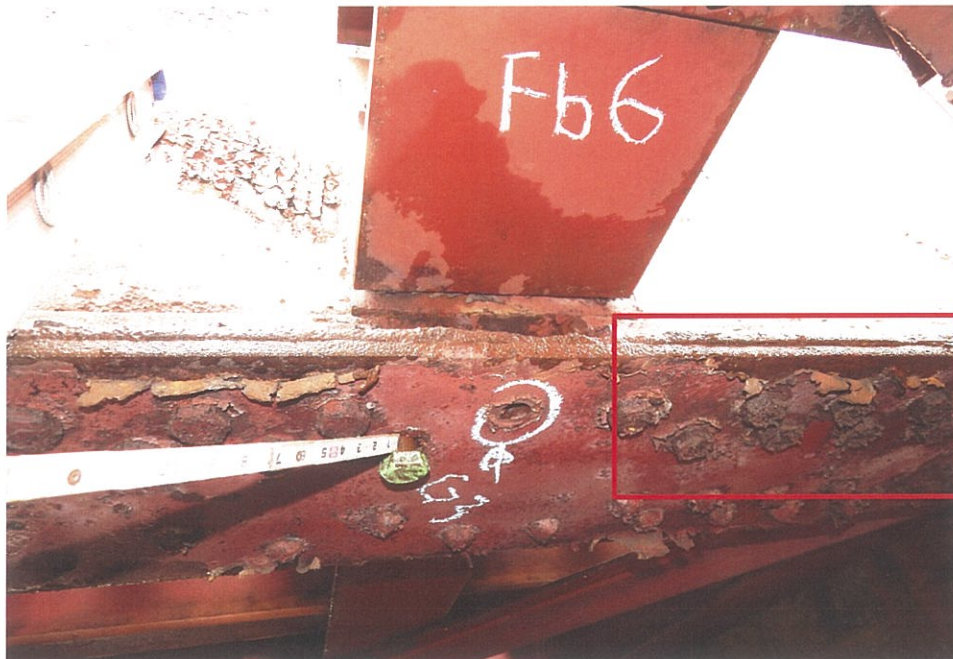
**PHOTO 5-14:** Missing bolt and loose bolt at the bottom flange of Girder G3 at Floorbeam FB6, looking south. Note the rivets at the bottom flange of Girder G3 exhibit greater than 50% head loss (Rectangle).

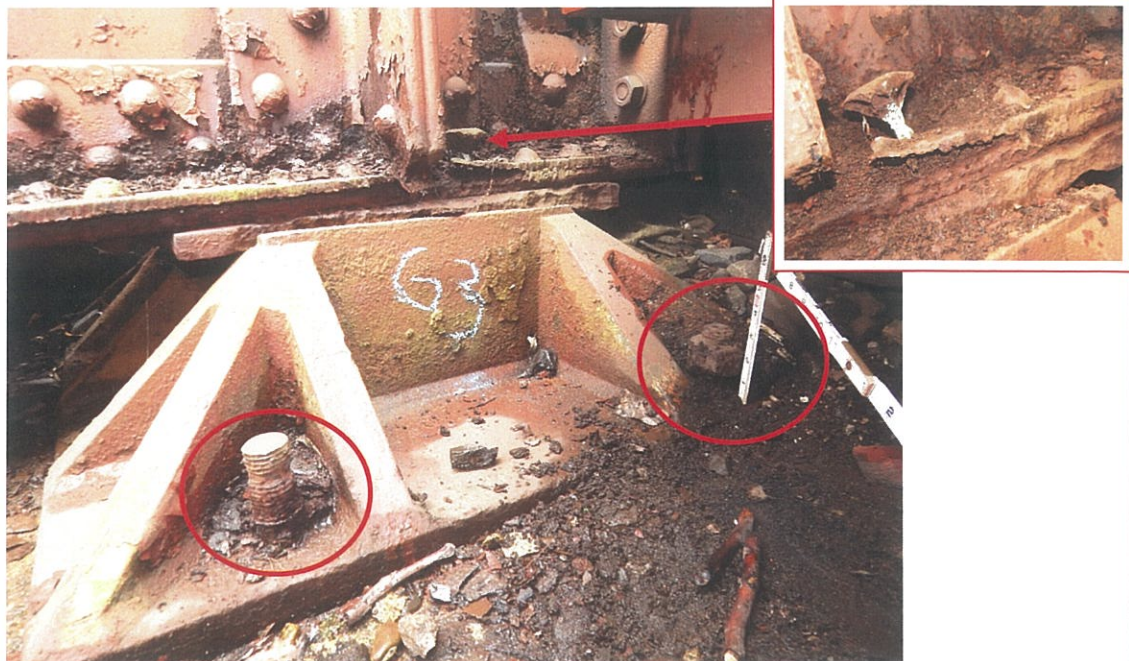
**PHOTO 5-16:** Missing and raised anchor bolt nuts (Circles) at the north side of Girder G3 bearing over the west abutment, looking southwest. Note up to 100% section loss to the sole plate bolt (Insert). Note also, the bearing is seized.

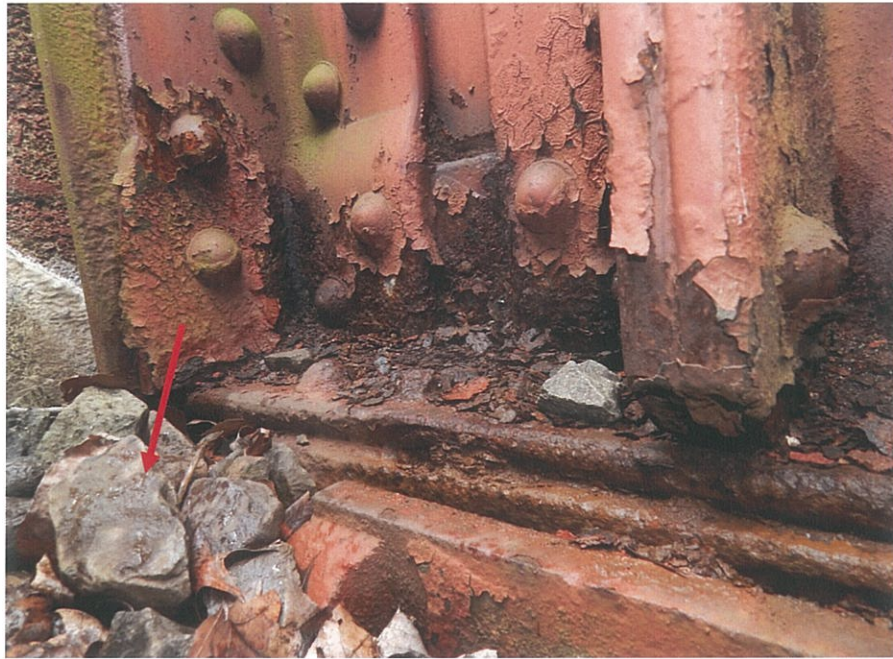
**PHOTO 5-17:** Missing sole plate bolt at the north side of Girder G3 bearing over the east abutment, looking southeast. Note the accumulation of ballast on the bearing seat.

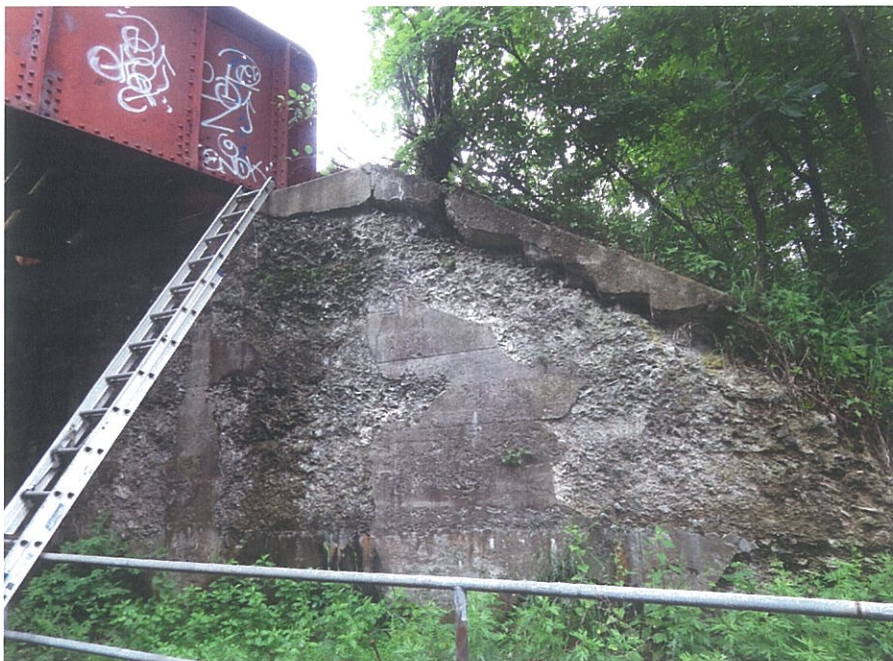
**PHOTO 5-18:** Large spalls and delaminated concrete throughout the southeast wingwall, looking northeast. Note tree growth behind the wingwall.

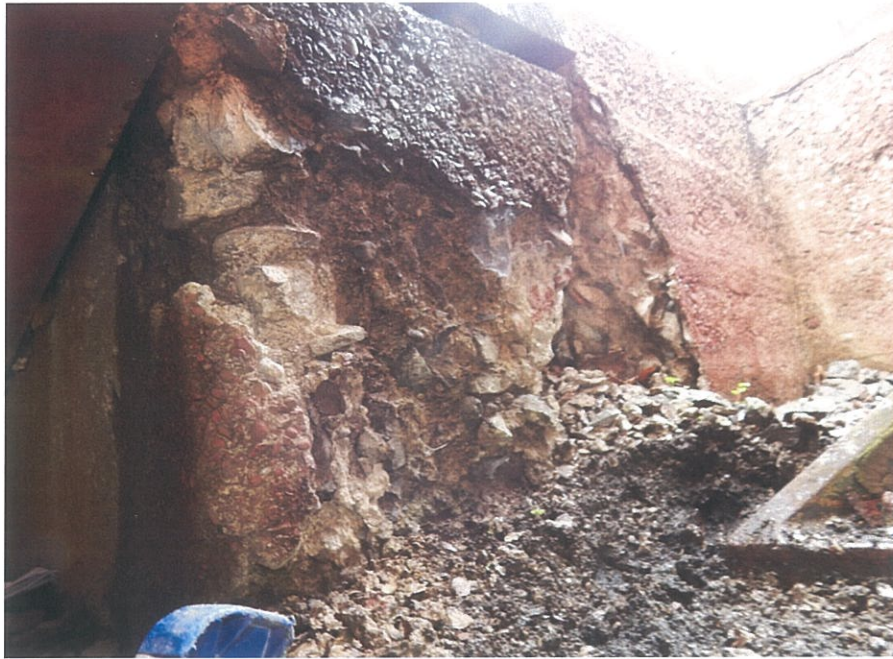
**PHOTO 5-19:** Large spall and delaminated concrete at the north face of the west abutment backwall adjacent to the Girder G4, looking southwest.

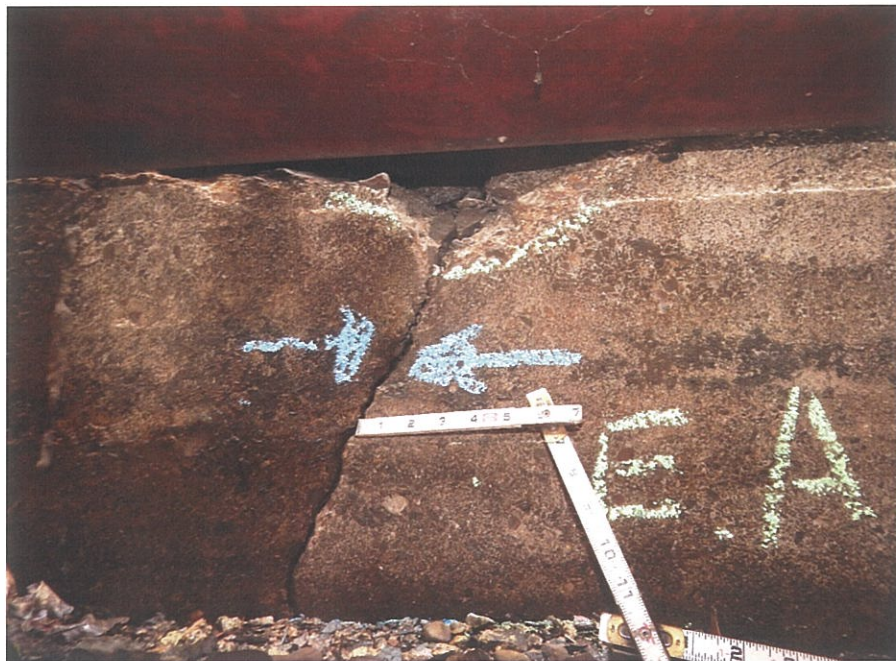
**PHOTO 5-20:** 1/4" wide crack and small spall at the east abutment backwall between Girders G3 and G4, looking east.

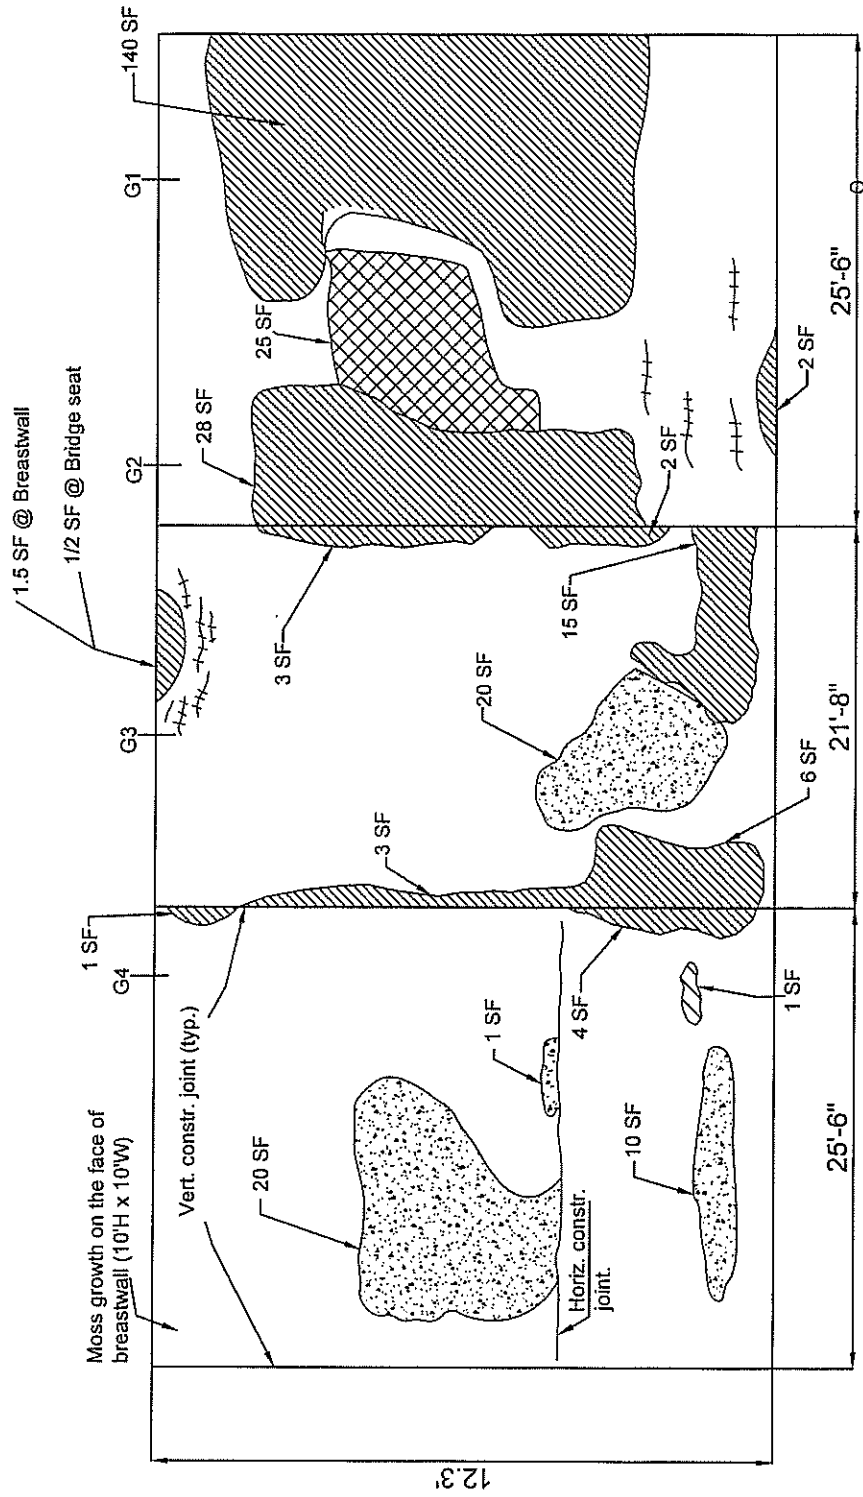
- Legend:**
- Hollow sounding concrete
  - Light scaling (Up to 1" Max.)
  - Spalling / Severe scaling (Up to 6" DP. Max.)
  - Fine cracks w/ efflorescence
