North Jersey Transportation Planning Authority

# Concept Development Report

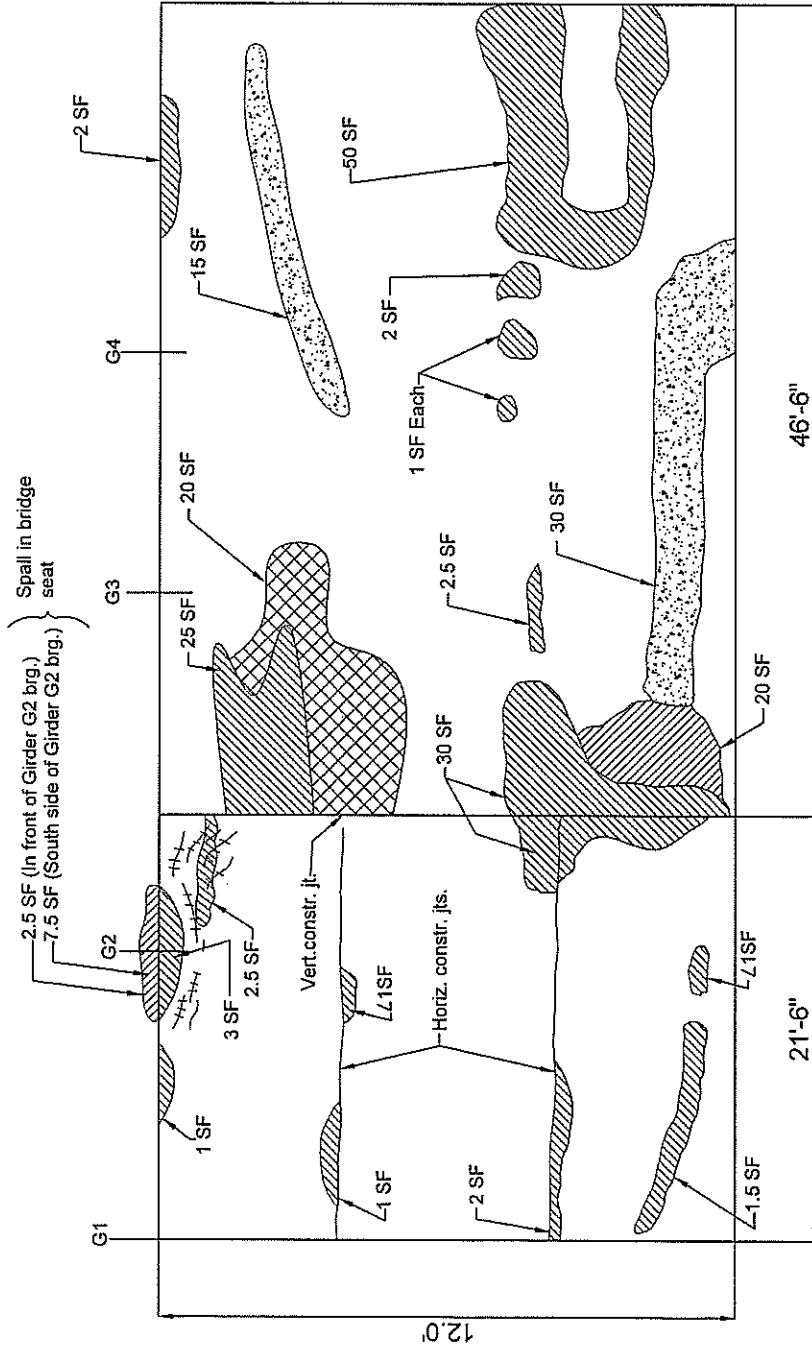
- Legend:**
- Hollow sounding concrete
  - Light scaling (Up to 1/2" DP Max.)
  - Spalling / Delaminated concrete (Up to 13" DP, Max.)
  - Fine cracks w/ efflorescence

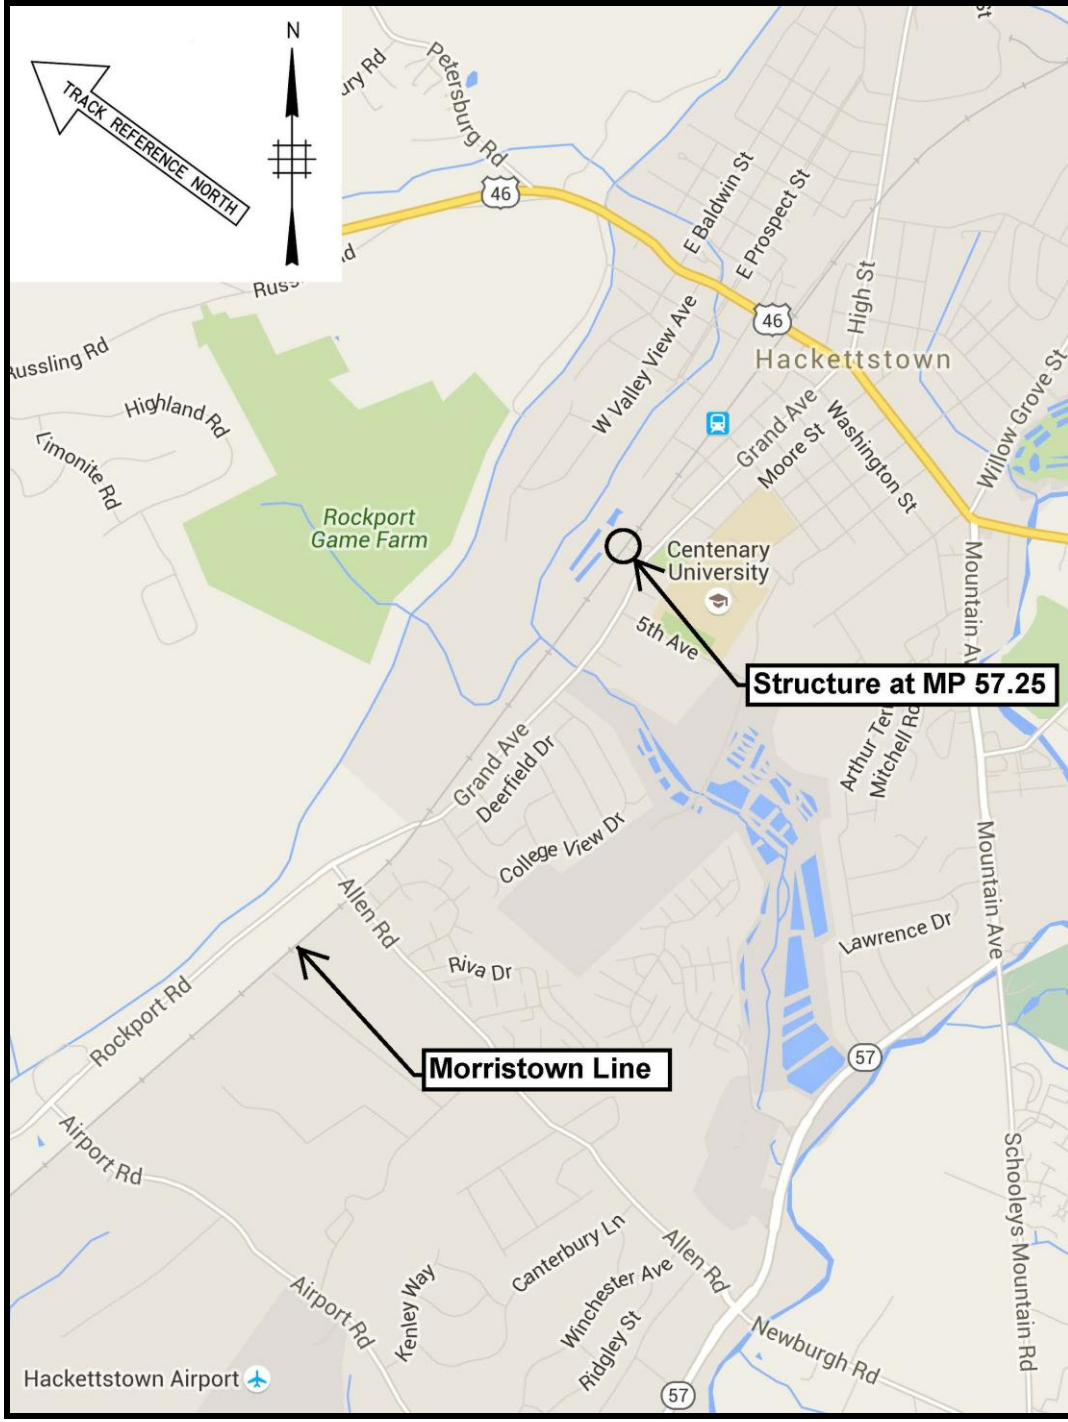
LOCATION MAP  
 MORRISTOWN LINE MP 57.25  
 Over DRAIN  
 HACKETTSTOWN, WARREN COUNTY  
 NEW JERSEY

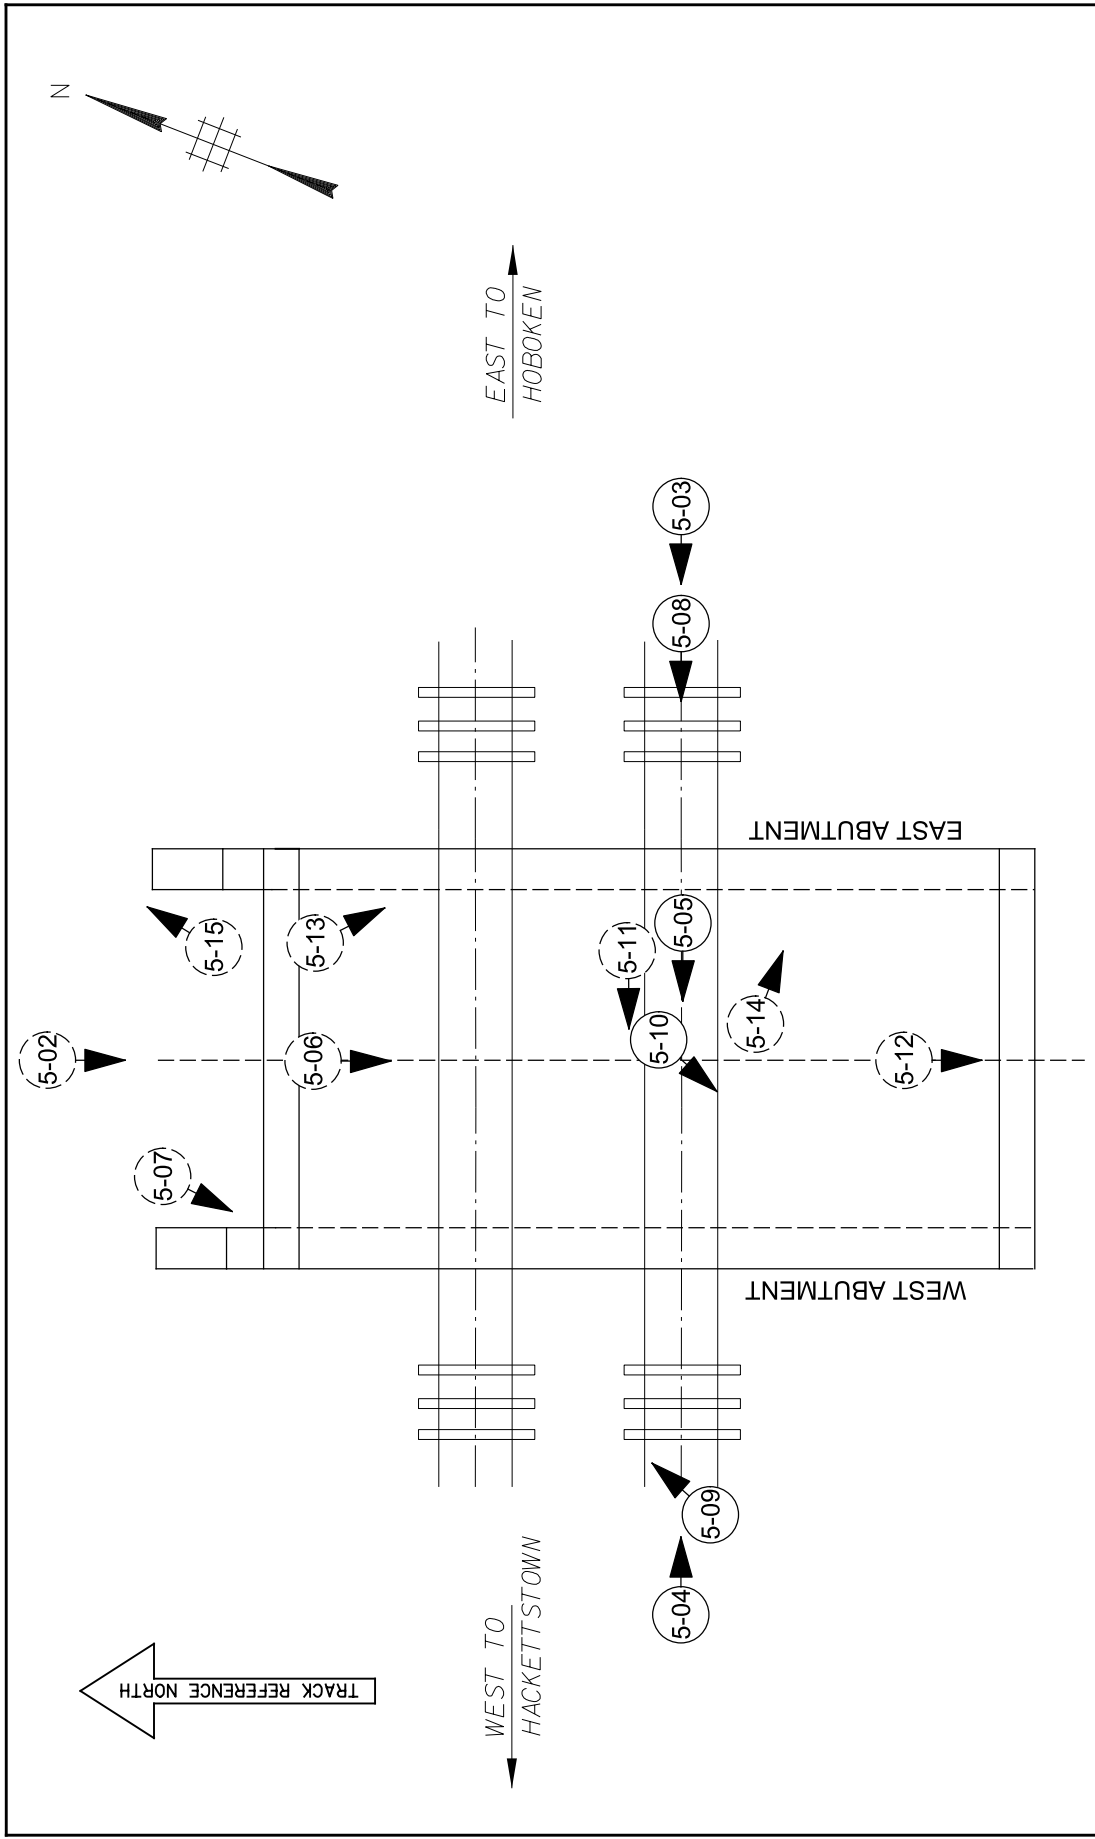
<b>NEW JERSEY TRANSIT</b>	
MORRISSETOWN LINE MP 57.25 OVER DRAIN	
PHOTO LOCATION PLAN	
Munic.: Hackettstown	Cycle No.: 5
County: Warren	Date: 01/05/16
 850 BEAR TAVERN ROAD WEST TRENTON, NJ 08628

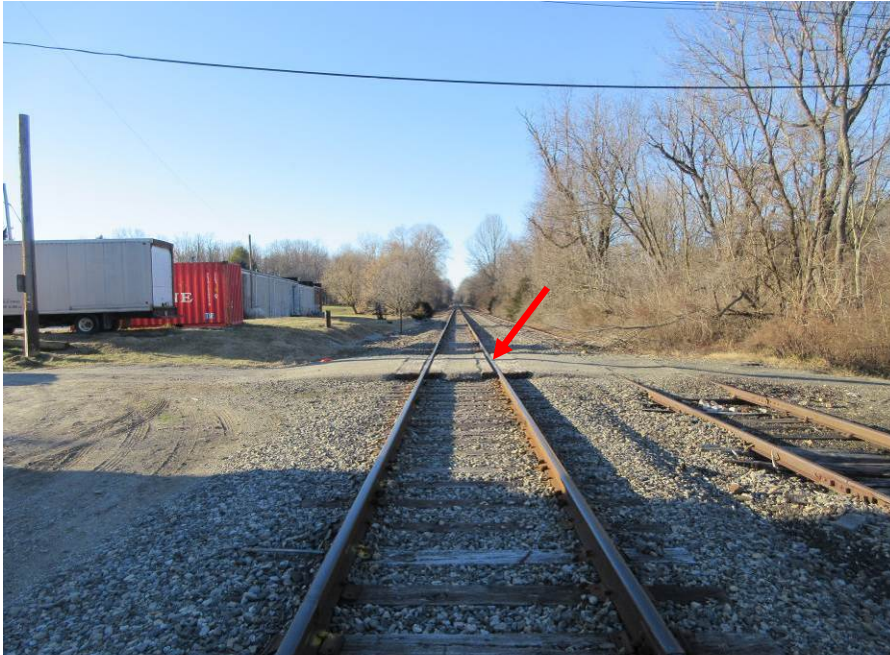
**Description:** General view. Note: Heavy vegetation growth obstructing view. Medium crack in north headwall.

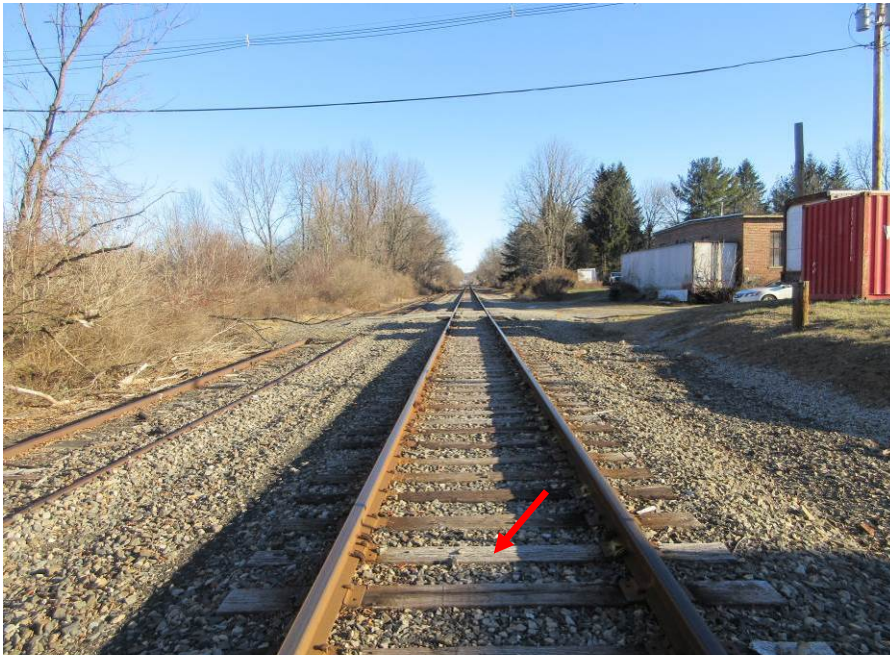
**Description:** General view. Note: Grade crossing covers some ties along the east approach. Work Done: Several ties have been replaced since previous cycle.

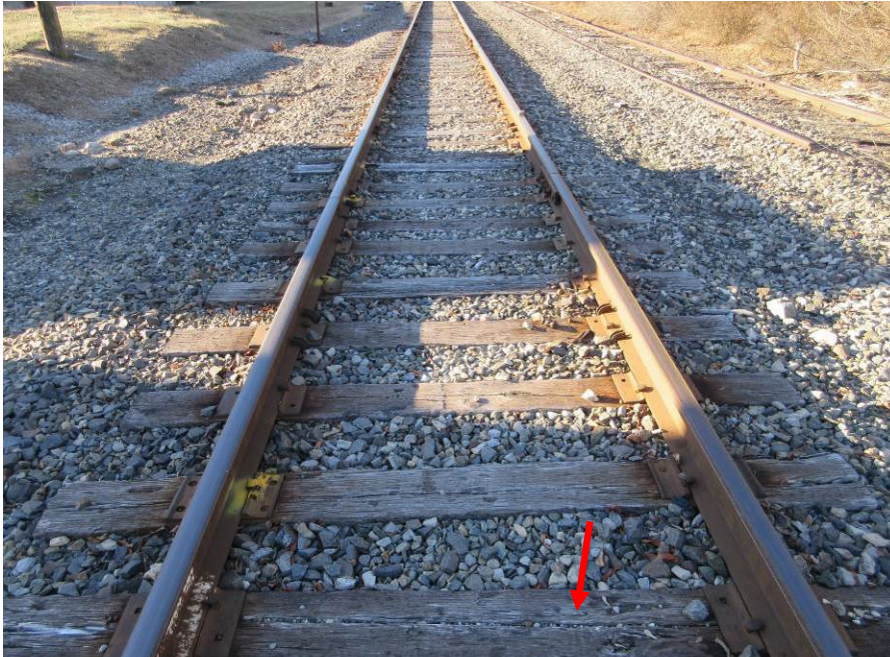
**Description:** General view. Note: Work Done: Several ties have been replaced since previous cycle.

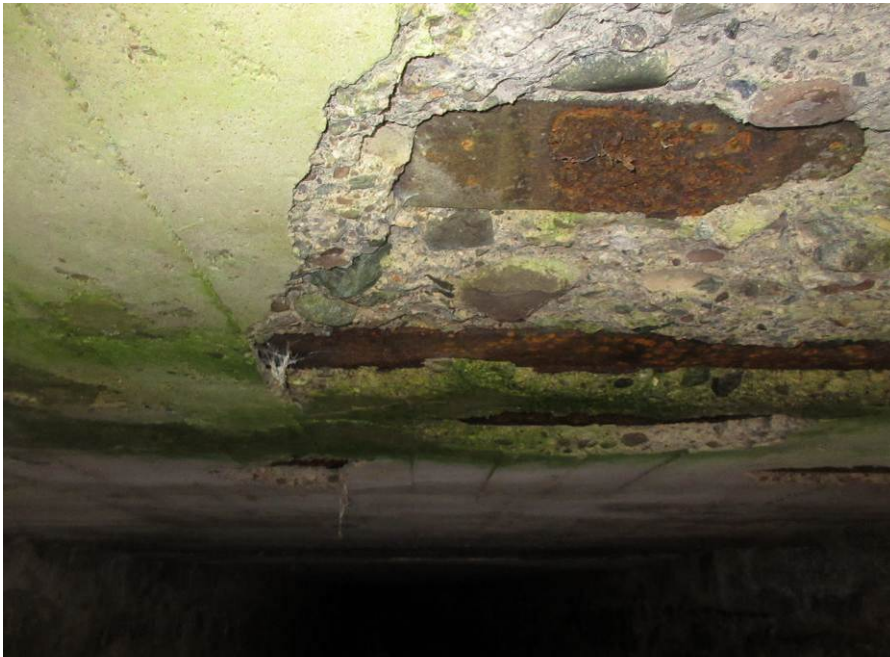
<b>Location:</b>	Deck ties on bridge, looking west.
<b>Description:</b>	General view. Note: Severely split and deteriorated ties on bridge (typical on both approaches).

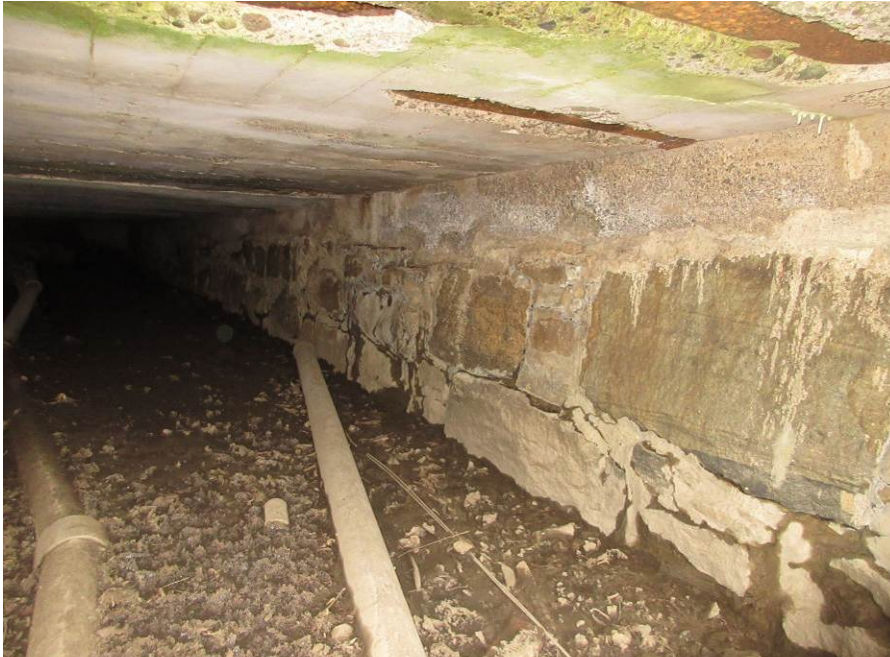
<b>Location:</b>	Underside of superstructure, looking south.
<b>Description:</b>	General view. Note: Spalled concrete and exposed steel rails on underside of concrete deck slab.

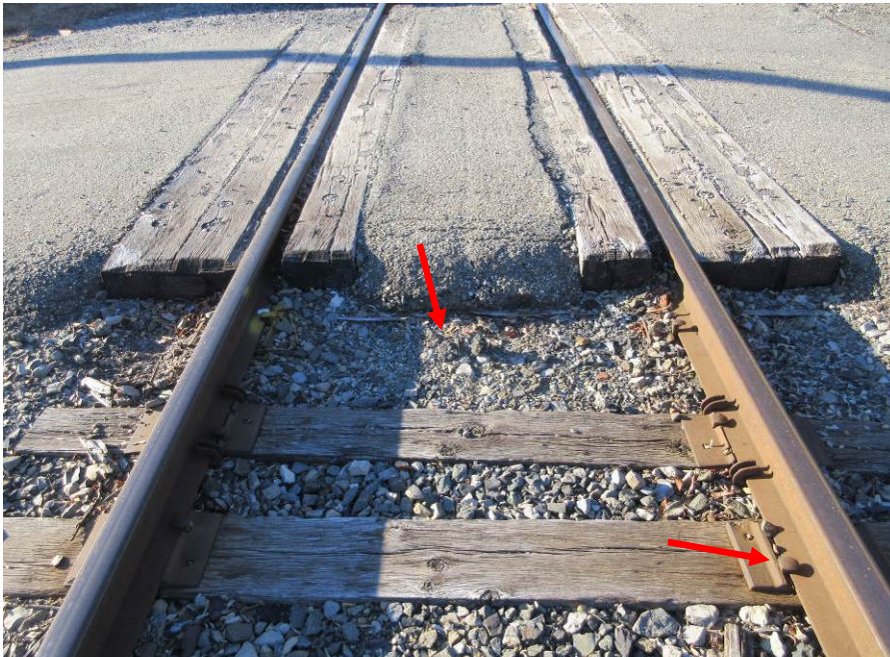
<b>Location:</b>	West abutment, looking southwest.
<b>Description:</b>	General view. Note: Missing/deteriorated mortar at various locations throughout wall (typical at east abutment).

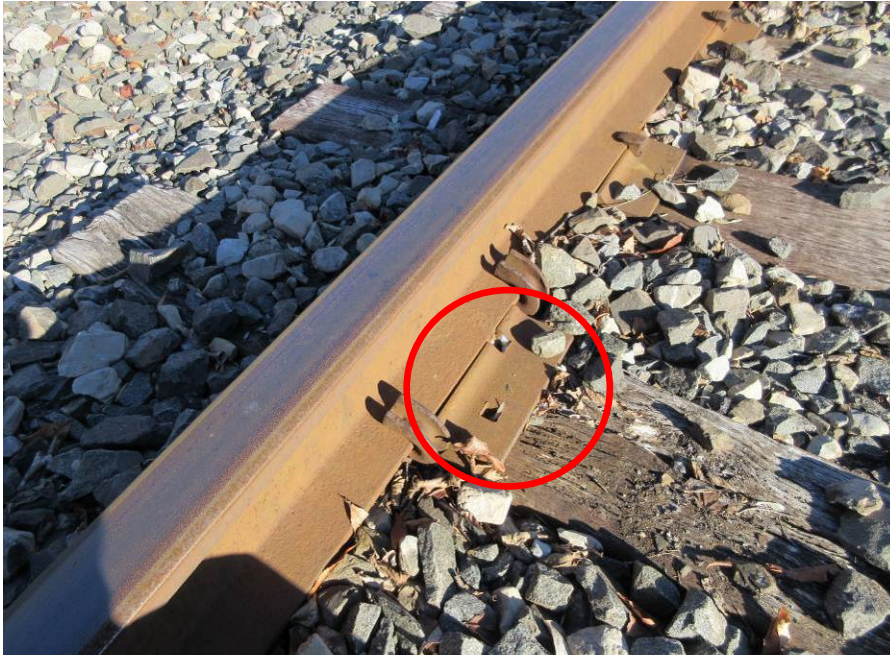
<b>Location:</b>	Grade crossing at east approach, looking west.
<b>Description:</b>	One missing timber tie at the east end of the grade crossing. Spike not properly securing tie plate on north rail.

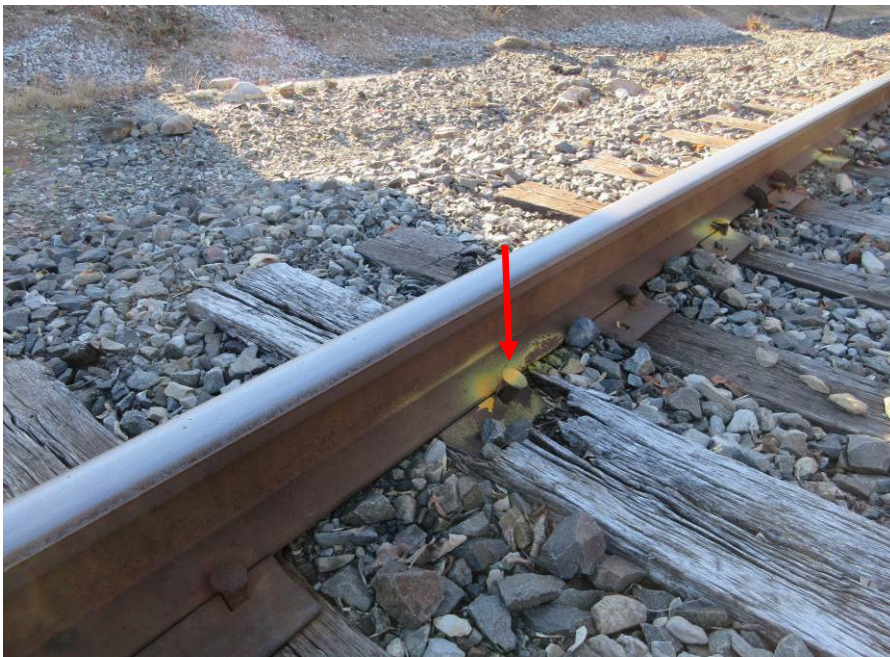
**Description:** Missing spike on inside of rail.

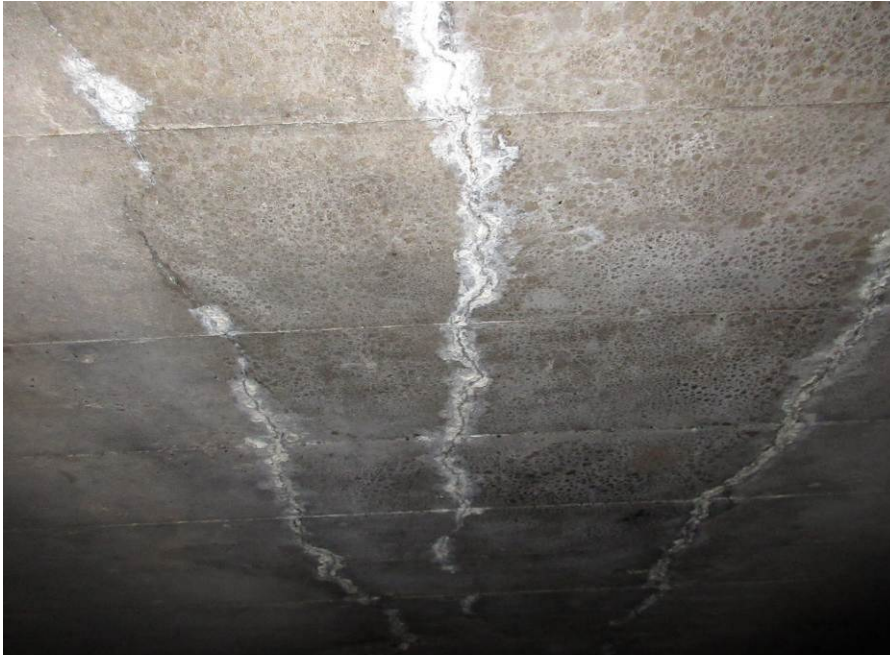
**Description:** Raised/bent spike (typical at both approaches) and deteriorated timber tie.

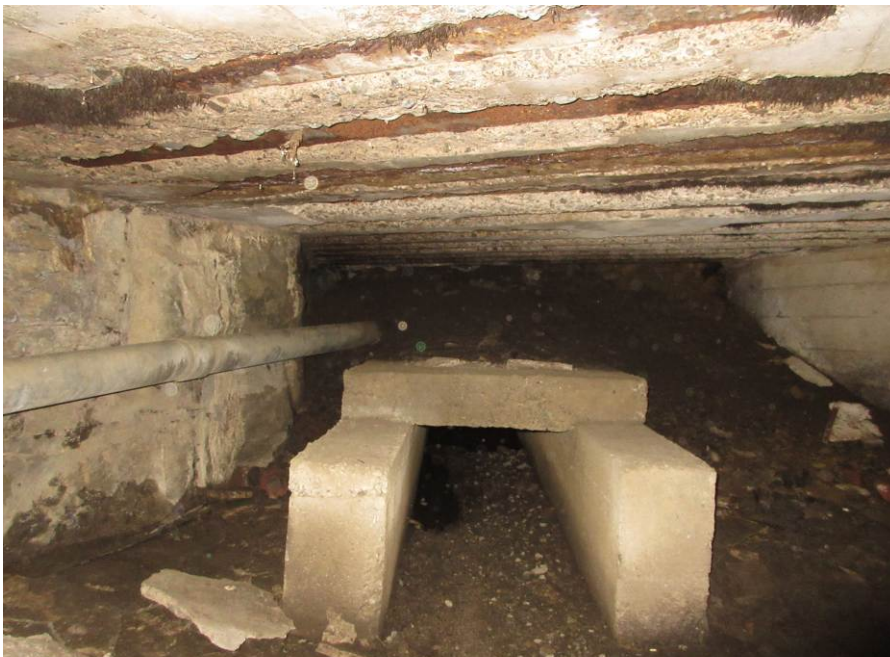
**Description:** Several full width, fine transverse cracks with efflorescence near midspan.

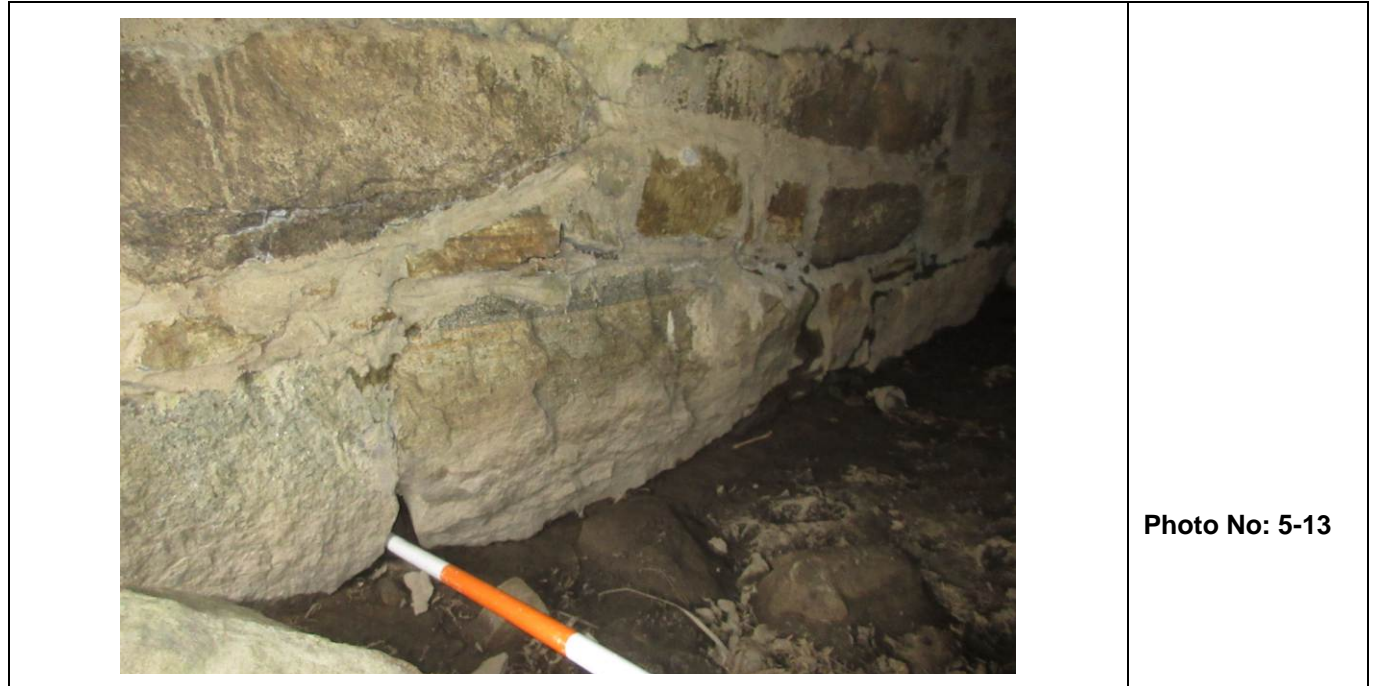
<b>Location:</b>	East abutment, north end, looking southeast.
<b>Description:</b>	Small void near base of wall (typical at west abutment).

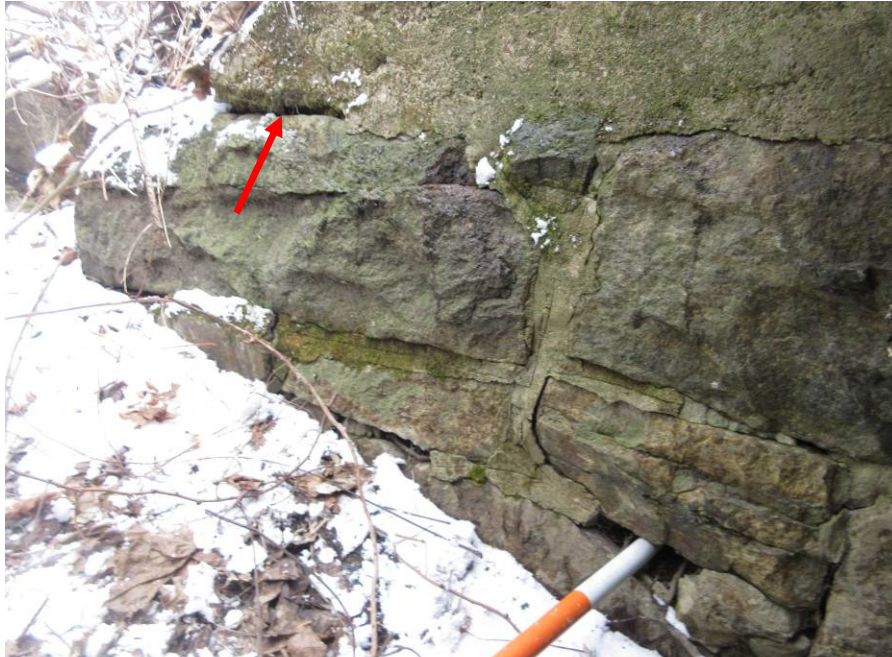
<b>Location:</b>	East abutment, looking southeast.
<b>Description:</b>	Displaced stone over drain pipe approximately 15' from south end of structure.

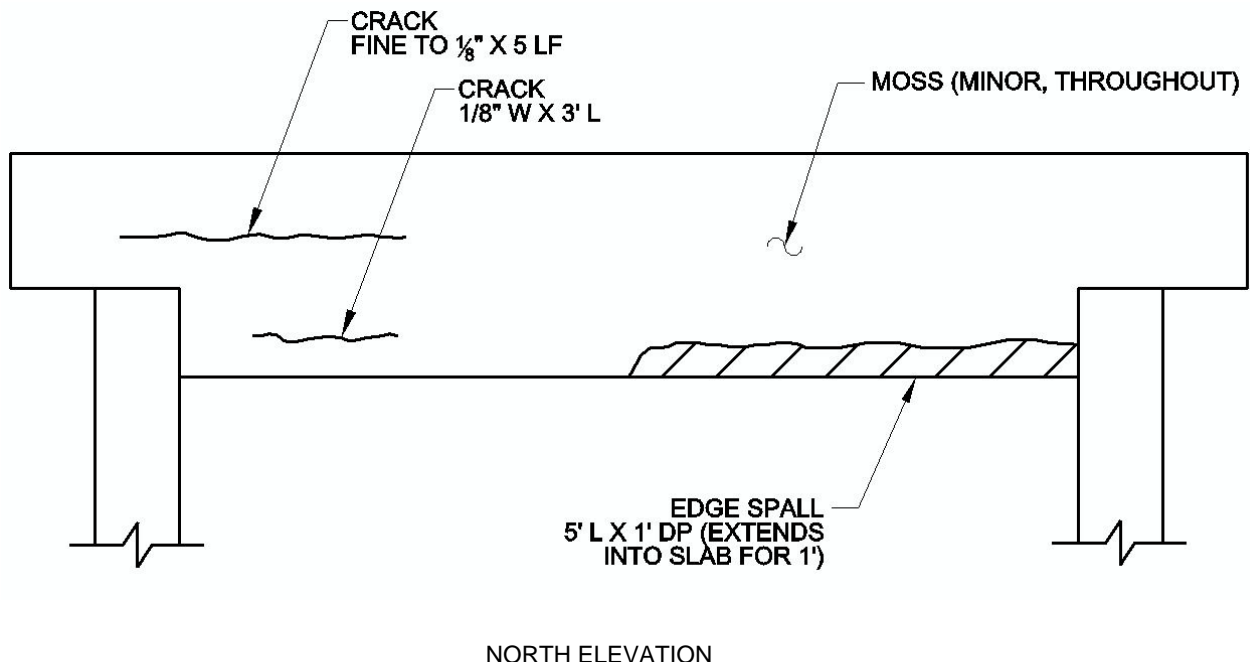
# NJ TRANSIT UNDERGRADE BRIDGE INSPECTIONS - FIELD NOTES

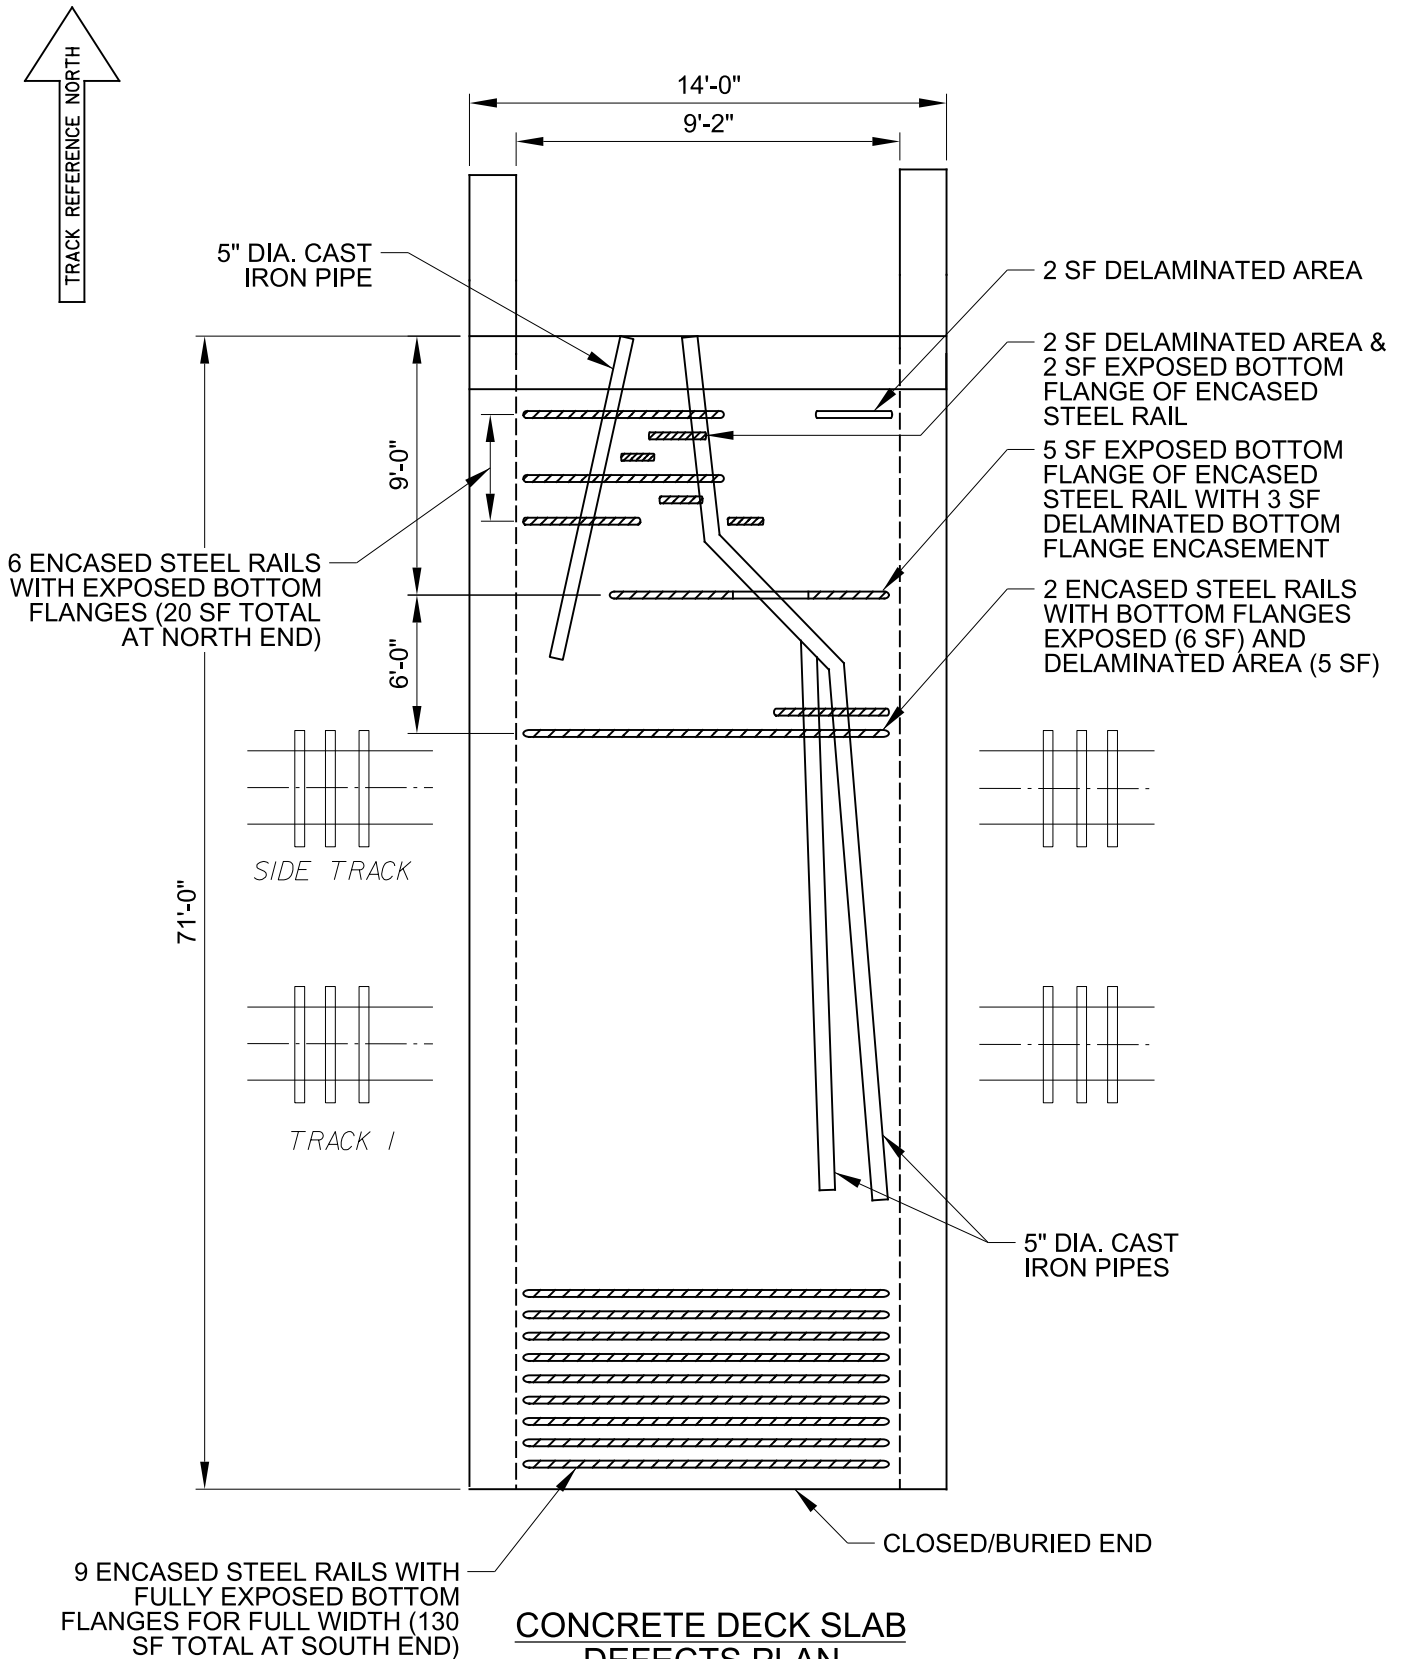
## CONCRETE DECK SLAB DEFECTS PLAN

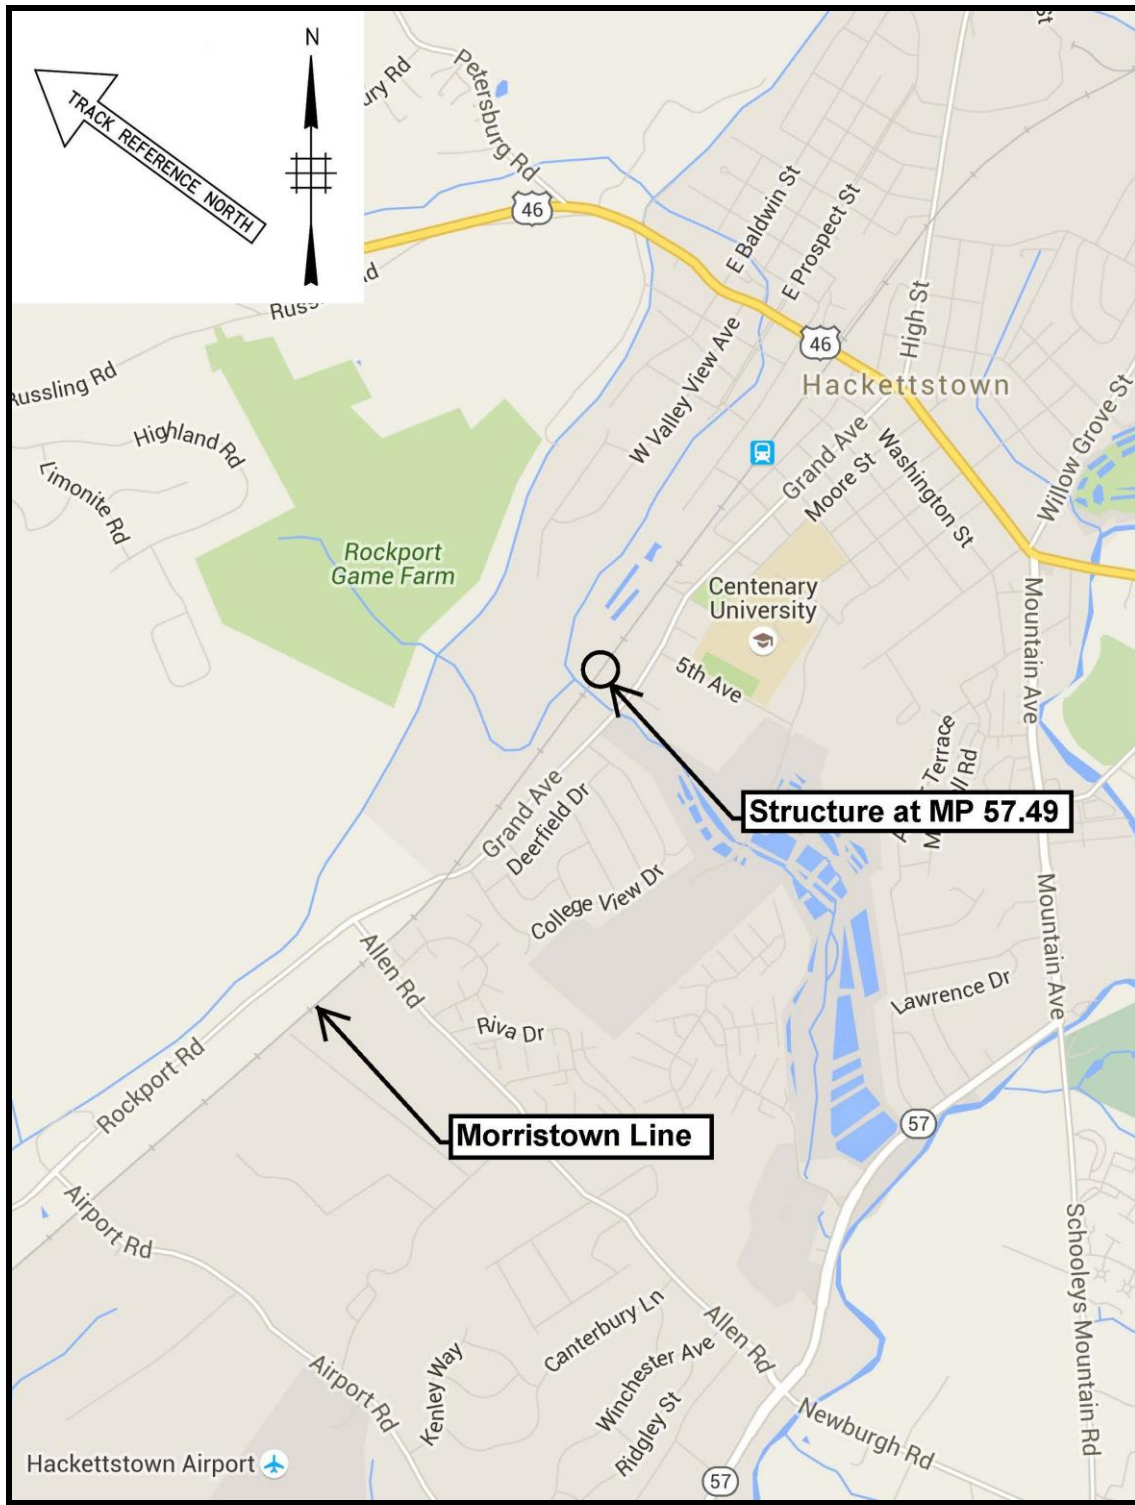
LOCATION MAP  
MORRISTOWN LINE MP 57.49  
Over CATTLE PASS  
HACKETTSTOWN, WARREN COUNTY  
NEW JERSEY

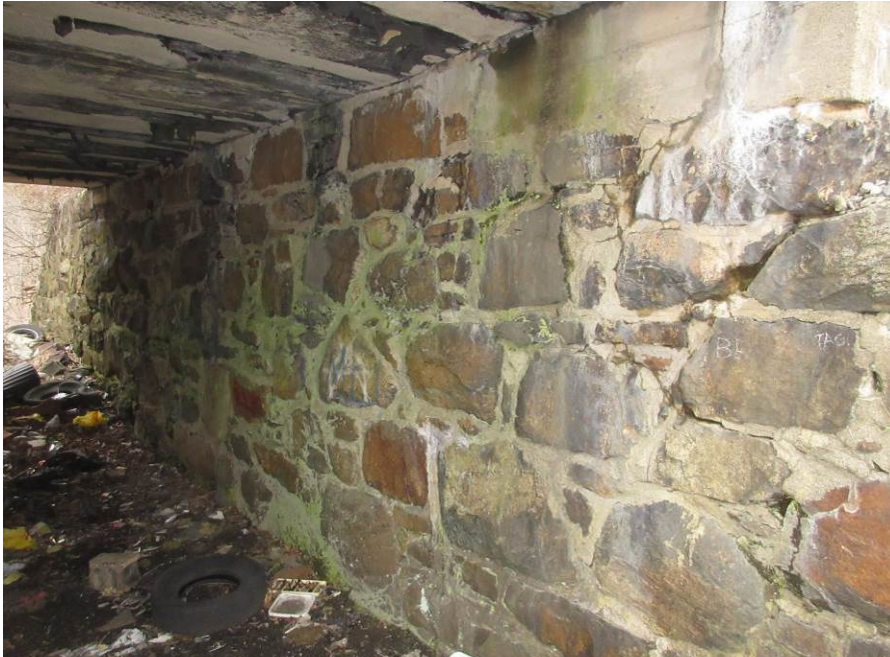
**Description:** General view. Note: Deteriorated and peeling waterproofing membrane on roof slab.

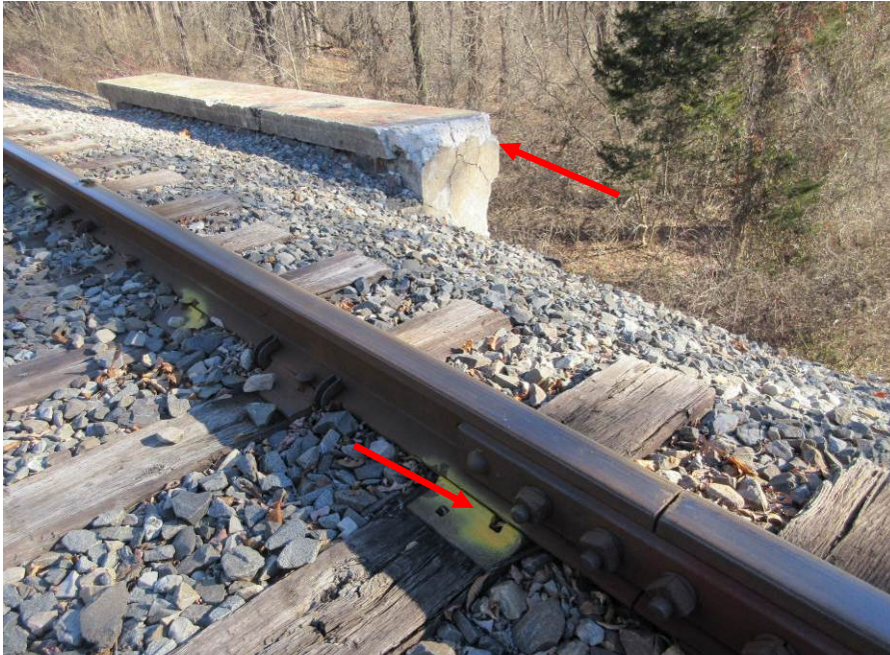
**Description:** One tie missing completely. Several ties exhibit wide splits and checks and require replacement (typical at west approach).

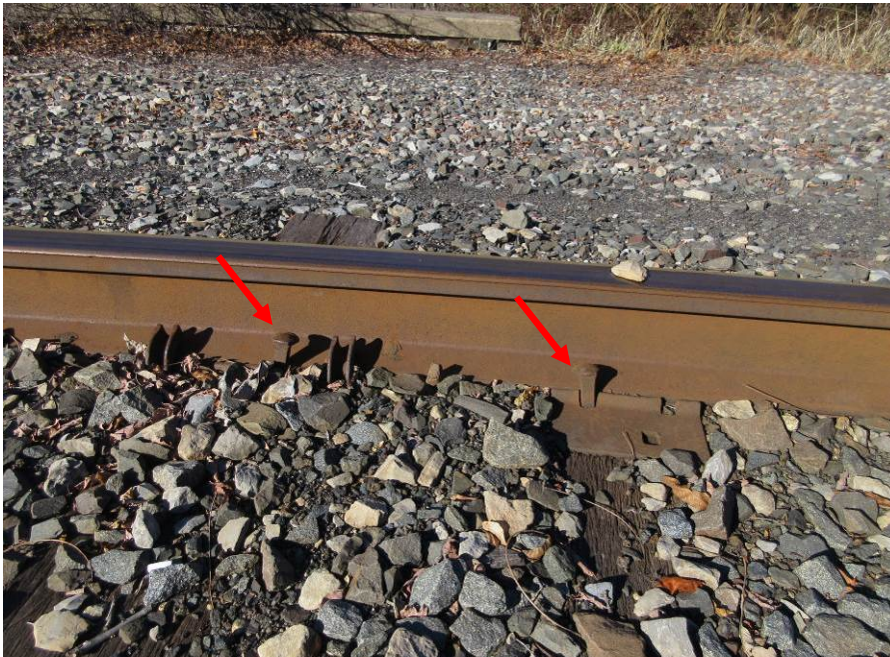
**Description:** Missing spike near rail joint. Spalled and delaminated area at west end of south parapet (spalling typical at north parapet).

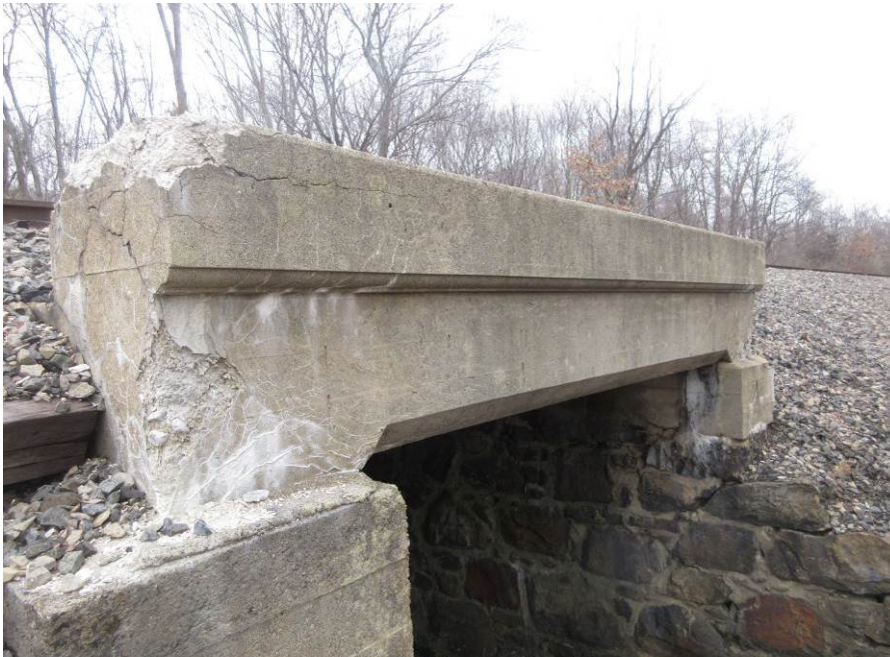
**Description:** Peeling asphaltic waterproofing membrane and water staining throughout slab. Hairline transverse cracks with minor efflorescence. Small popout with exposed rebar.

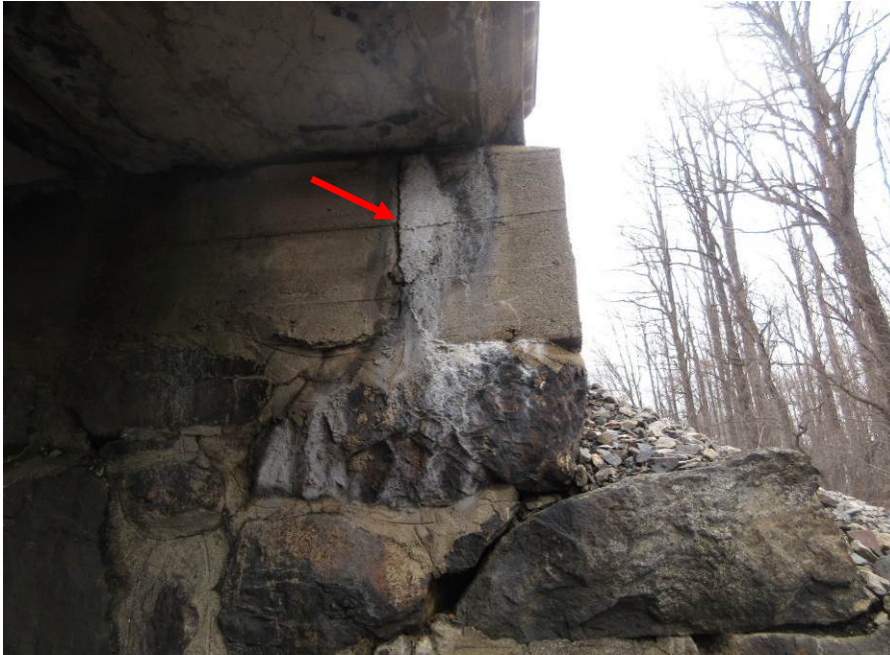
**Description:** Spalls and light map cracking at both ends of slab/parapet. Delaminated area at west end of slab/parapet and fine to medium cracks throughout. Note moderate erosion of ballast at the steep south embankments near the bridge.

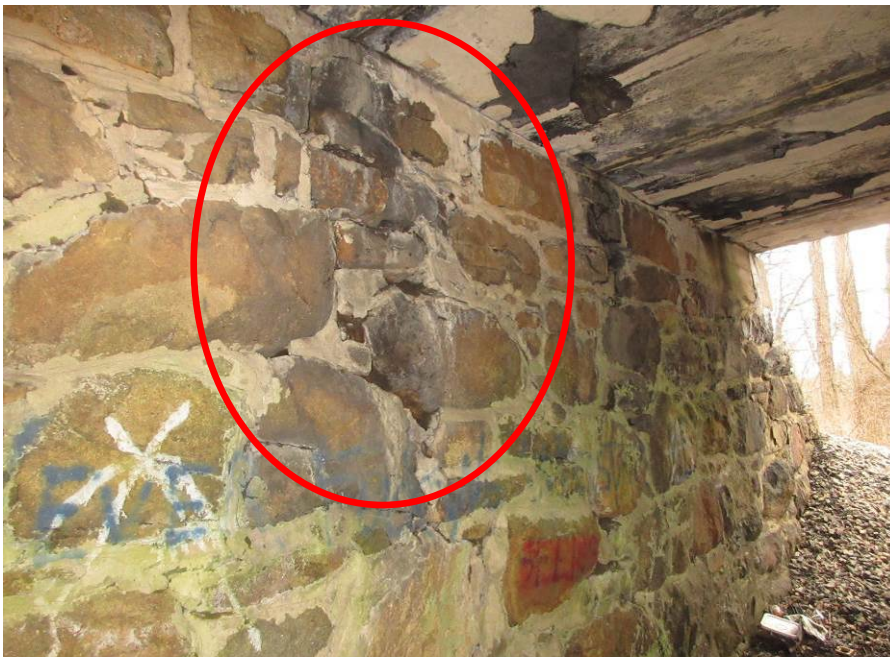
**Description:** Vertical crack in concrete with efflorescence and light map cracking.

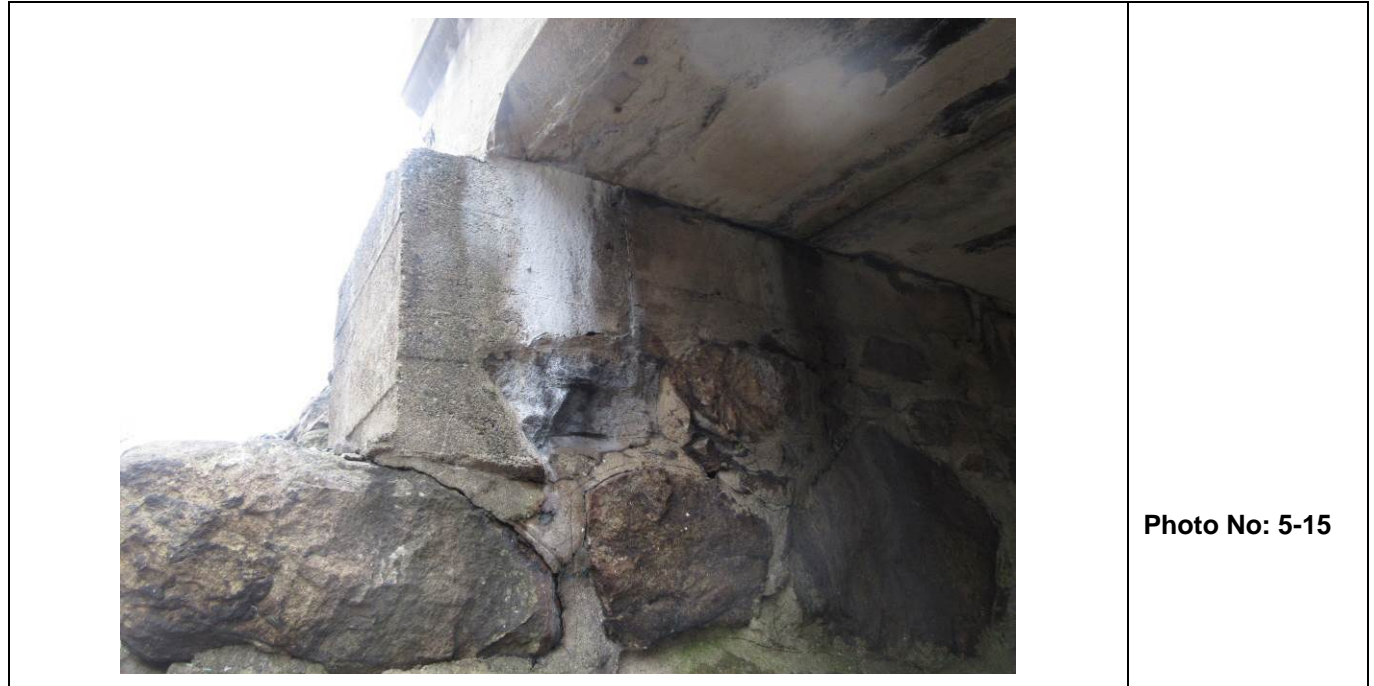
<b>Location:</b>	West abutment, south end, looking northwest.
<b>Description:</b>	Spall with efflorescence in concrete portion near south fascia.

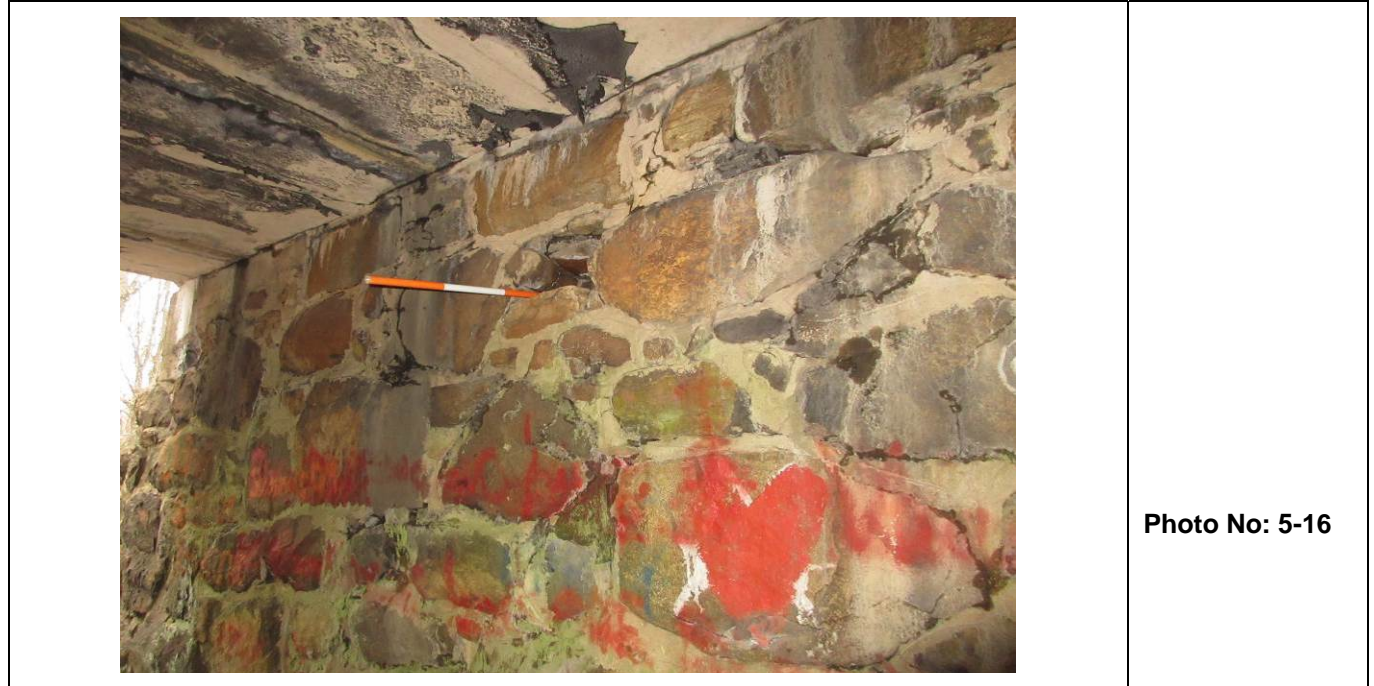
<b>Location:</b>	West abutment, below slab panels 3 & 4, looking southwest.
<b>Description:</b>	Area of large voids/missing and deteriorated mortar/missing stones. Note graffiti on breastwall (typical at east abutment and southeast wingwall).
