North Jersey Transportation Planning Authority

# Concept Development Report

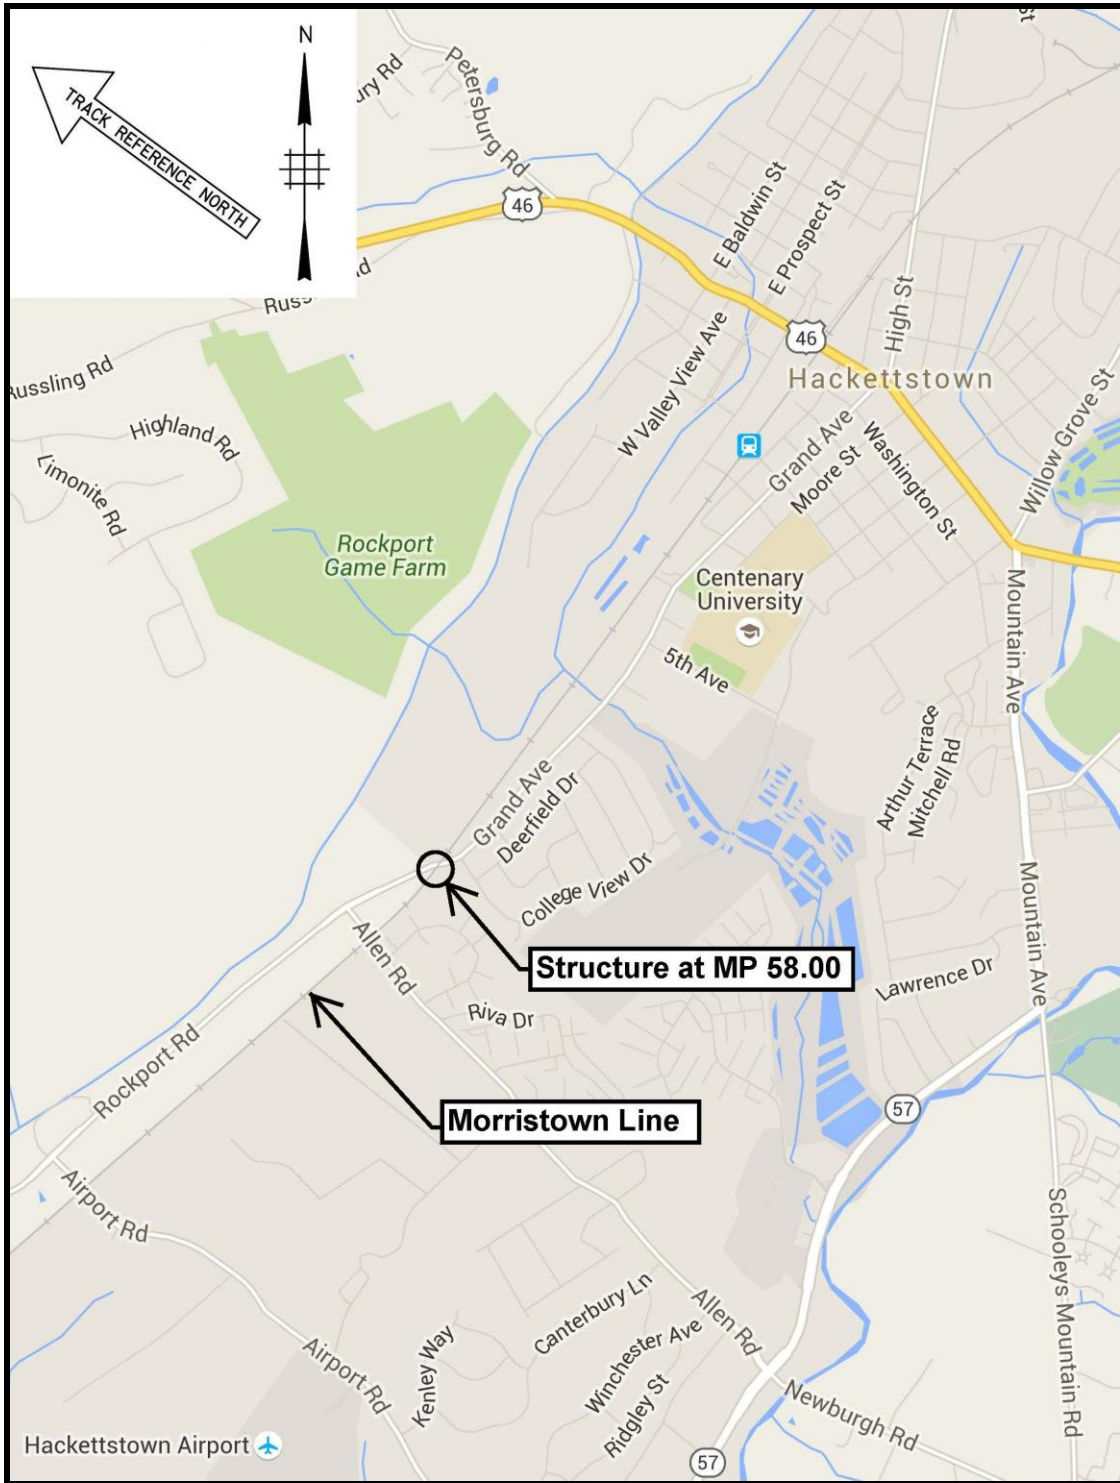
LOCATION MAP  
MORRISTOWN LINE MP 58.00  
Over GRAND AVENUE  
HACKETTSTOWN, WARREN COUNTY  
NEW JERSEY

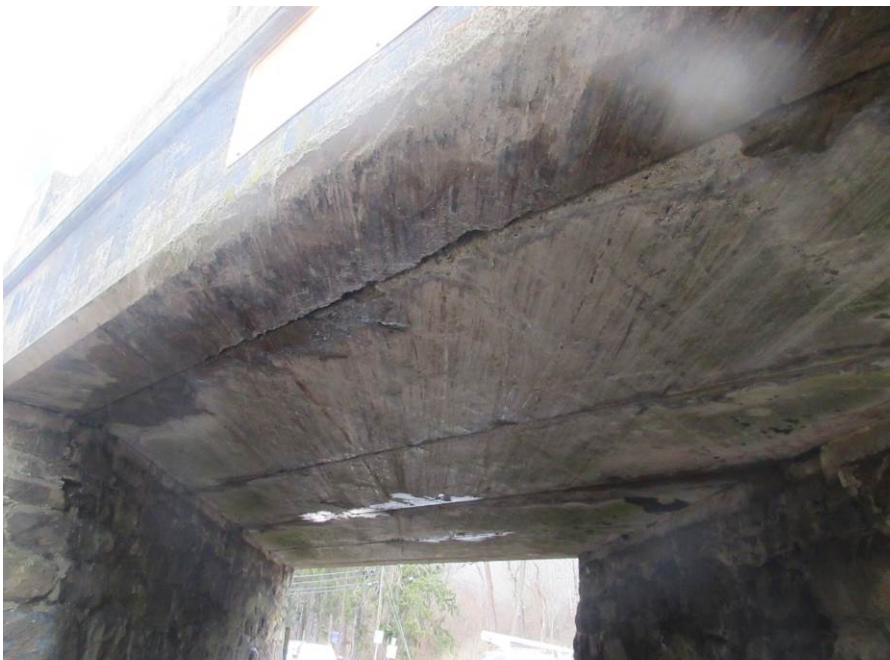
**Description:** General view. Note: Several ties exhibit wide splits and checks and rot and require replacement (typical on east approach).

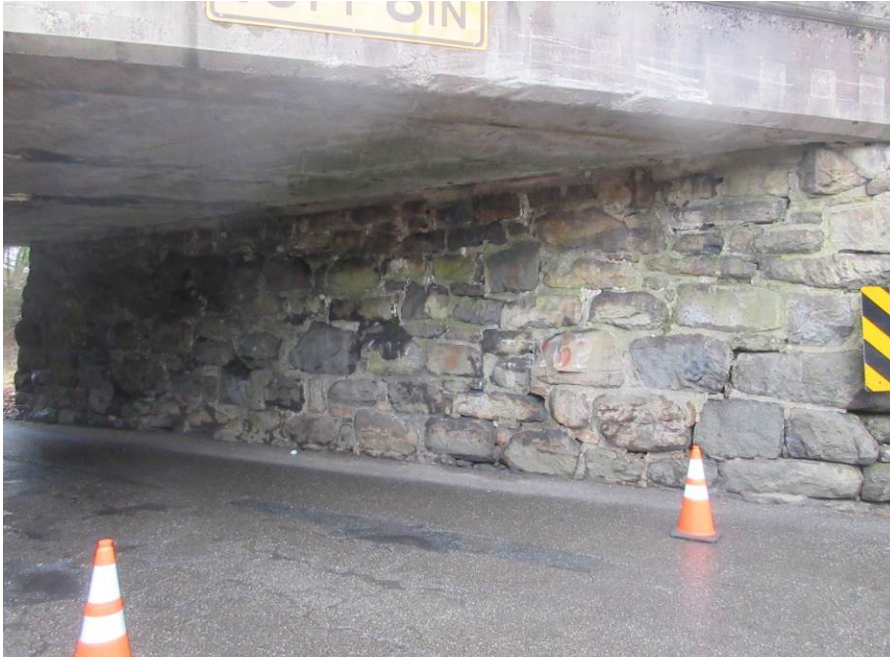
**Description:** General view. Note: Minor edge spalling and water leakage/staining between slab panels (typical). Impact damage (scrape marks and minor chipping) throughout.

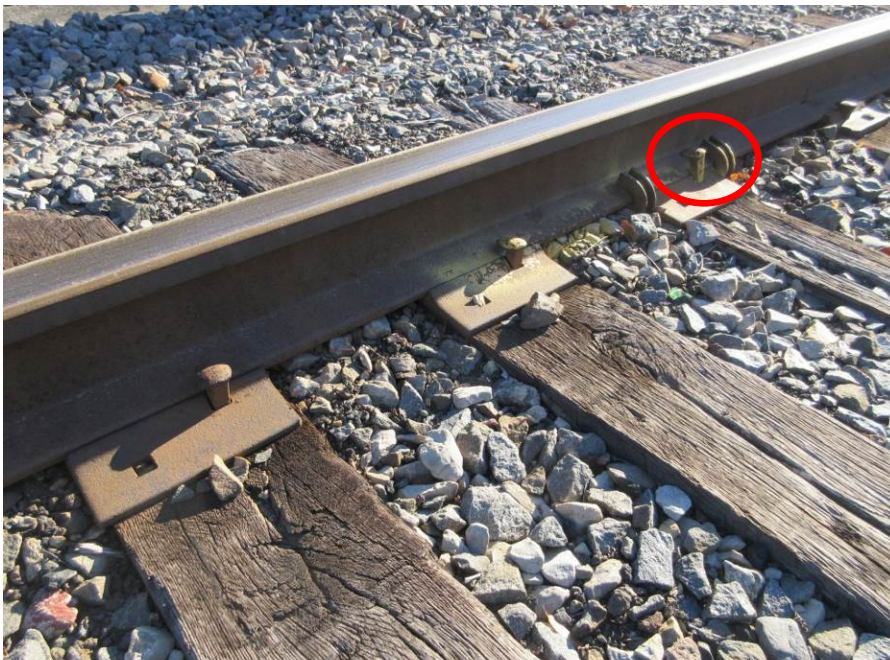
**Description:** General view. Note: Missing/deteriorated mortar at several locations throughout wall with voids (typical at east abutment). Work Done: Previously observed phone cable running across the top of the west abutment has been removed.

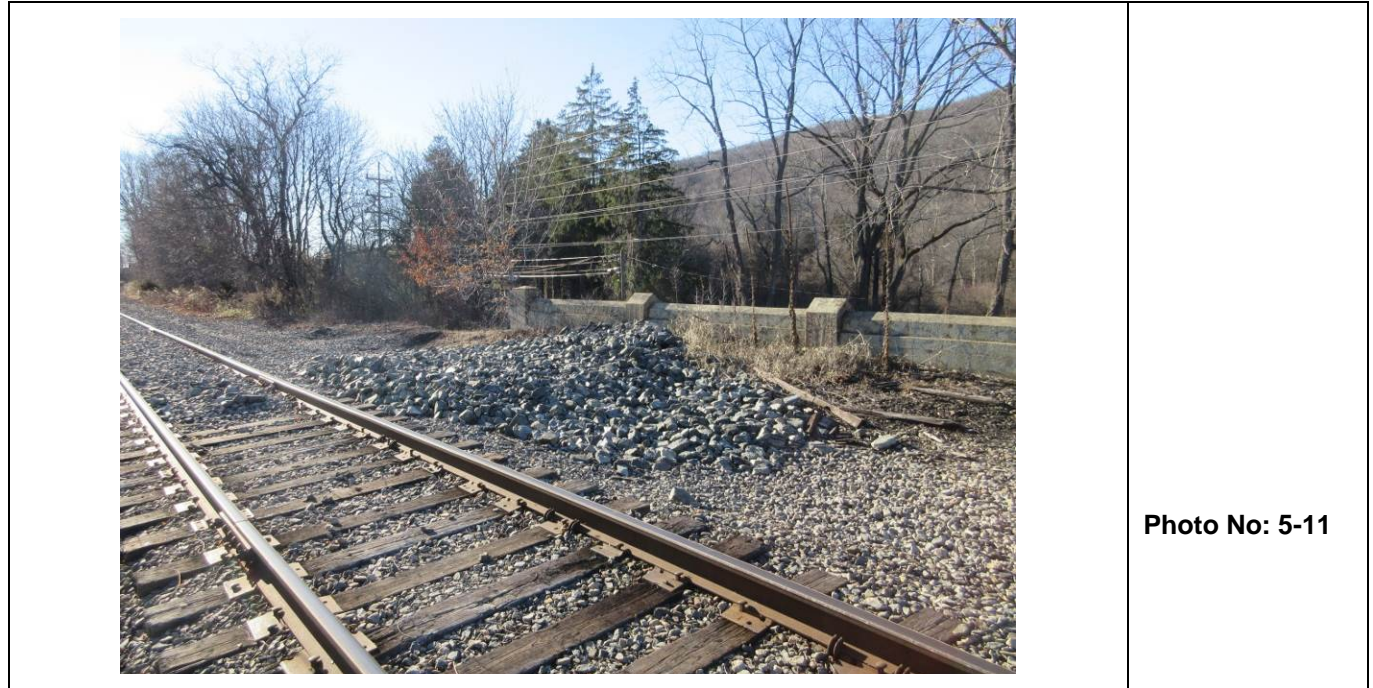
**Description:** Medium to wide cracks and light honeycombing in parapet pylon.

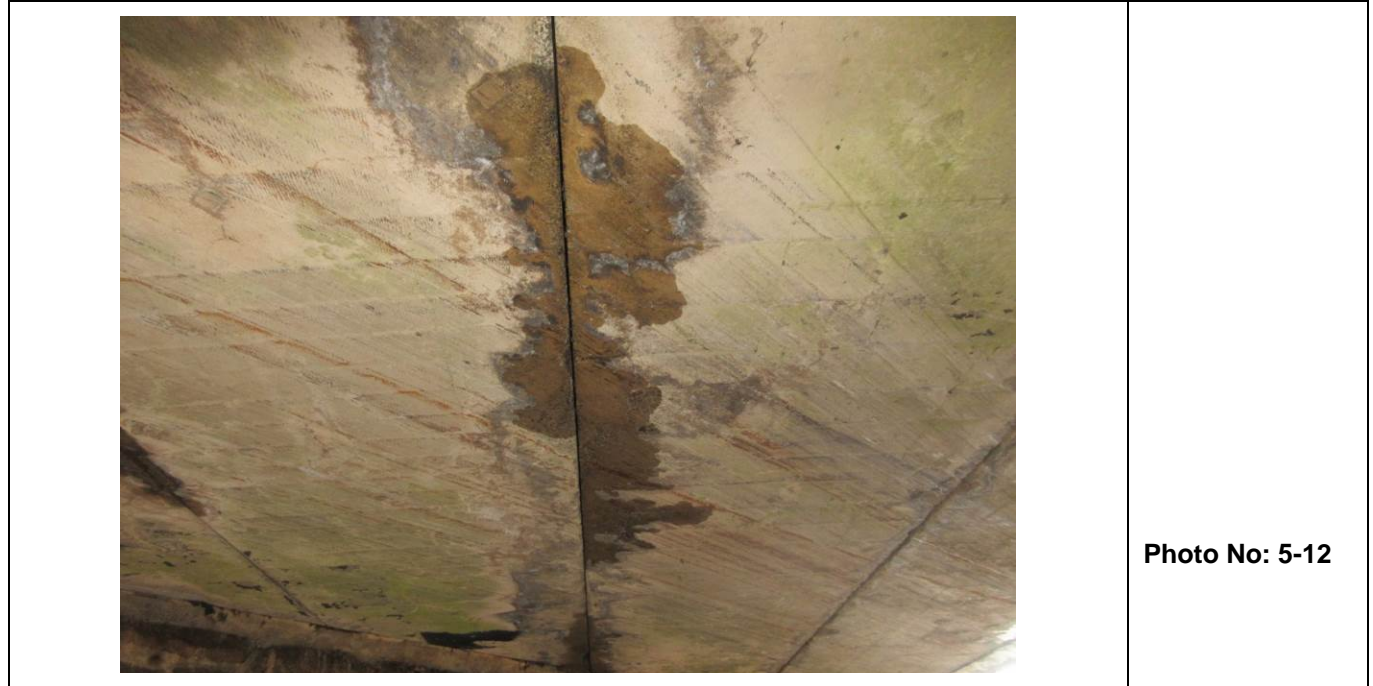
<b>Location:</b>	West end of structure, looking northwest.
<b>Description:</b>	Large stones are covering the north shoulder of the bridge. Light graffiti on parapet face (100% covered).

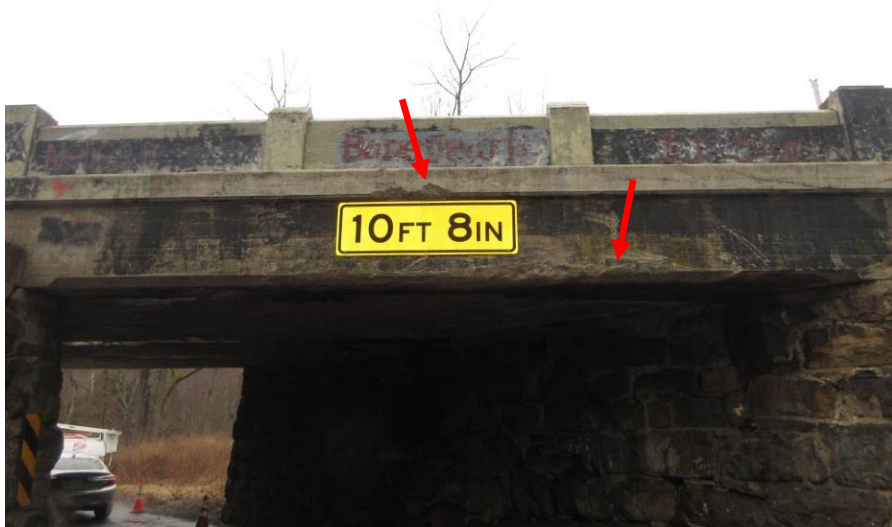
<b>Location:</b>	Underside of superstructure at panel joints, looking east.
<b>Description:</b>	Water leakage and staining with light efflorescence and minor edge chipping at panel joint. Scrape marks on underside of deck slab (typical throughout).

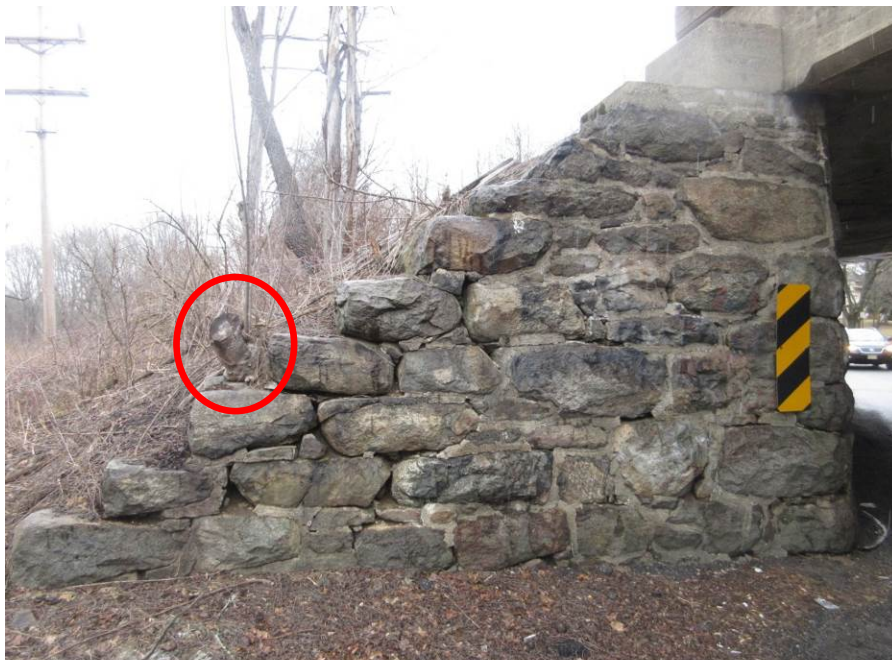
**Description:** Spall above clearance posting. Minor edge spalling and scrape marks to base of headwall due to impact damage. Note graffiti on parapet.

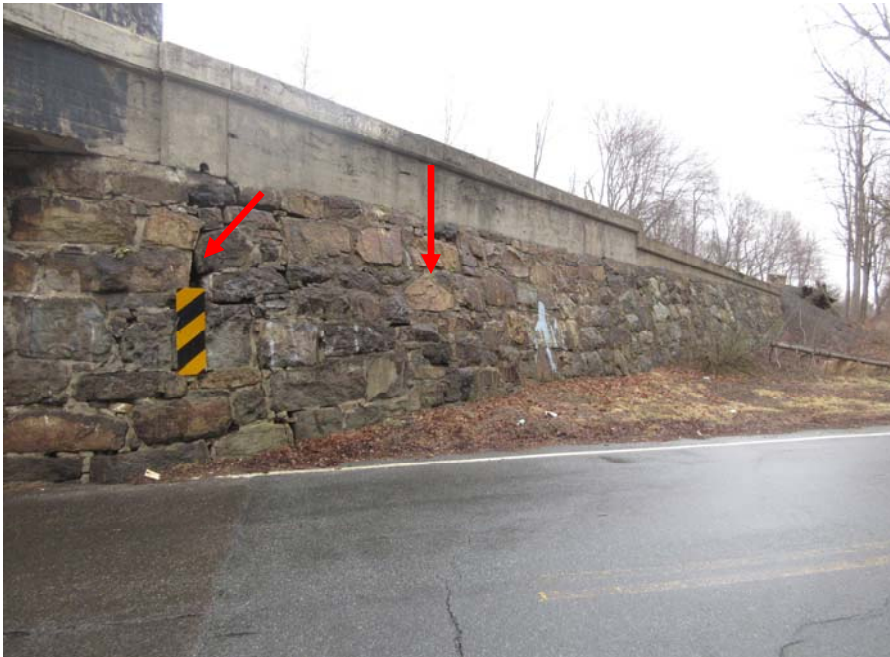
**Description:** Areas of deteriorated/missing mortar throughout wall with voids (typical at all wingwalls). Work Done: Small tree has been cut at base; stump remains on wall.

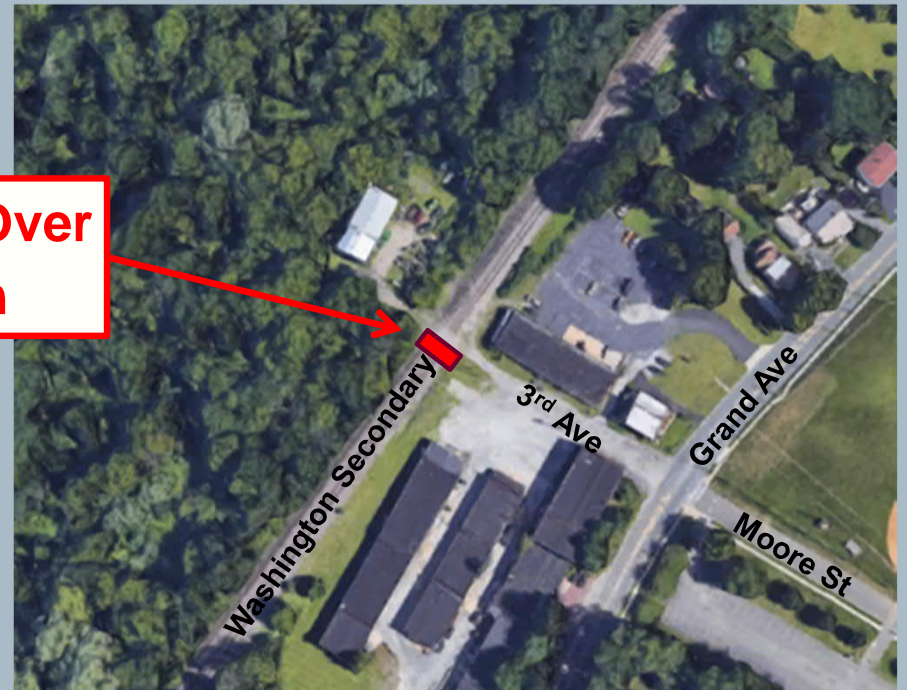
# Existing Condition

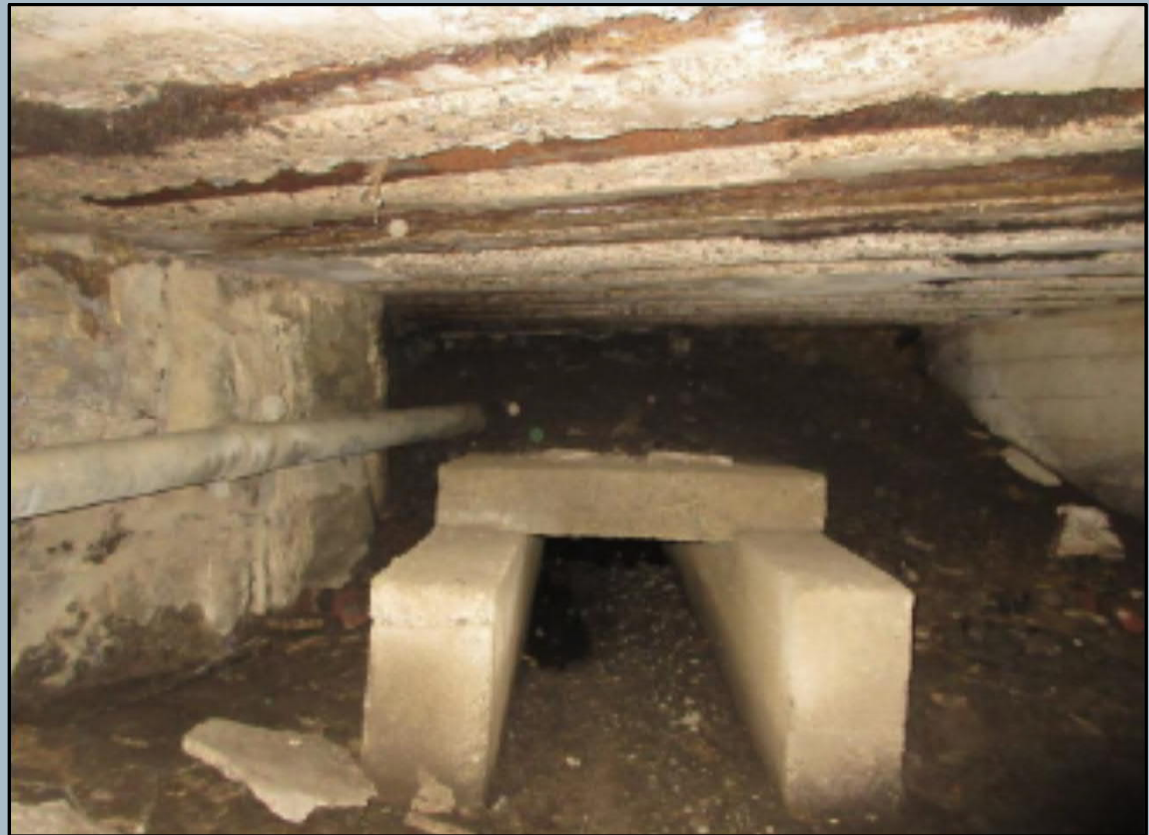
# Existing Condition

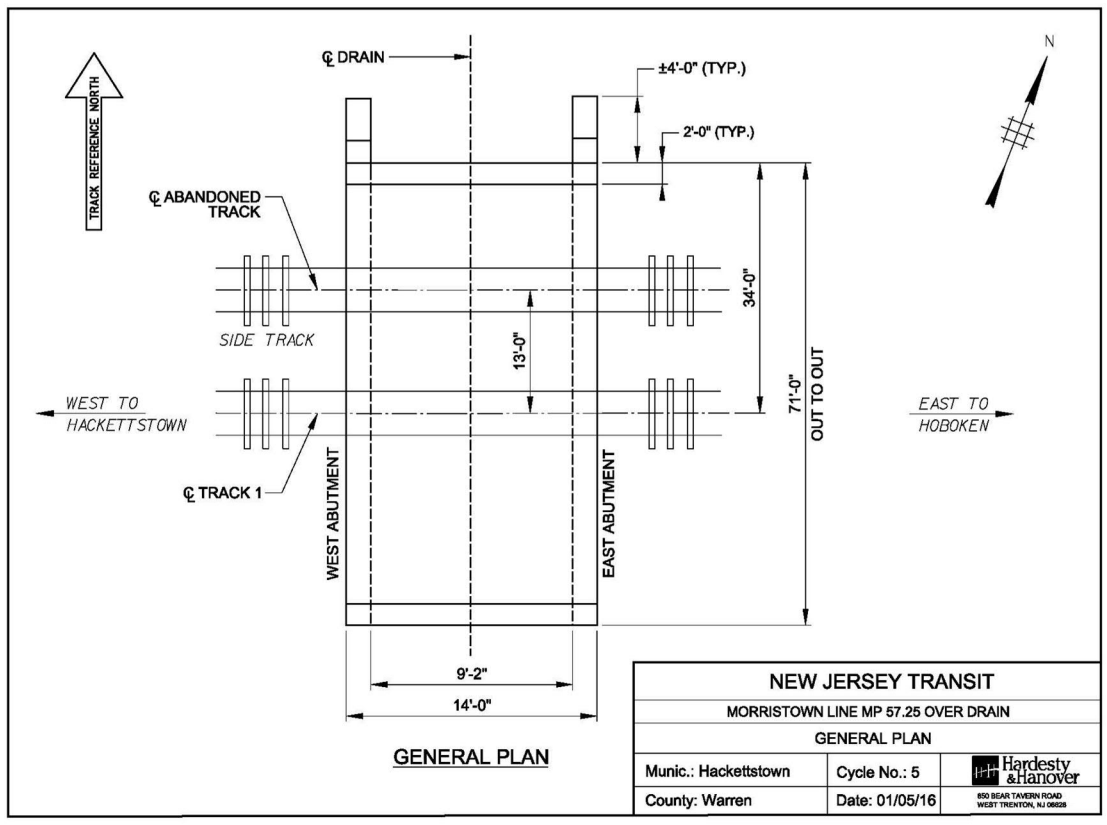
# Existing Condition

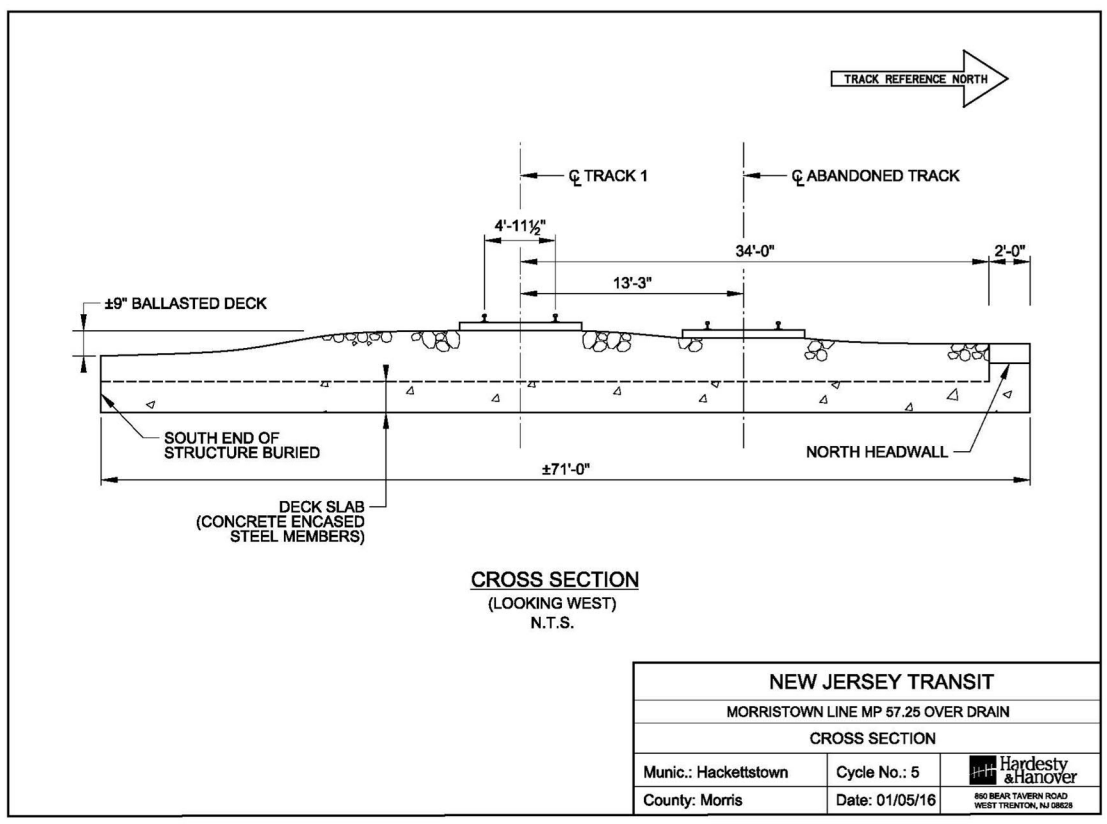
Cross Section of Bridge

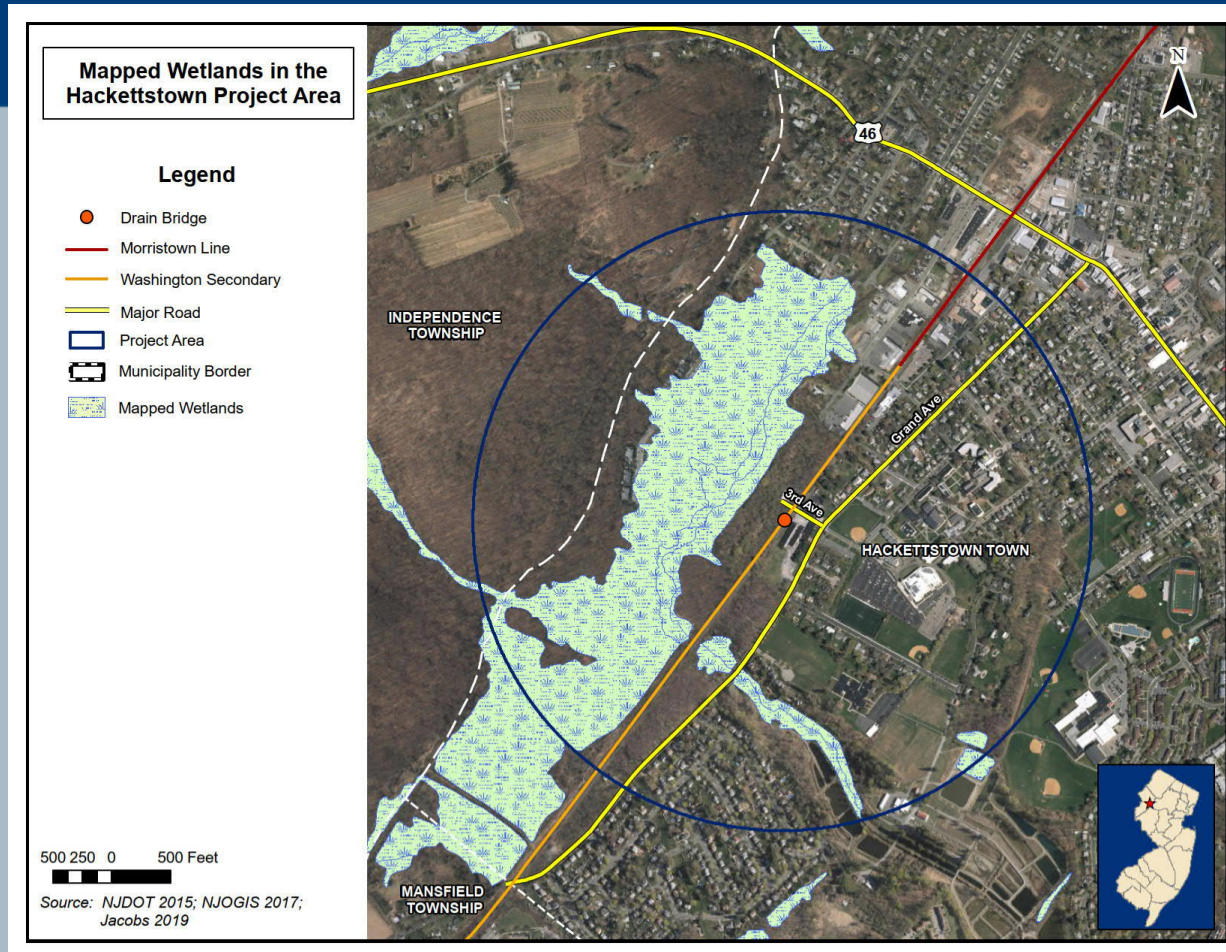
# Environmental Constraints

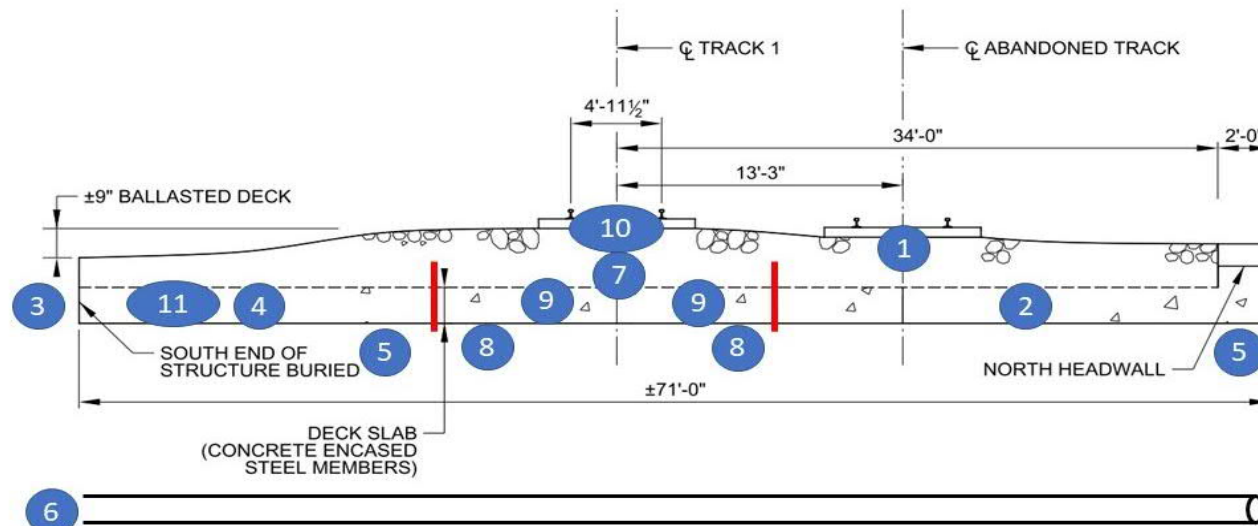
1. Remove side track and ballast to allow clearing of the slab
2. Remove northern concrete and rail slab
3. Excavate south end of structure to expose drainage pipe below slab
4. Remove southern concrete and slab and earth covering drainage pipe
5. Repoint abutments and repair headwall
6. Extend 15-inch drainage pipe into culvert
7. Remove active track, ballast and slab
8. Level top of abutments with grout
9. Set two (2) new precast 8-ft by 14-ft slabs
10. Place new ballast and new track panels. Reopen track for service
11. Install remaining slabs

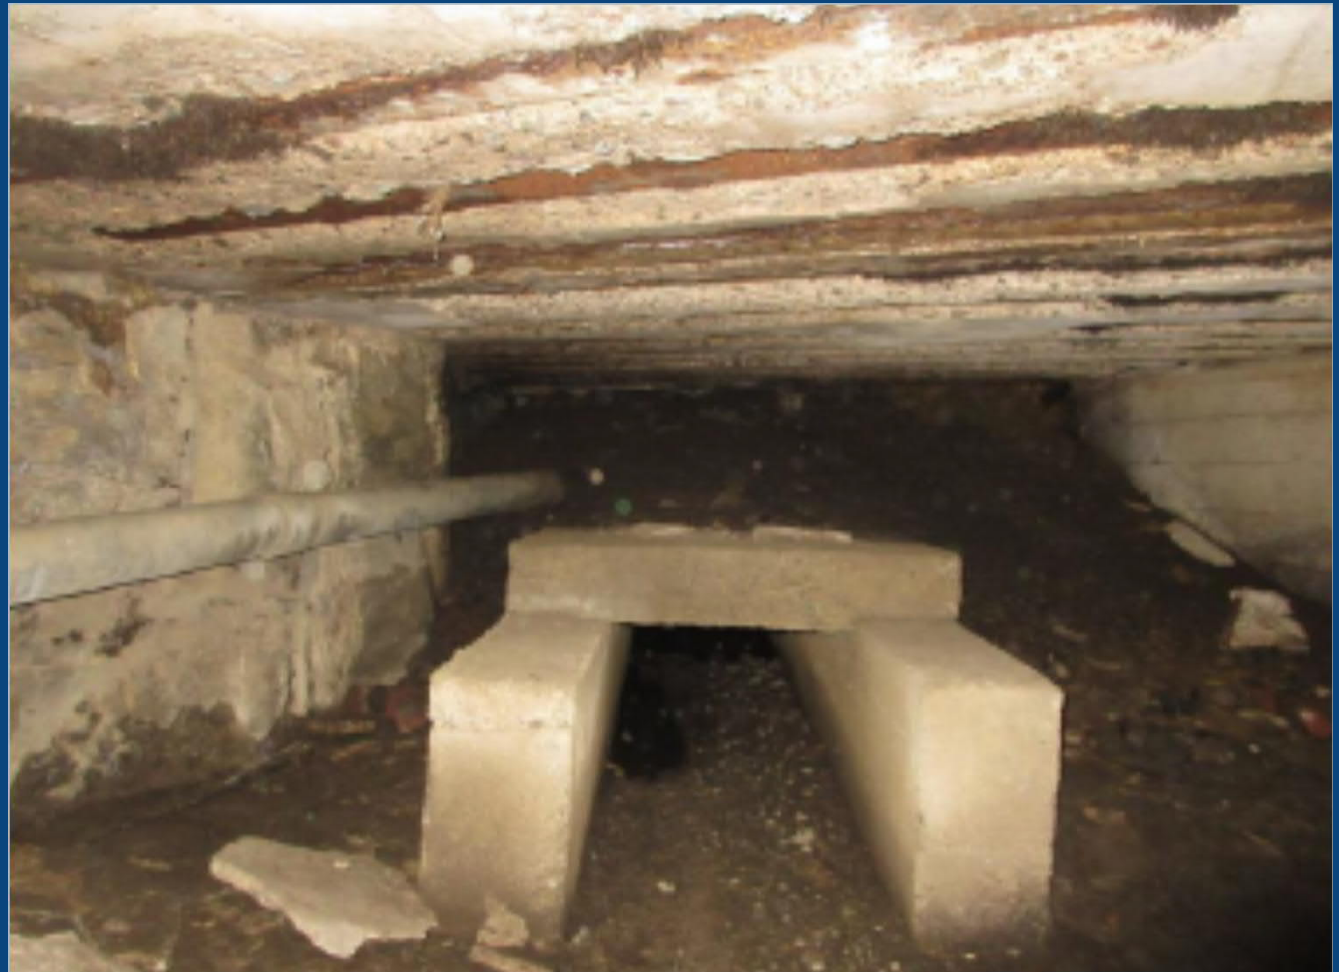
View Beneath  
Bridge - South  
End of Structure  
Looking South

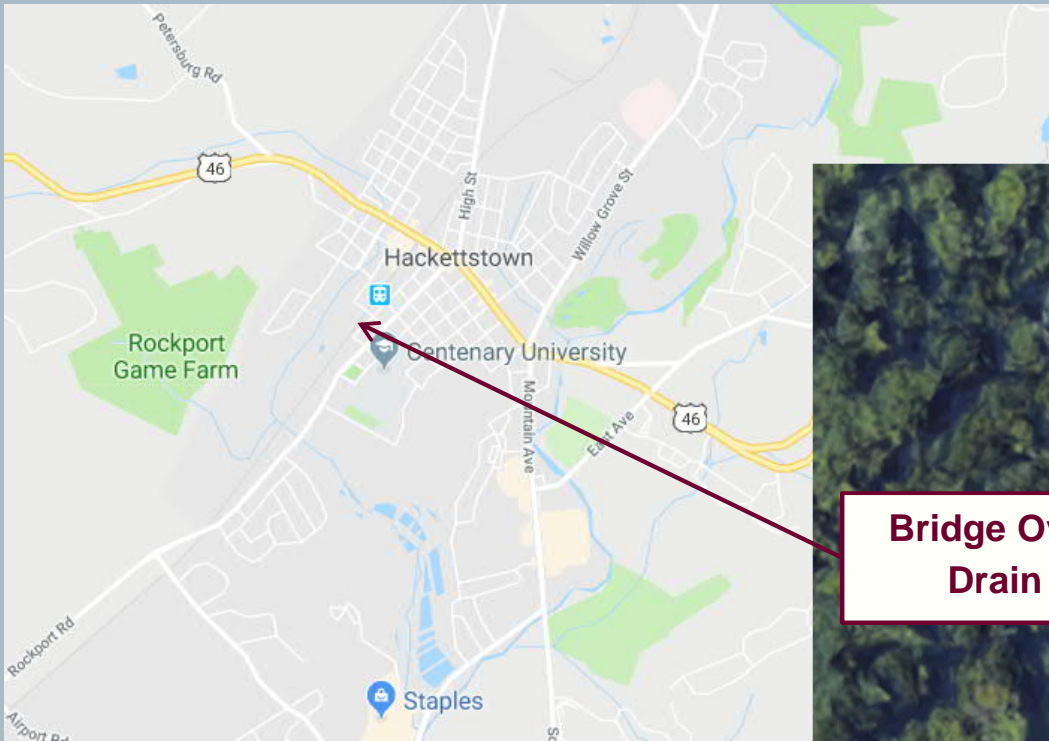
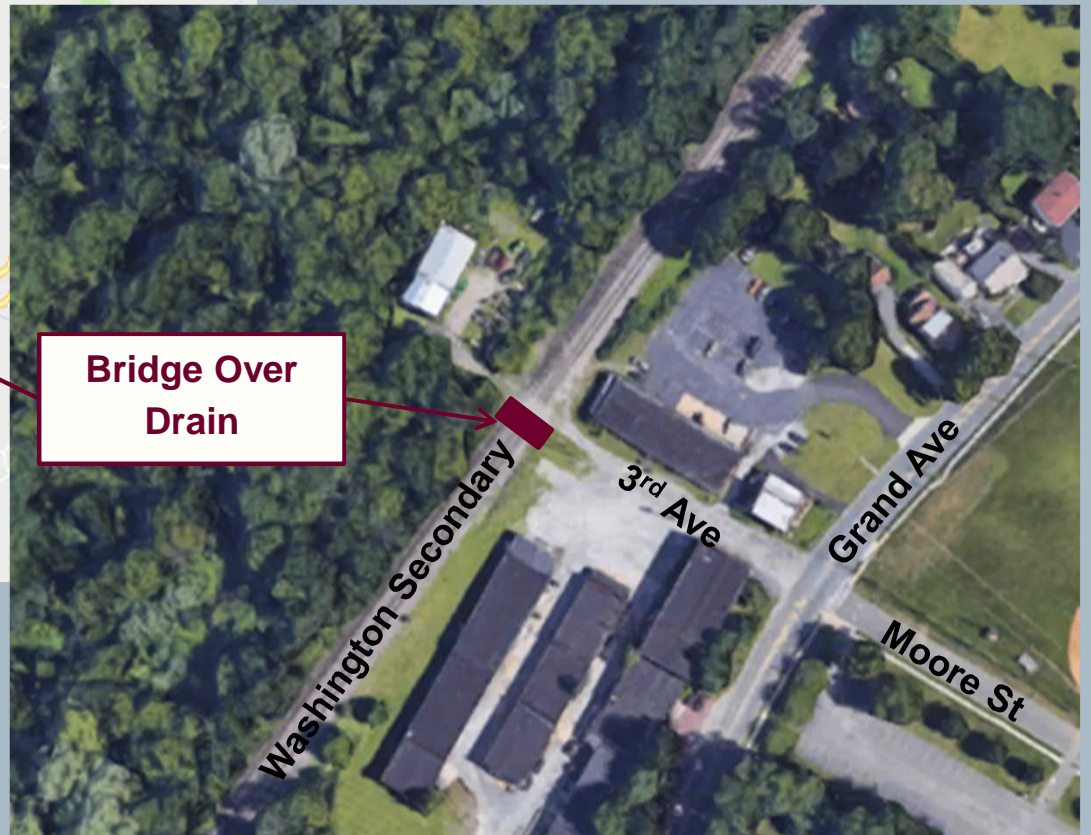
# Existing Condition

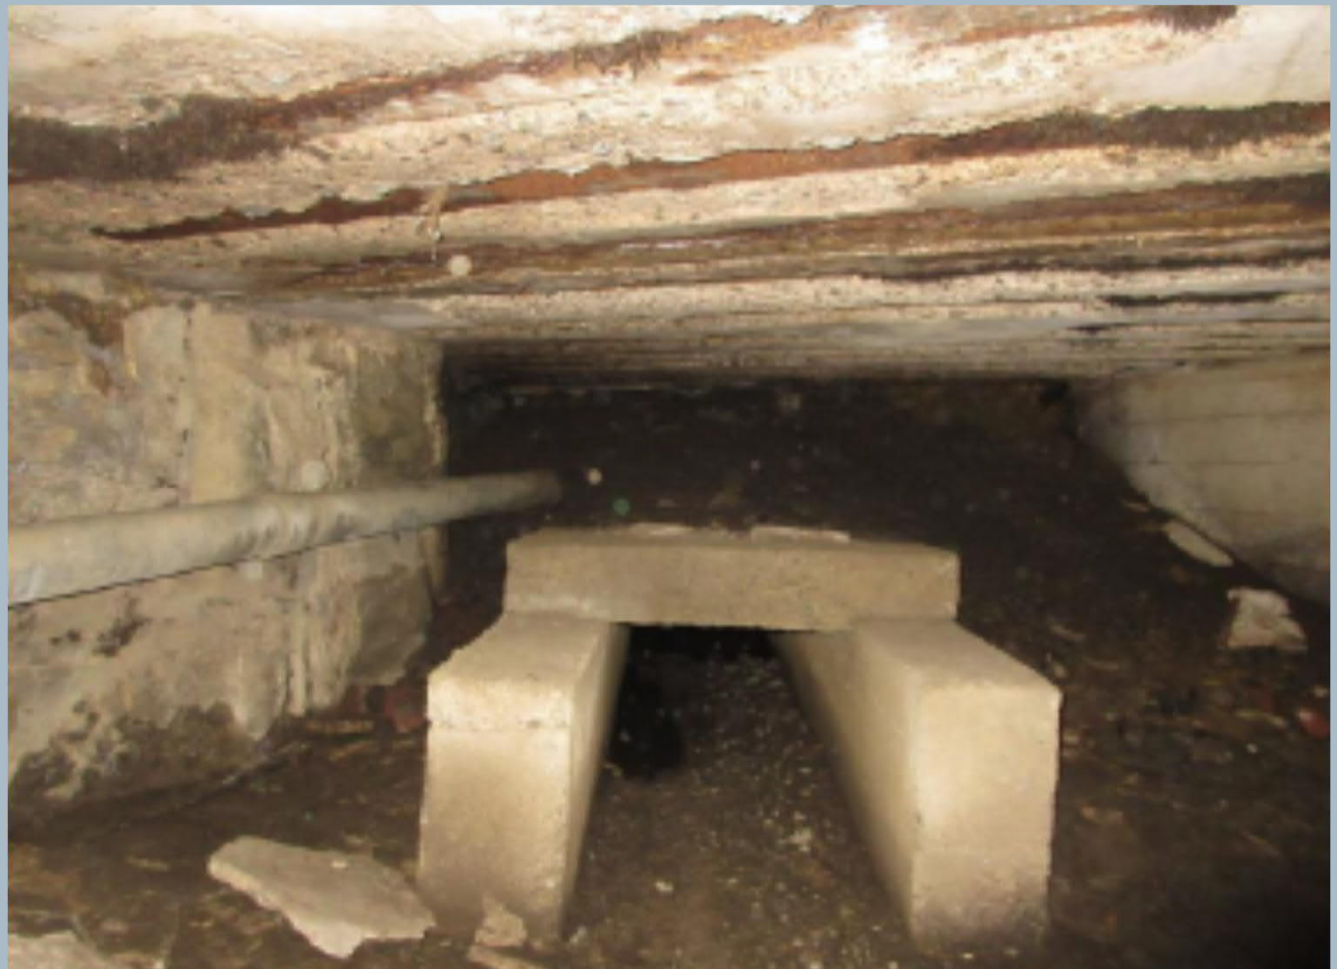
View Beneath  
Bridge - South  
End of Structure  
Looking South

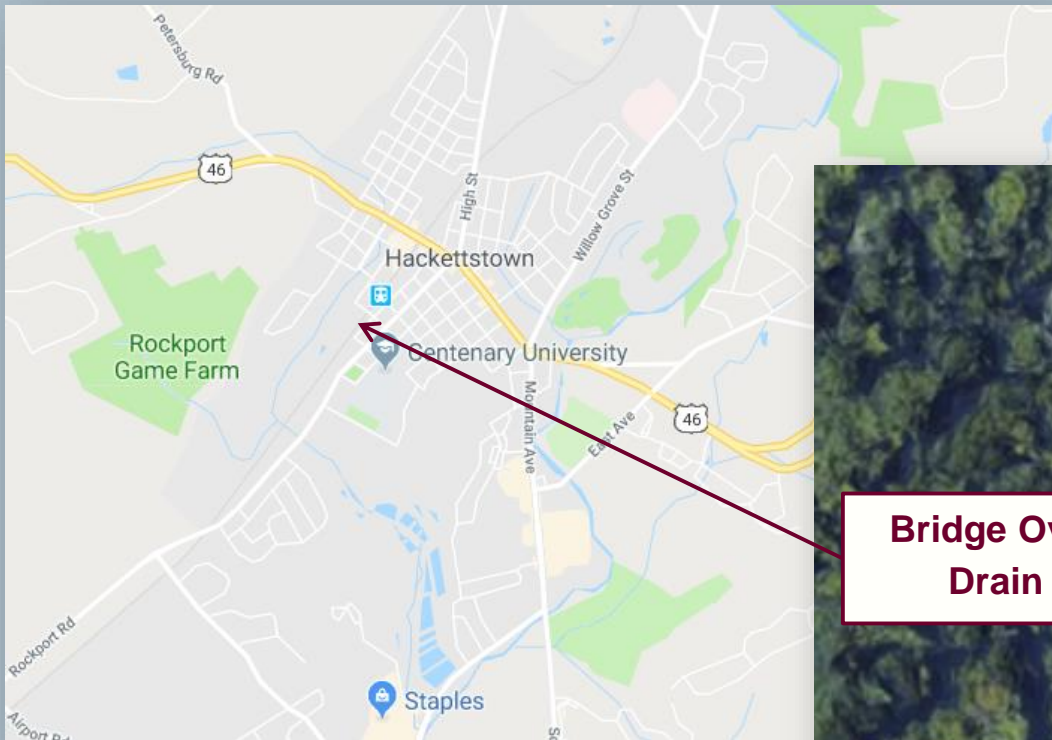
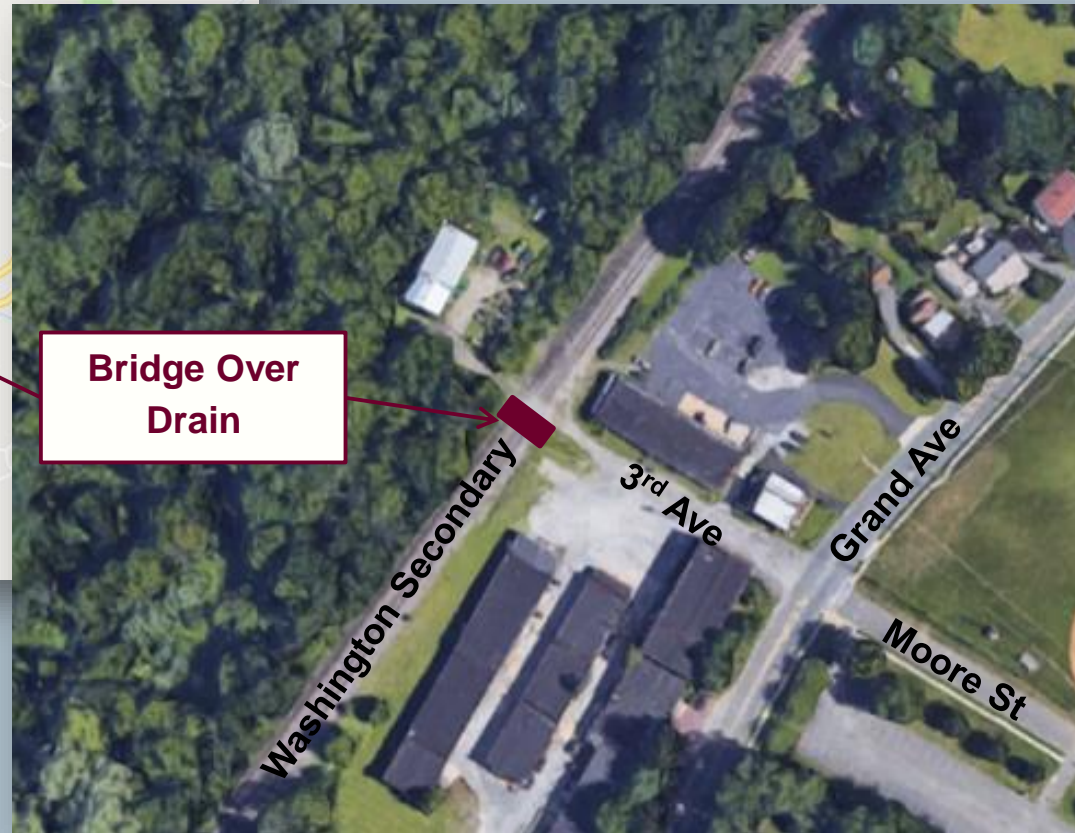
# Existing Condition

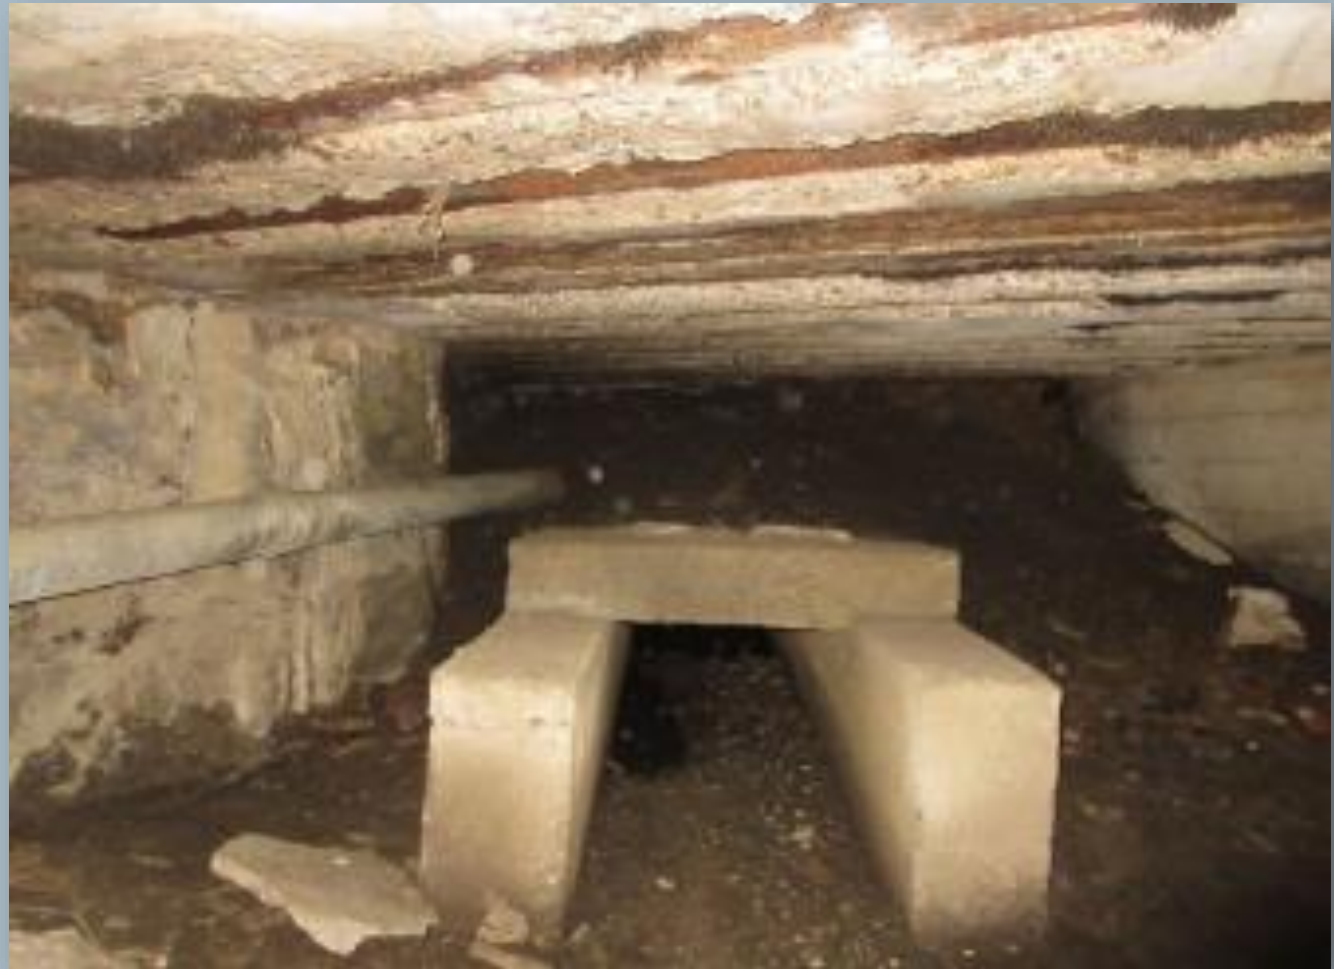
# Existing Condition

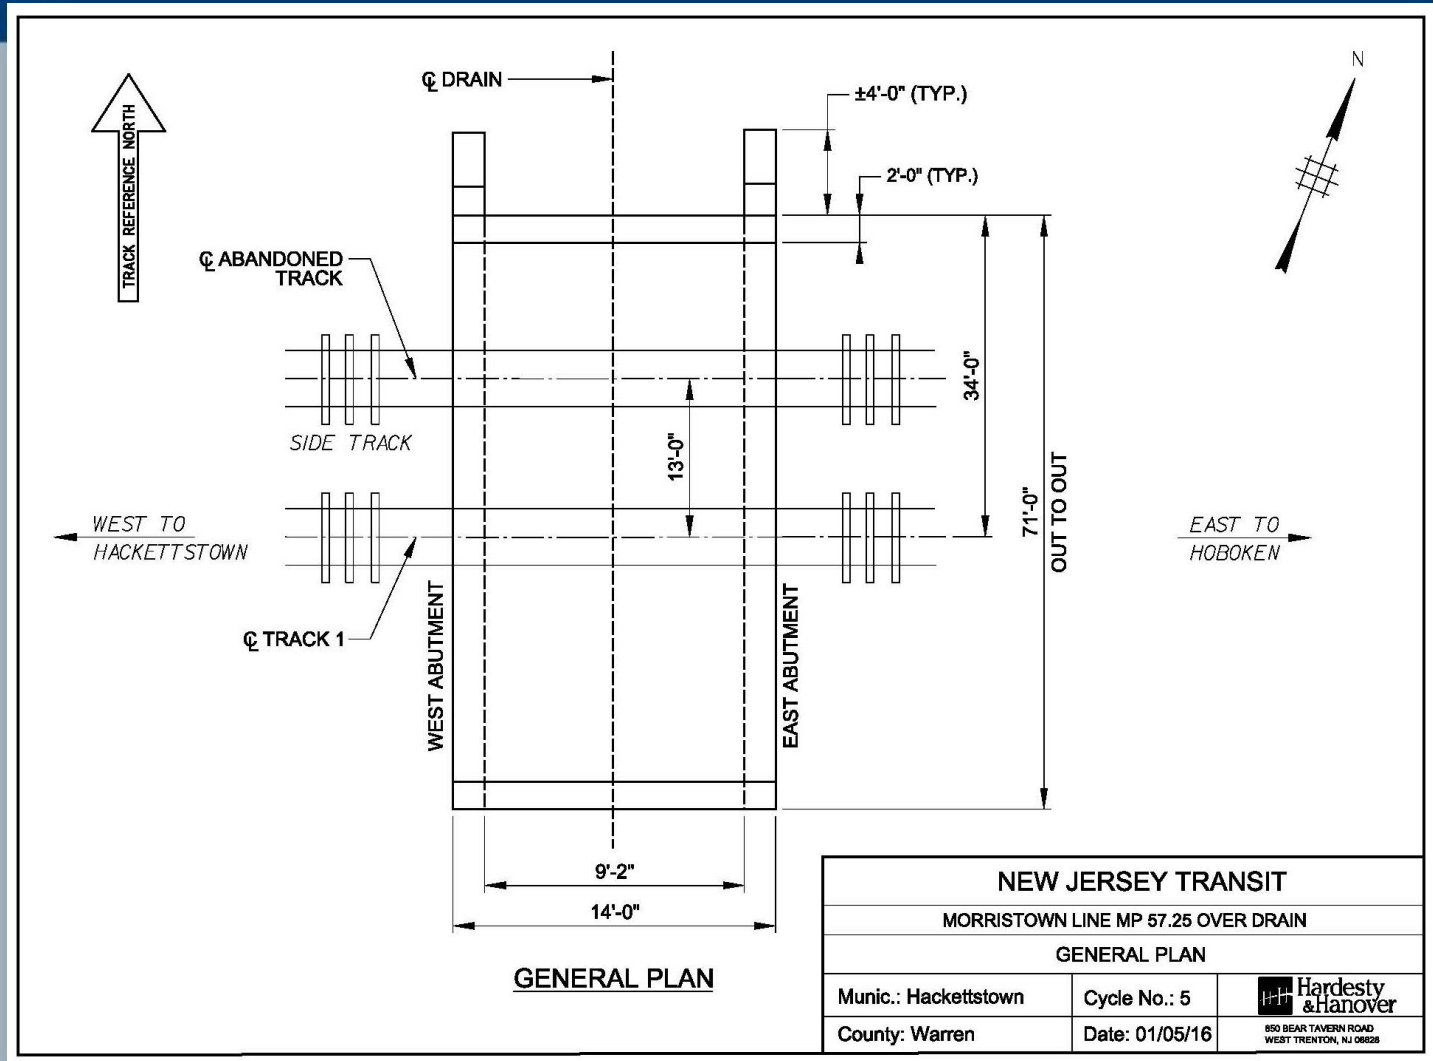
# Existing Condition

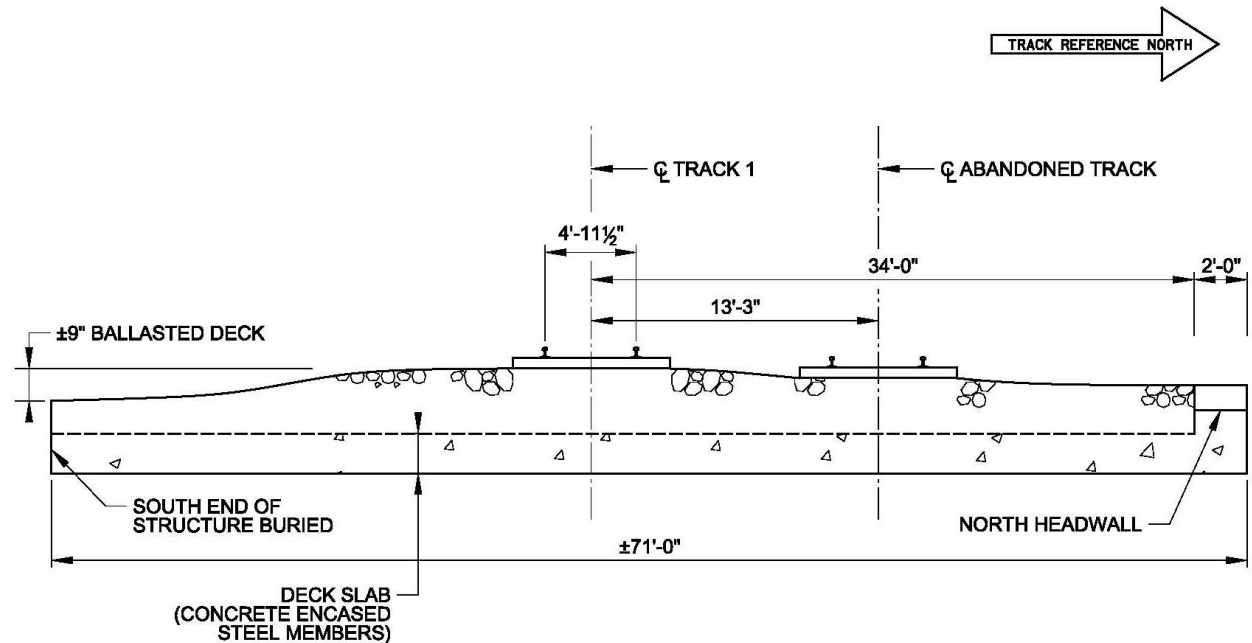
**CROSS SECTION**  
(LOOKING WEST)  
N.T.S.
