North Jersey Transportation Planning Authority

# Concept Development Report

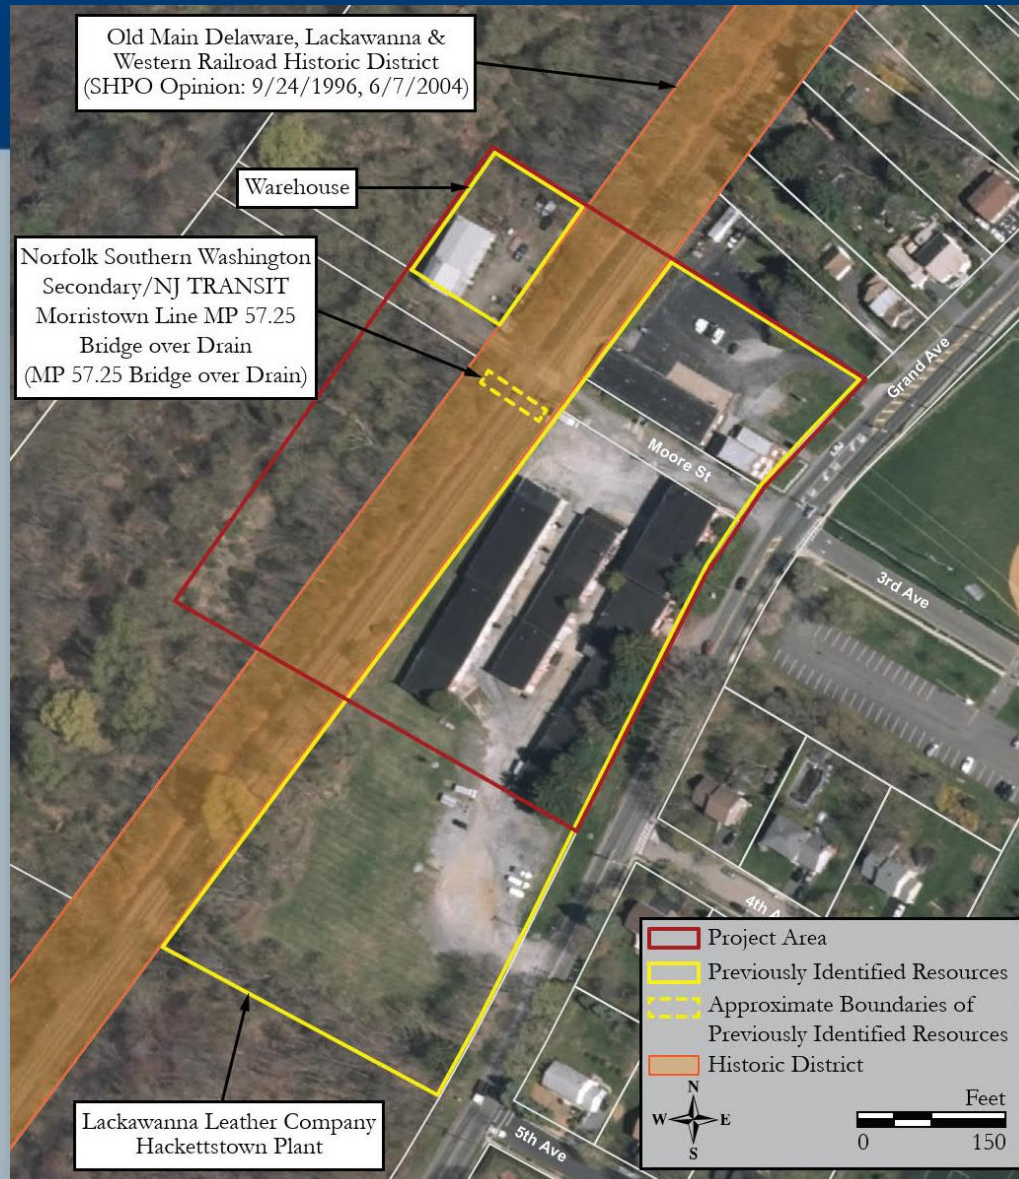
# Alternatives Evaluated

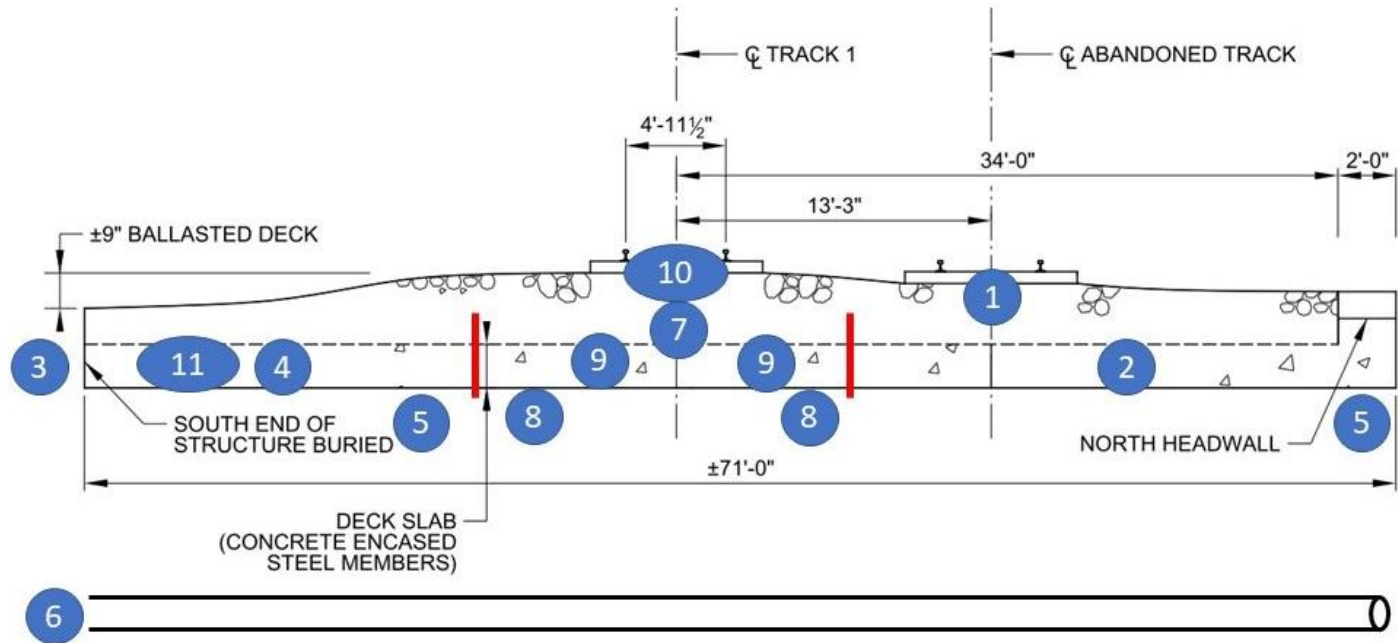
1. Remove side track and ballast to allow clearing of the slab
2. Remove northern concrete and rail slab
3. Excavate south end of structure to expose drainage pipe below slab
4. Remove southern concrete and slab and earth covering drainage pipe
5. Repoint abutments and repair headwall
6. Extend 15-inch drainage pipe into culvert
7. Remove active track, ballast and slab
8. Level top of abutments with grout
9. Set two (2) new precast 8-ft by 14-ft slabs
10. Place new ballast and new track panels. Reopen track for service
11. Install remaining slabs

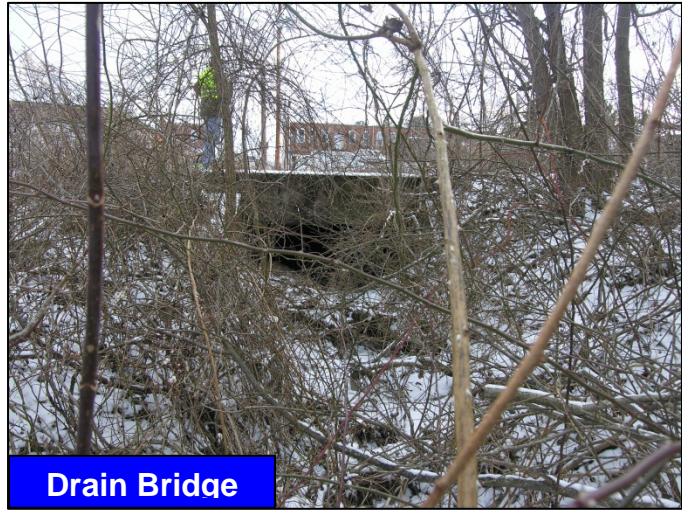
Similar to the Cattle Pass bridge at MP 57.49, this bridge is located within the Delaware Lackawanna & Western Historic Corridor and as such is likely considered an historic bridge of cultural and architectural significance. Removal of the bridge would require coordination with the SHPO. The recommended option for improvements to this location to accommodate 286K railcars is removal of the bridge, replacing the existing concrete slab superstructure and abutments with a precast concrete box structure.

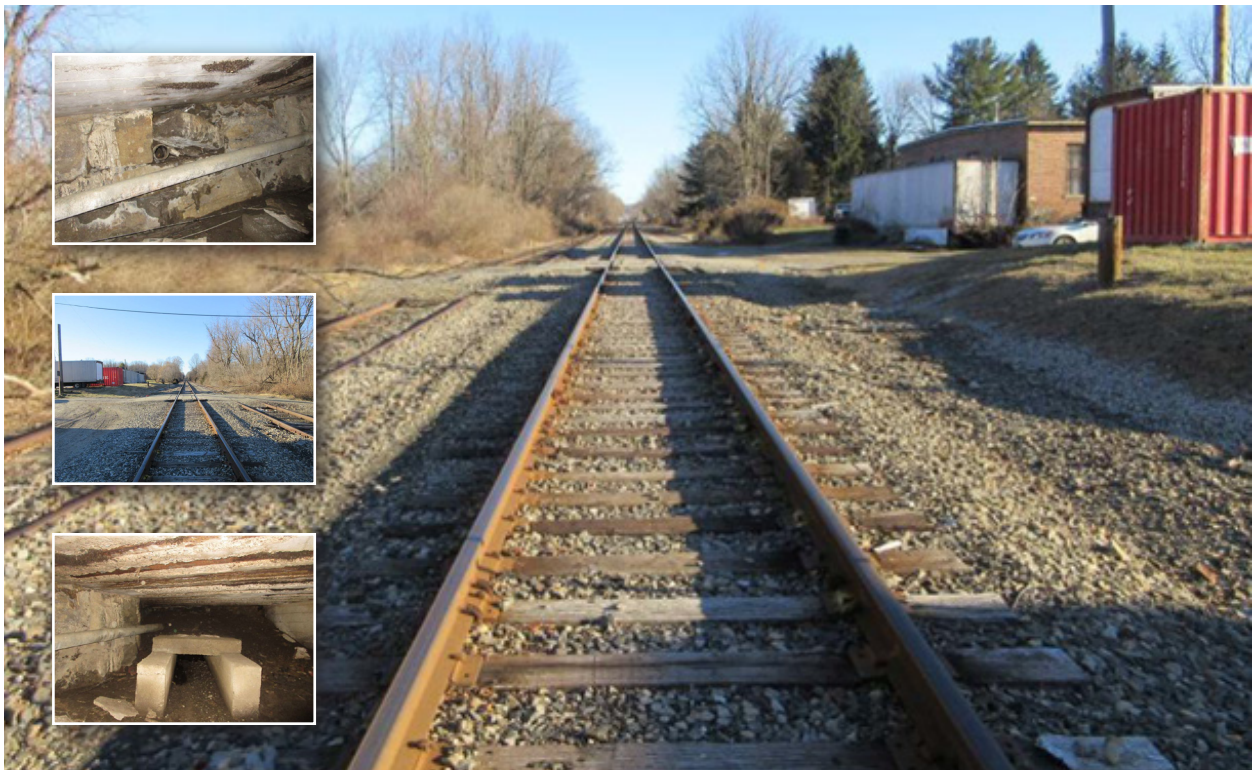
Hackettstown Drain Bridge - Washington Secondary MP 57.25  
 Alternatives Considered for Elimination of Weight Restriction

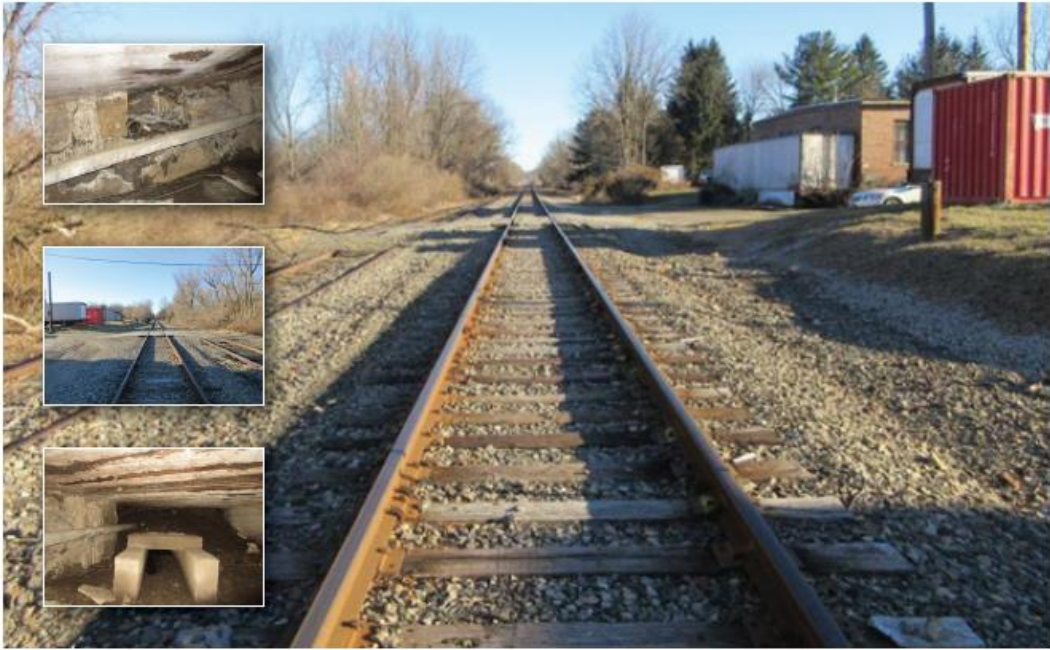
Potential Funding Programs for Advancement of PPA into Design and Construction
