Hamilton Avenue Walkable Community Workshop

Borough of Glen Rock, Bergen County, NJ

2019

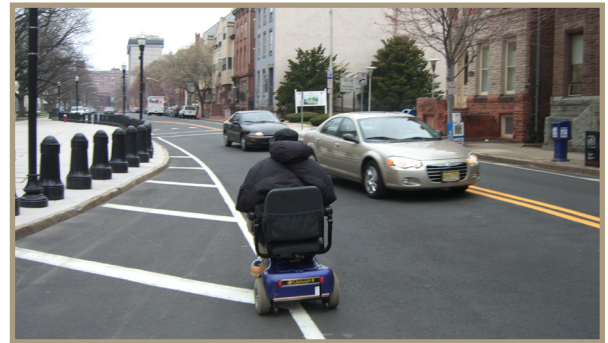
Figure 6. When a street lacks accessible sidewalks and ramps, it is not complete.

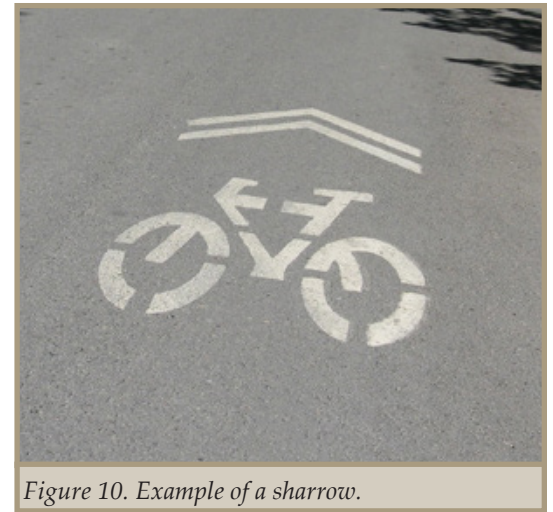
Figure 10. Example of a sharrow.

The walk audit provided an opportunity to educate the attendees on how sharrows recommended by the CBBPP can help bicyclists and motorists by creating a safer environment for all users. The lessons learnt during the audit and the improvements proposed for Hamilton Avenue can be used as a template for other roadways in Glen Rock, thereby establishing a complete network of safe streets.

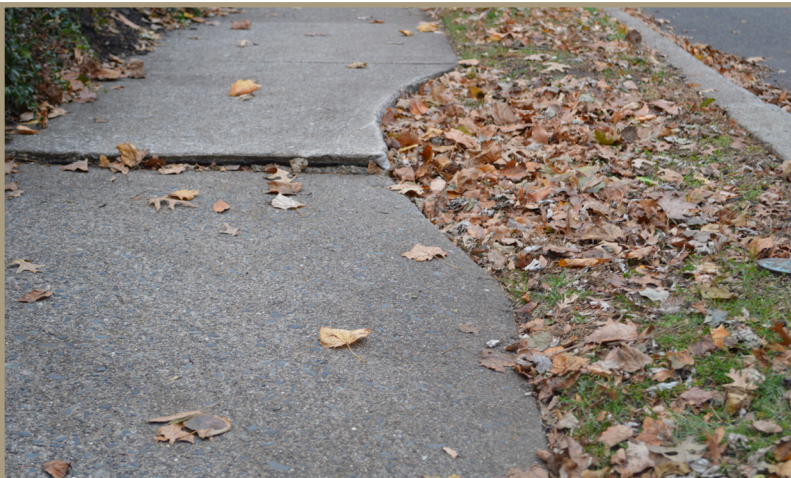
While sidewalks are present along the entire corridor and are generally in good condition, there are a few instances where the sidewalks are cracked or raised (Figure 14, Figure 15). The five-foot sidewalks also represent the bare minimum width necessary for pedestrians to walk side by side, which may discourage some students from walking on the sidewalk. Although the New Jersey Complete Streets Design Guide states that a minimum width of five feet is required to meet accessibility standards, the desired sidewalk width should be based on pedestrian needs. Since the majority of foot traffic consists of groups of students, a wider sidewalk is warranted along portions of the corridor, and installation of a six-foot wide sidewalk would be appropriate. Additionally, the sidewalk narrows in sections where trees were previously planted. For most of the length, the sidewalks are separated from the roadway with a small planting strip, which creates a buffer between pedestrians and moving vehicles. Other issues observed along the corridor included incursion by vegetation (Figure 16), and a cross slope towards the roadway (Figure 17).

Figure 14. The sidewalk frequently narrows where mature trees once stood. The roots of those trees have raised the sidewalks at some locations.

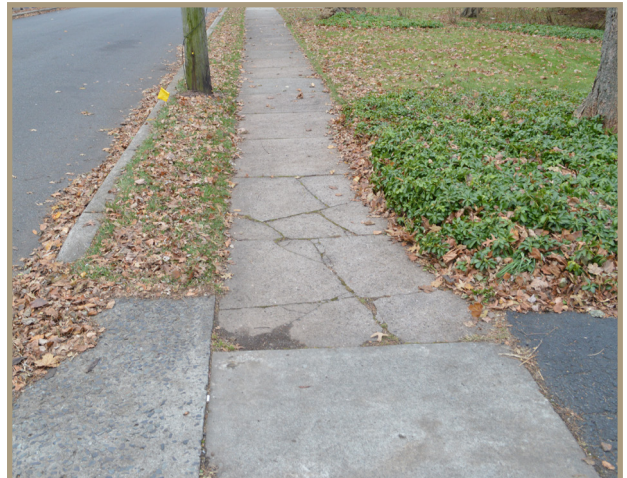
Figure 15. The corridor has continuous sidewalks on both sides, although cracking is apparent in parts.

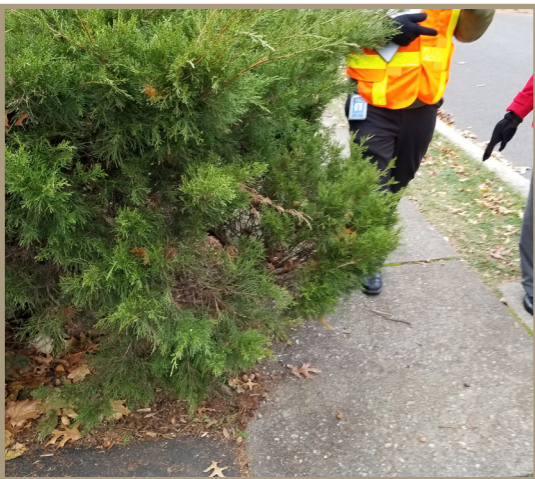
Figure 16. Sidewalk blocked by vegetation.

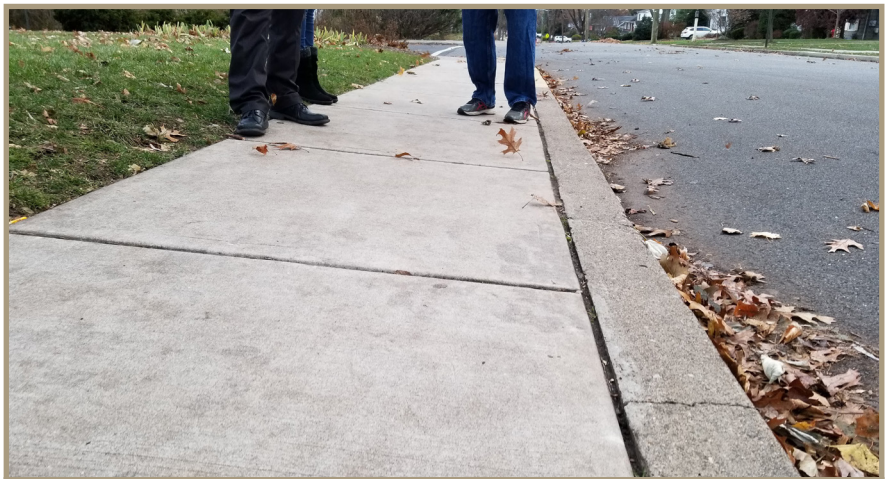
Figure 17. Sidewalk sloped towards roadway.

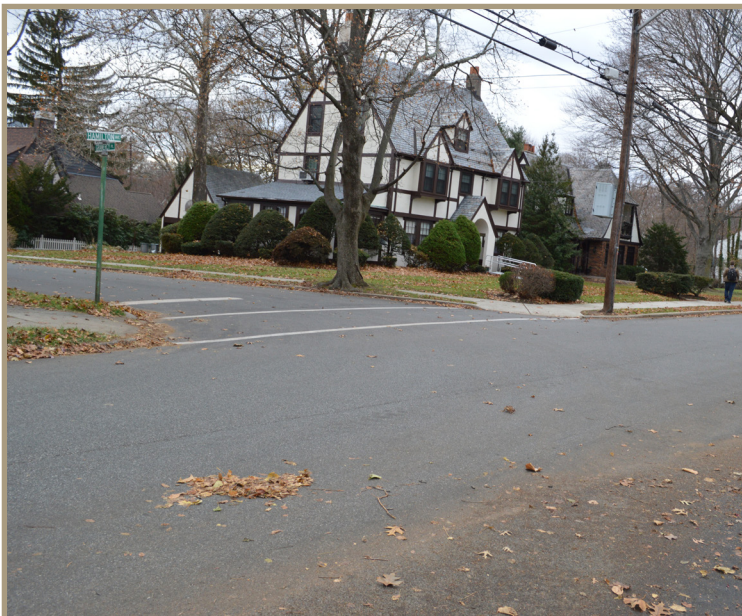
Figure 18. Crosswalks across Hamilton Avenue are absent at the various T-intersections, (looking north on Hamilton Avenue).

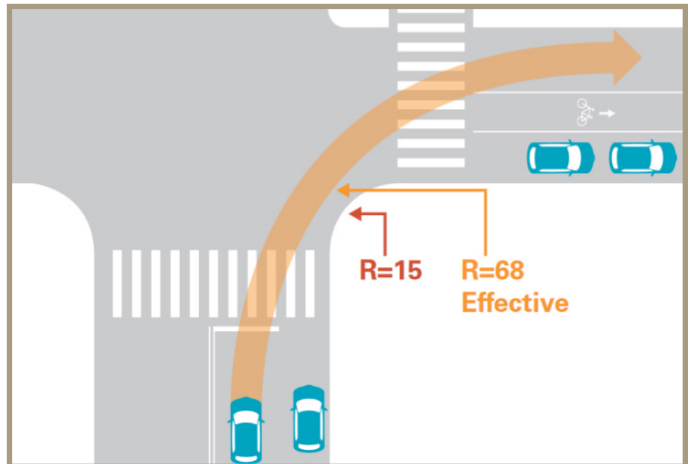
Figure 19. The actual turning radius (red) should be minimized to lower vehicle turning speeds. A larger effective turning radius (orange) is still available to larger vehicles as they can use the full width of the roadway to turn.

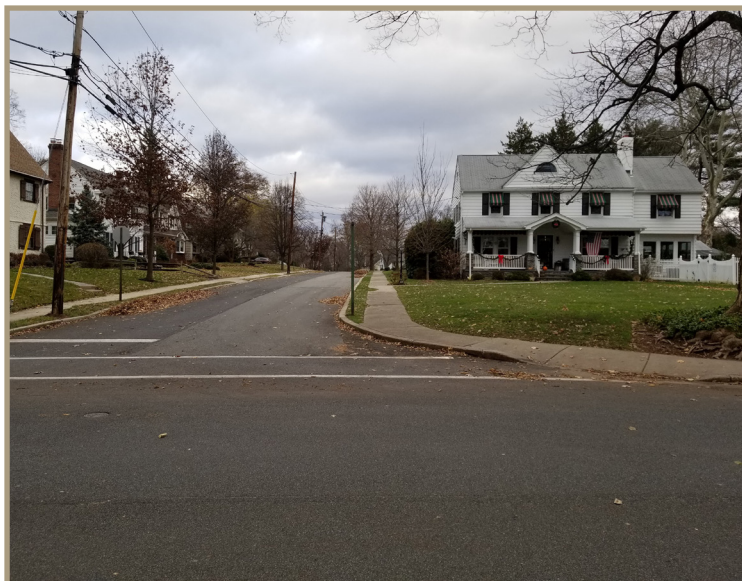
At these same major intersections, large turning radii allow drivers to quickly enter Hamilton Avenue (Figure 20). This results in higher driving speeds can intimidate pedestrians and reduce the likelihood that drivers will stop for people who are waiting to cross. Intersection geometry should be designed for the types of vehicles that typically frequent the intersection and does not need to be designed for larger vehicles if they are an infrequent occurrence. There are no traffic signals at Maple Avenue, Rock Road, or Harristown Road, so drivers are required to stop and stay stopped for a pedestrian that wants to use the crosswalk. Unfortunately, not all drivers follow the law, making it difficult for pedestrians to cross at these locations.

Figure 20. Wide turn radius at various intersections.

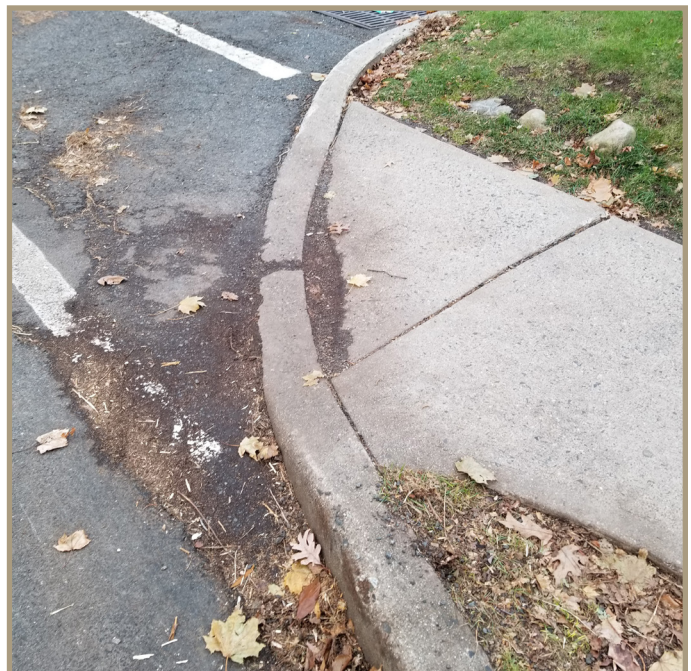
Figure 21. Ramps not ADA compliant along corridor.

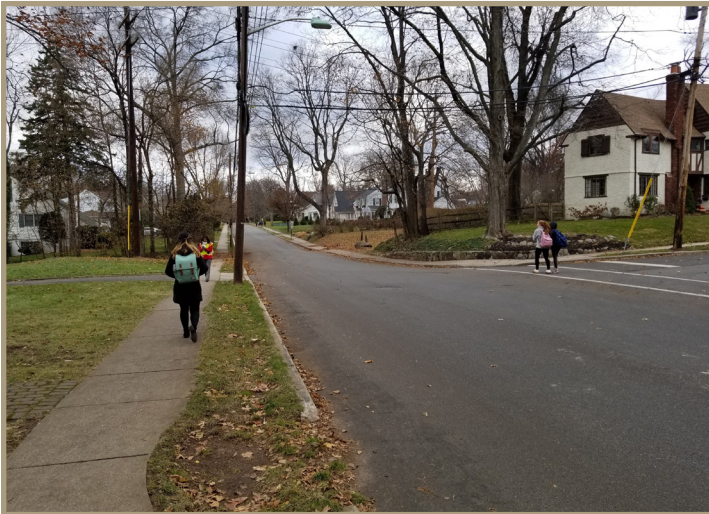
Three traffic safety concerns were apparent during the audit. The first was the ease at which drivers could reach high speeds between Harristown Road and Rock Road. This is possible because it is a long, straight section of road without any traffic controls (Figure 22). Second, between Harding Road and Maple Avenue, the narrow width of the street discourages speeding. However, when the street is further narrowed with leaves or snow, the possibility of vehicle collisions (sideswipes) increases (Figure 23). Finally, crossing Maple Avenue and Rock Road can be dangerous for pedestrians due to the high traffic volumes on these roadways and the lack of a pedestrian signal. Although pedestrians can walk to the nearby signalized intersection, most pedestrians prefer to use the most direct route to their destination.

Figure 22. High speeds are possible along Hamilton.

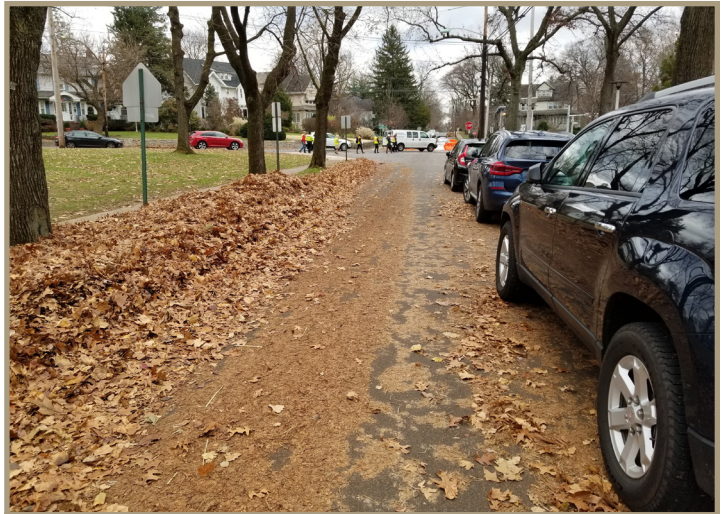
Figure 23. Roadway narrowed by leaves near Elementary School.

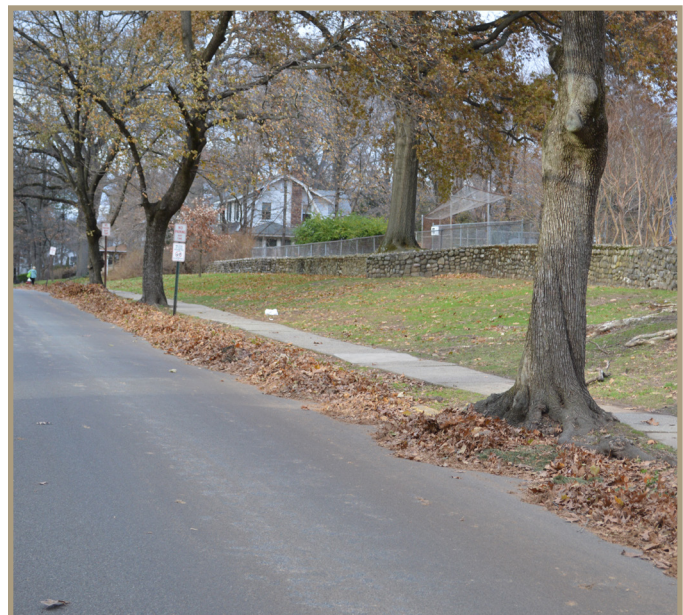
Within the last decade, Glen Rock lost a large quantity of trees during several storms. Many of these trees were not replaced, leaving behind obvious gaps along the sidewalk where trees once grew. Tree replacement would assist with traffic calming, as they visually narrow the width of the roadway to drivers. Trees also can enhance the attractiveness of the corridor and provide additional shade. Because large trees can block street lighting at night, it is important to consider placement and canopy size when planting. It is also important to consider the root structure of fully grown trees, as they can disrupt the sidewalk. Green streets principles, such as a rain garden, can be applied to tree pits and curbing at time of planting to reduce stormwater runoff.

Figure 24. There are more street trees north of Maple road than to the south (looking north on Hamilton Avenue).

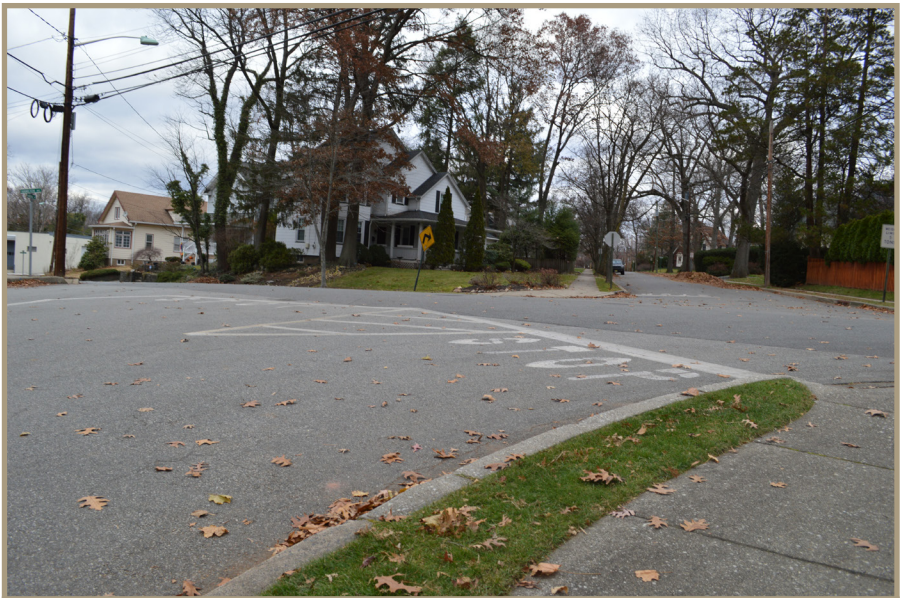
Figure 25. Wide crosswalk, split lanes, and traffic island at Harding Avenue.

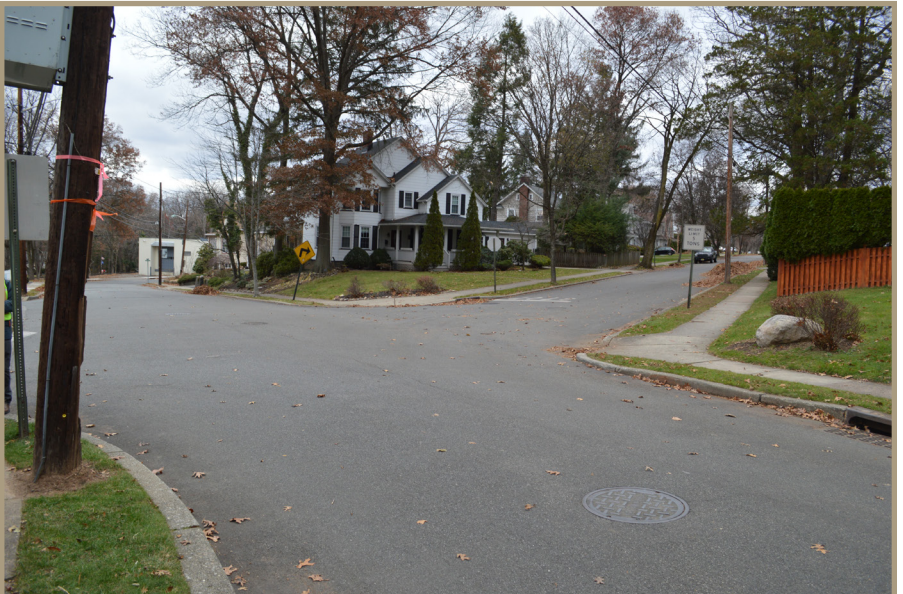
There are no marked crosswalks at this intersection and the existing sidewalk ramps are not ADA compliant and are oriented towards the center of the intersection, rather than into the unmarked crosswalks (Figure 26). On the northern leg of the intersection, an additional curb ramp is warranted to allow for the shortest possible crossing distance. The intersection has a single overhead cobra light on Hamilton Avenue, over where the northern crosswalk would be.

Figure 26. Crosswalks are not painted in any direction (looking northeast).

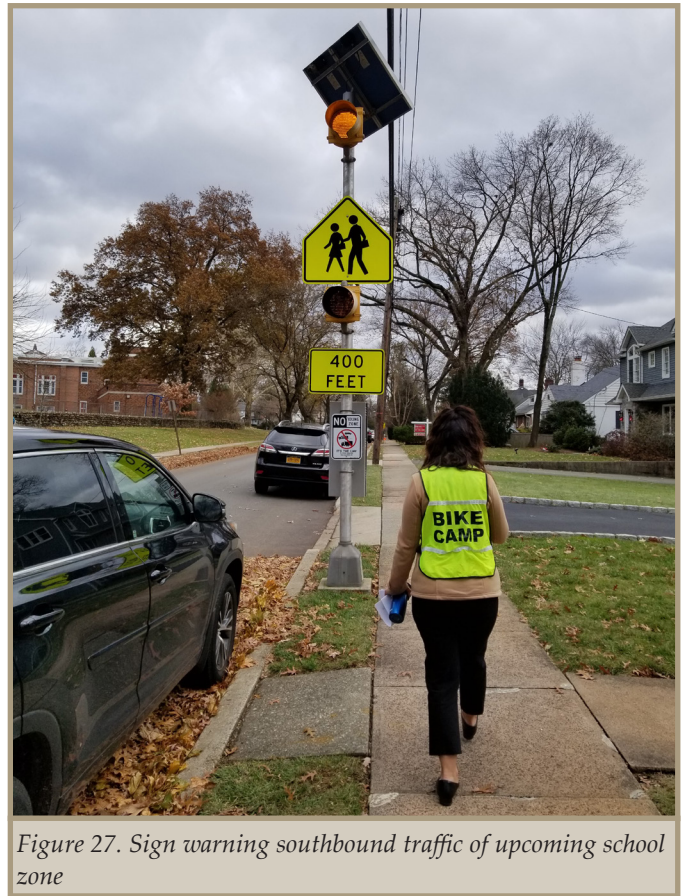
Approaching Central Elementary School, southbound drivers are presented with a large school warning sign featuring flashing yellow lights that are activated at the appropriate times (Figure 14). Google Streetview shows that in the past, this sign was accompanied by pavement striping that said SCHOOL but this was not visible during the audit. The curb on the east side of the street is painted yellow along the school property to reinforce the ban on parking. The sidewalk in front of the school narrows in part to allow space for trees; however, some of the trees are no longer there.

Figure 27. Sign warning southbound traffic of upcoming school zone

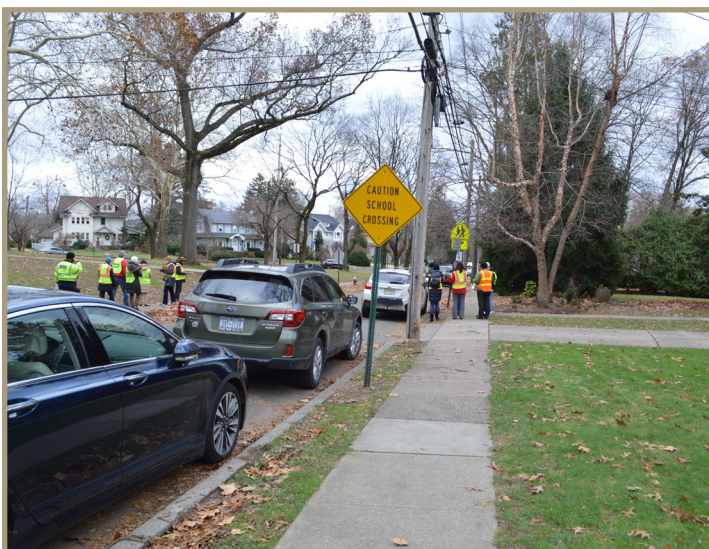
A mid-block crosswalk is painted in front of the school (Location B). Southbound traffic is presented with an outdated “Caution school crossing” sign prior to the crosswalk, and then a modern pedestrian crossing sign at the sidewalk itself (Figure 28). However, the sign at the crosswalk is mostly blocked by tree canopy. Northbound traffic sees a modern “pedestrian crossing ahead” sign prior to the crosswalk, and then an additional sign at the crosswalk (Figure 29). The crosswalk itself is mostly faded, and is a mixture of white and yellow paint. Google Streetview shows that in the past, the crosswalk had a fake brick overlay. In the southbound direction, the curb has been painted yellow just prior to and just after the crosswalk to remind drivers that it is illegal to park close to the crosswalk. There is no other physical barrier to prevent drivers from parking illegally. At the appropriate times, a crossing guard is posted to facilitate crossings. Auditors found remnants of an in-street pedestrian crossing sign.

Figure 28. Mid-block crosswalk in front of school, looking south.

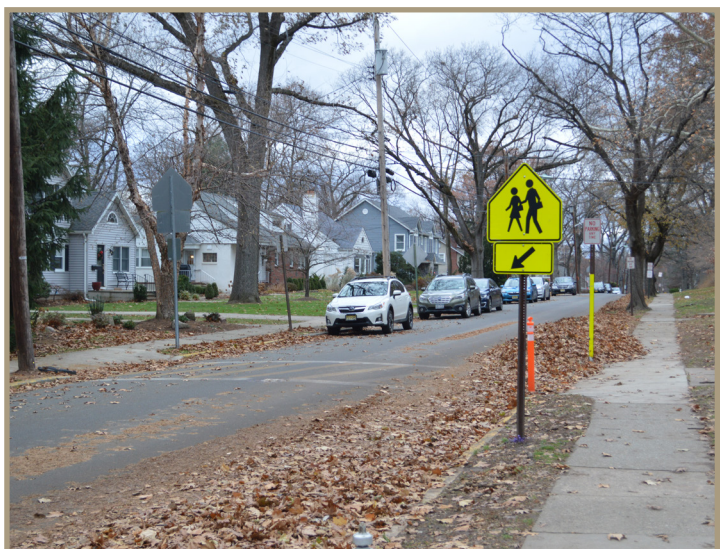
Figure 29. Mid-block crosswalk in front of school, looking north.

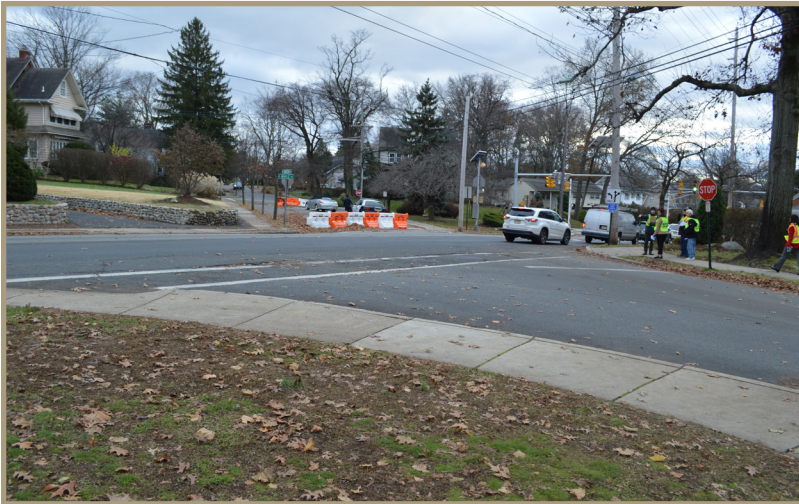
South of the school, on the west side of the street, the sidewalk is interrupted by the vehicle entrance to the Glen Rock Free Public Library. There is no painted crosswalk, and the curb ramps are not ADA-compliant. As Hamilton Avenue approaches Maple Avenue, the street widens due to the angle at which the roadways intersect. This results in a 70-foot crossing distance within the marked crosswalk (Figure 30). The turning radius on both corners is very wide, allowing vehicles to quickly enter and exit Hamilton Avenue without stopping.

Figure 30. Very wide turning radius at the intersection of Hamilton and Maple.

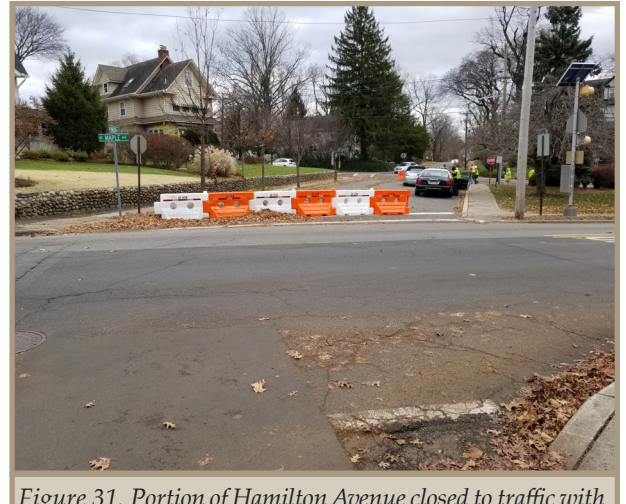
Figure 31. Portion of Hamilton Avenue closed to traffic with temporary traffic control.

Hamilton Avenue intersects with Maple Avenue (CR 507) and Rock Road (CR 134) in rapid succession – the two intersections are only 150 feet apart. Additionally, Maple Avenue and Rock Road intersect with each other less than 200 feet to the west. This results in three intersections in very close proximity, creating a triangular island in the middle. However, only the intersection of Maple Avenue and Rock Road is controlled by a traffic signal. Due to the complications created by this arrangement, Glen Rock recently decided to close the section of Hamilton Avenue between Maple Avenue and Rock Road to vehicular traffic (Figure 31, Location C). The municipality would like to make this closure permanent, and use the space for a public park or plaza.

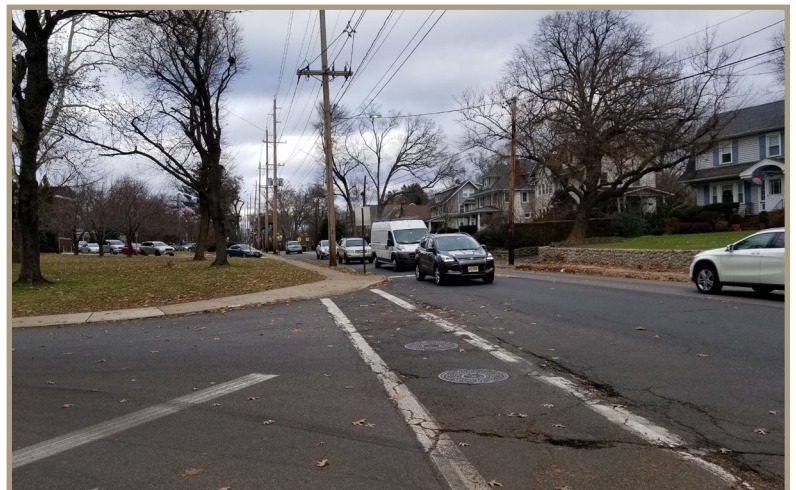
Maple Avenue has the right of way over Hamilton Avenue, which is controlled by a stop sign. Just north of the intersection, Maple Avenue has a stop bar accompanied by a “do not block intersection” sign. During the audit, motorists were observed adhering to the sign, and leaving the intersection open for turns onto and off Hamilton Avenue. Crosswalks are painted across Hamilton Avenue, but not Maple Avenue. All four corners of the intersection have curb ramps, although none meet ADA standards. If crosswalks were to be painted at their current locations, the resulting crosswalks would be very long due to the skewed angle created by the ramp positions.

Figure 32. Drivers did not block the intersection when observed during the audit (looking northeast).

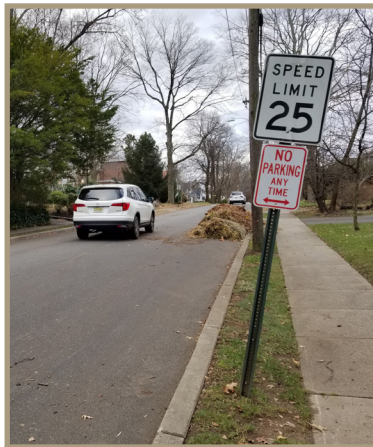
South of the Rock Road intersection, Hamilton Avenue continues to be a two-way road with parking allowed only on the eastern side. Where parking is prohibited, signs are posted but they are faded. The speed limit is signed for 25 mph (Figure 33). This stretch of roadway is slightly wider than the section of the corridor north of Maple Avenue. Lighting is provided by standard overhead cobra fixtures. During the audit, residents noted that Hamilton Avenue northbound becomes congested during peak hours, as drivers wait to turn onto Rock Road.

Figure 33. Speed limit and parking regulations clearly posted.

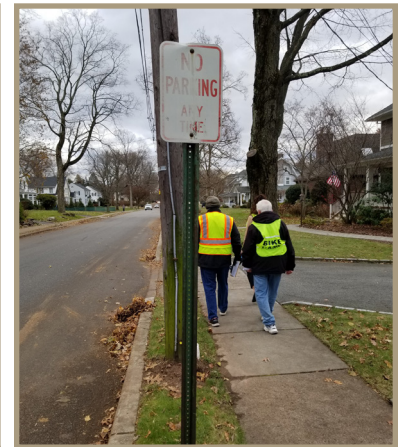
Figure 34. Some signs have faded and should be replaced.

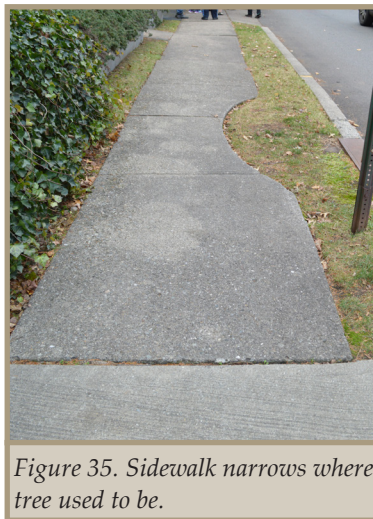
Figure 35. Sidewalk narrows where tree used to be.

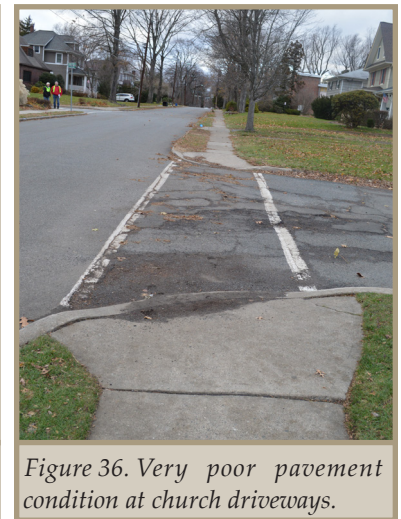
Figure 36. Very poor pavement condition at church driveways.

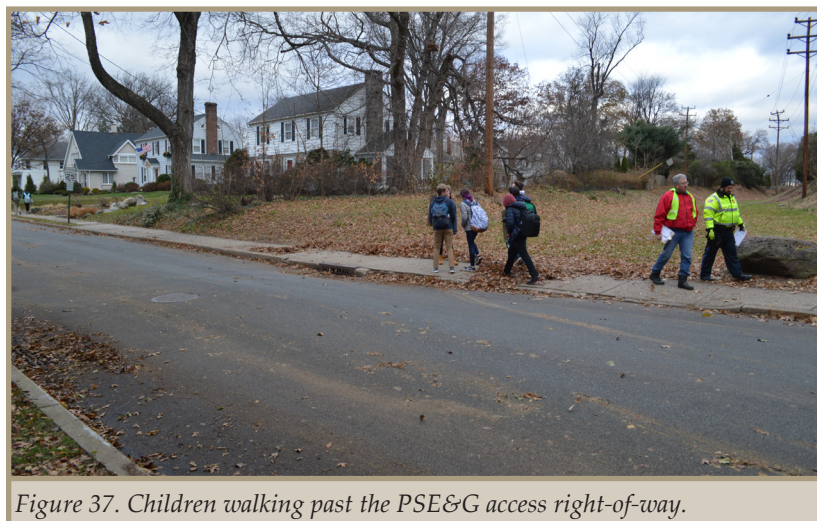
Figure 37. Children walking past the PSE&G access right-of-way.

Sidewalk and road conditions along Hamilton Avenue do not change south of Clinton Place. Just north of Gramercy Place, Hamilton Avenue is bisected by an unpaved PSE&G access road (Figure 37). There is a driveway to this right-of-way on the east side of the road, which creates a slope on the sidewalk. On the west side, there is no driveway, but the vegetation is overgrown. A "no trespassing" sign is posted on the access road, but residents say the path is used by pedestrians. This right-of-way may offer an opportunity to one day create a valuable east-west pedestrian connection across Glen Rock.

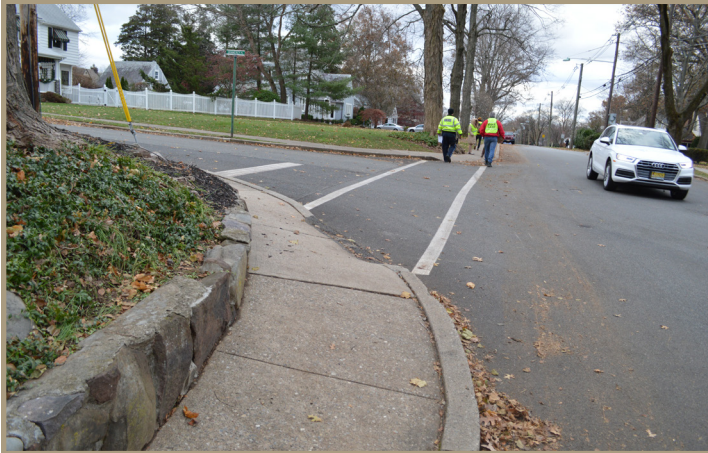
From the east, Gramercy Place comes to a T-intersection (Location E) at Hamilton Avenue. As with Clinton Place, Gramercy Place has a stop sign while Hamilton Avenue has the right-of-way. There is a well-marked stop bar, but the stop sign is placed well before the intersection. A standard crosswalk is painted only across Gramercy Place and the two curb ramps are only on the east side of the road. The ramps are in poor condition and are not ADA-compliant. The sidewalk is narrowed by the presence of a small retaining wall, and is sloped towards the road. The turning radius onto Gramercy Place is wider than necessary for a residential area, encouraging faster driving speeds (Figure 38). There is a single light over the intersection, on the west side of Hamilton Avenue.

Figure 38. At Gramercy Place, the sidewalk narrows, there is a strong cross-slope, the corner ramp is not ADA compliant, and the wide turning radius encourages faster vehicle speeds.

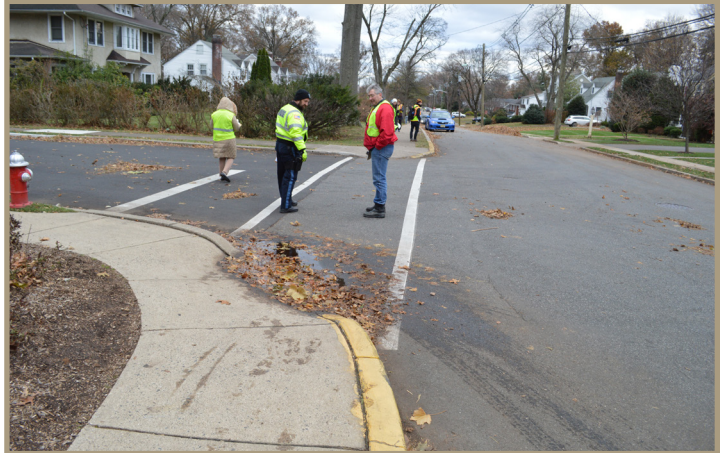
Figure 39. The curb ramp at Emerson Road accumulates debris, and is not ADA compliant. There is no marked crosswalk across Hamilton Avenue.

Emerson Road also terminates on Hamilton Avenue, but from the east. The setup of the intersection is identical to the previous ones, including a stop sign placed oddly distant from the stop bar. One minor difference is that south of Emerson Road, the eastern sidewalk regains the grass strip adjacent to the roadway. Pooling water and leaves were noted at the bottom of the curb ramp (Figure 39) at this intersection.

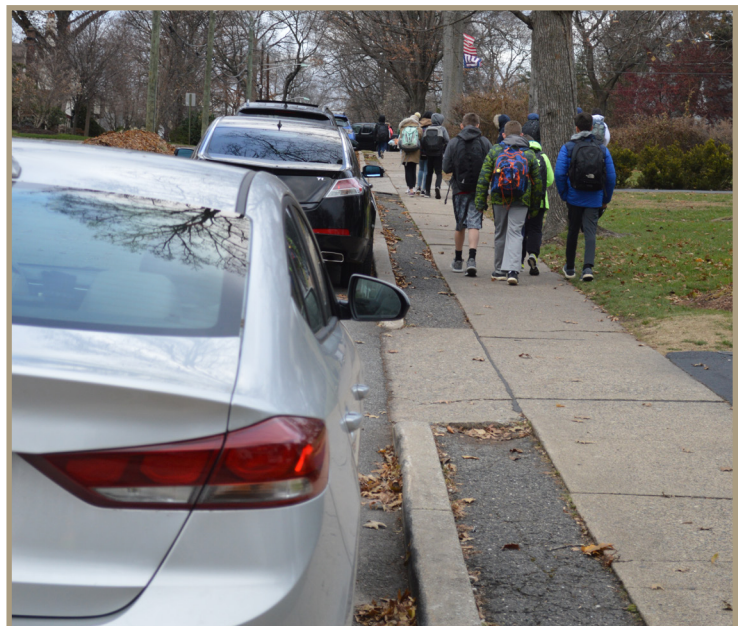
The character of the road changes slightly south of Emerson Road, as parking on the east side of Hamilton Avenue is marked with painted stalls (Figure 40). These stalls are positioned to allow drivers entering and exiting the driveways adequate space. This parking continues until Harristown Road, and is used by students attending the nearby high school. The grass strip adjacent to the parking has been filled in with asphalt.

Figure 40. Pedestrian traffic, parked cars, and a paved over planting strip near the southern end of the corridor (looking north).

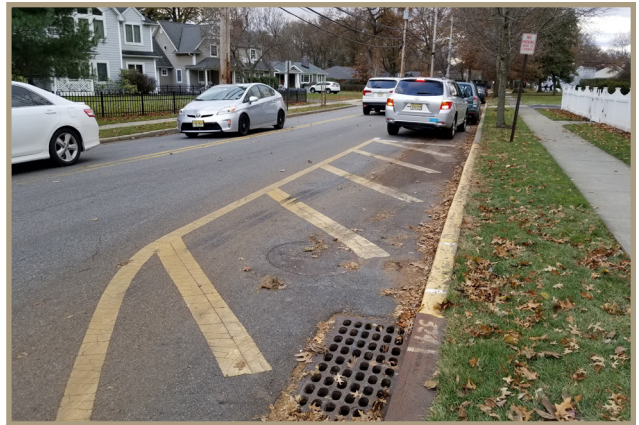
The intersection of Harristown Road and Hamilton Avenue is well marked, with high-visibility crosswalks painted on three legs (Location F). Additionally, Harristown Road has been striped with yellow hatch marks to prevent parking near the crosswalks (Figure 41). Drivers on Harristown Road are presented with pedestrian crossing signage in both directions, which is reinforced by a crossing guard posted during the appropriate school hours (Figure 43). There is one overhead cobra light at this intersection, directly over the crosswalk.

Figure 41. The crosshatch striping on Harristown Road effectively deters illegal parking (looking west).

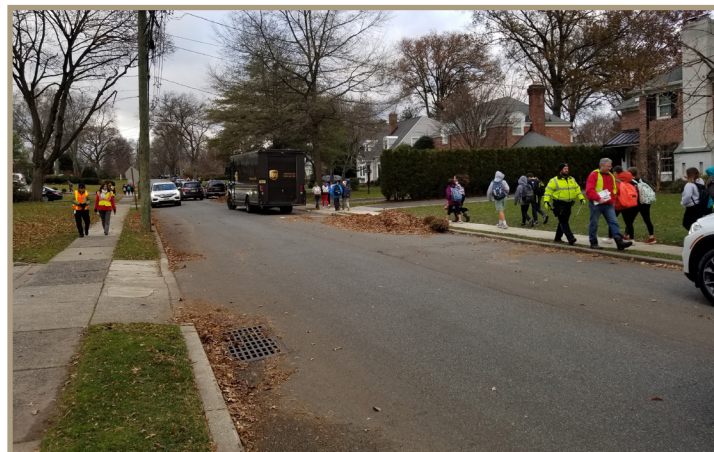
Figure 42. Pedestrian traffic on Hamilton Avenue is heavy at school dismissal time (looking north).

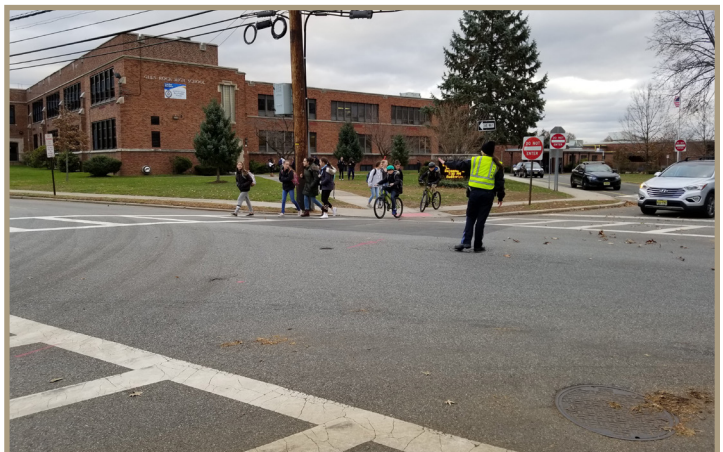
Figure 43. A police officer controls traffic at Hamilton Avenue and Harristown Road to allow bicyclists and pedestrians to cross safely.

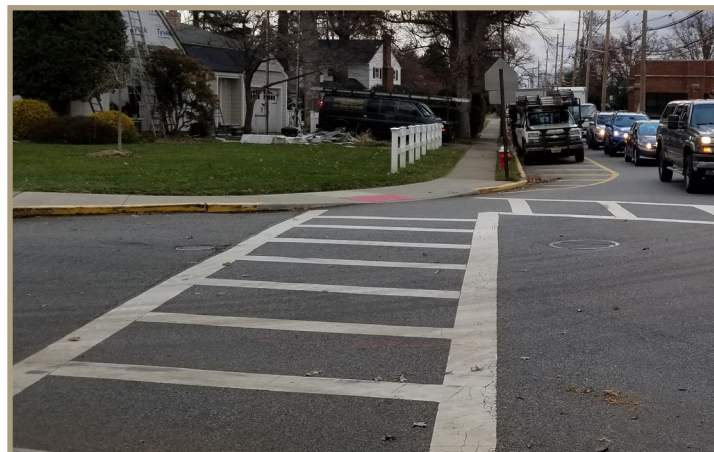
Figure 44. It is best practice to build a ramp oriented directly into each crosswalk, rather than a single diagonal ramp shown here.

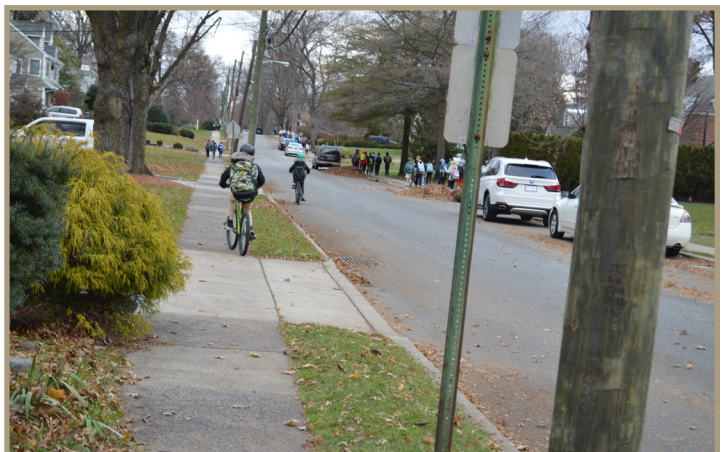
Figure 45. Bicyclists do not have a defined space on Hamilton Avenue, resulting in unsafe behavior (looking north).

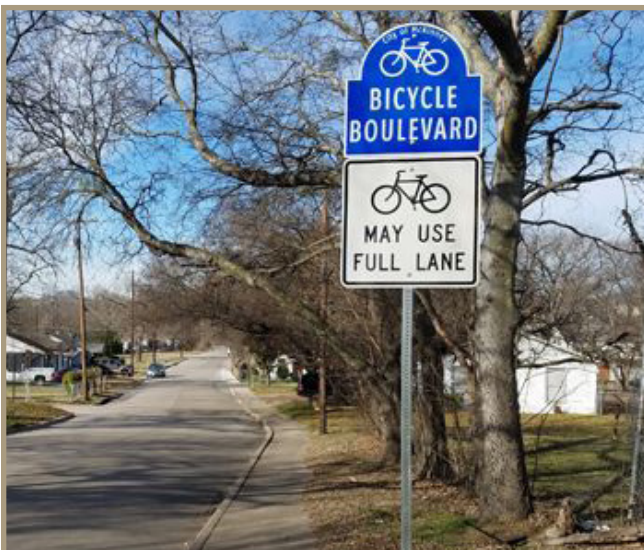
Figure 46. Bicycle Boulevard signage in McKinley, Texas.

Bicycle boulevard treatments include signs, pavement markings, and other traffic-calming measures to discourage through-trips by motor vehicles, while accommodating local access. Essentially, a bicycle boulevard sends a message that pedestrians and bicyclists have priority along the corridor, and drivers need to be especially careful, or select an alternative route. Hamilton Avenue already sees low motor vehicle traffic volumes, and is a natural corridor for pedestrians and bicyclists heading to the schools, library, or downtown. The treatments deployed with a bicycle boulevard would fit with the character of the neighborhood, which contains large single-family properties and plenty of greenery.

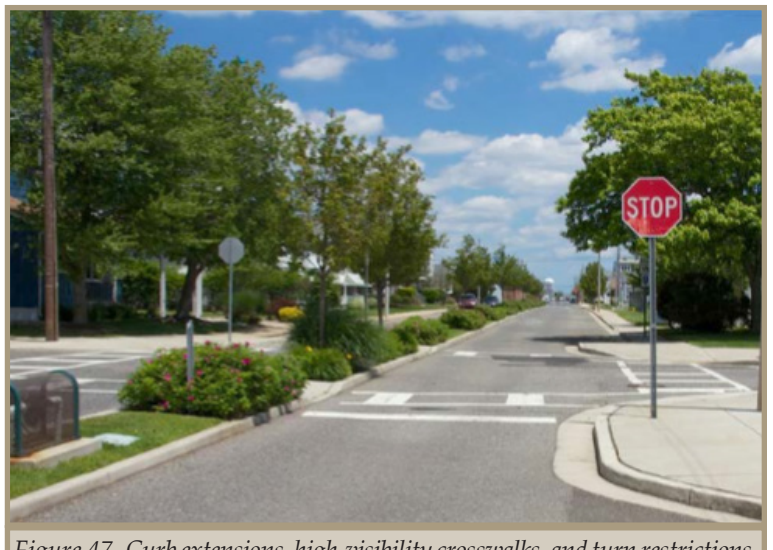
Figure 47. Curb extensions, high-visibility crosswalks, and turn restrictions calm traffic along a bicycle boulevard in Ocean City, NJ.

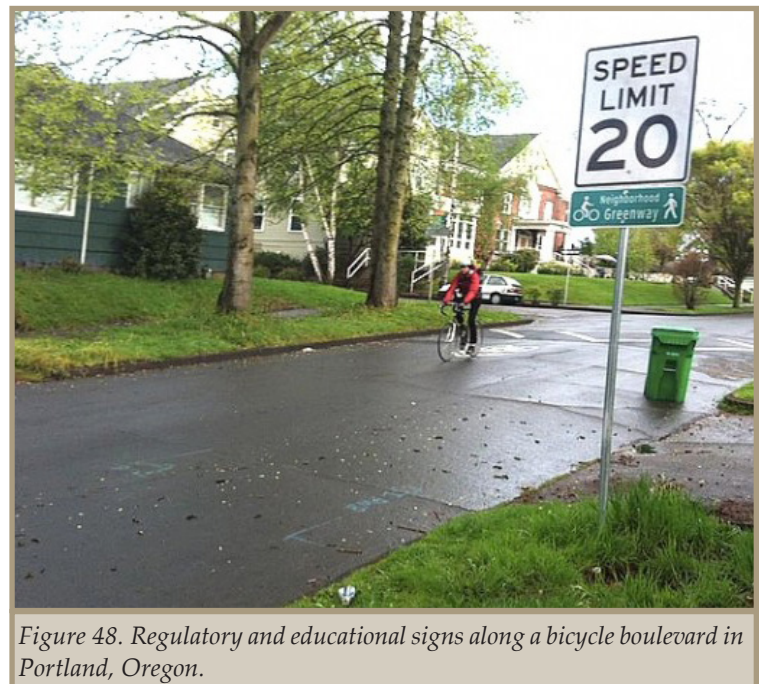
Figure 48. Regulatory and educational signs along a bicycle boulevard in Portland, Oregon.

On the corridor itself, there are two forms of signs and pavement markings that need to be deployed: regulatory and educational/informational. Regulatory markings include speed limit signs, marked crosswalks, and instructions to drivers, bicyclists, and pedestrians where appropriate (Figure 48). This can include the “bicycles may use full lane” (R4-11) signs. Informational signage may include branding, wayfinding, and explanations of the project purpose (Figure 49). It is important that the branding be developed with community input. Pavement markings reinforce the message being delivered by the signs. Large shared-lane pavement markings advise bicyclists on where to position themselves, and remind drivers that bicyclists may use the center of the lane (Figure 50).

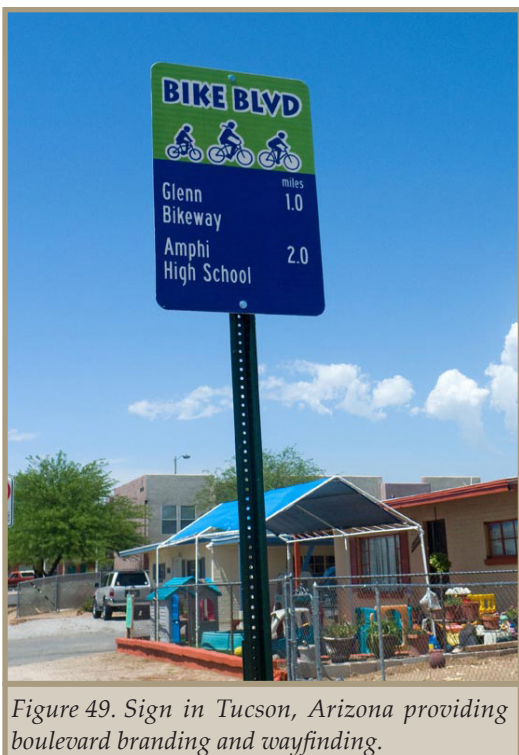
Figure 49. Sign in Tucson, Arizona providing boulevard branding and wayfinding.

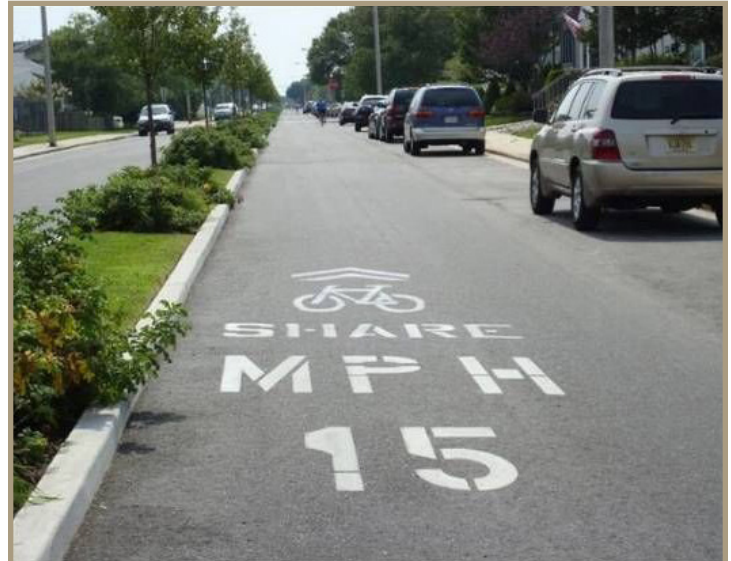
Figure 50. Pavement markings in Ocean City, New Jersey.

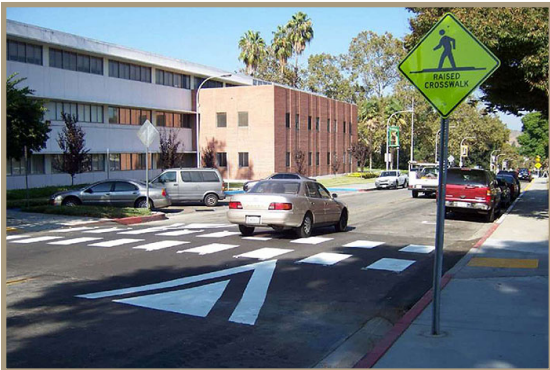
Figure 51. A speed table with a marked crosswalk (a raised crosswalk).

Traffic calming measures can include vertical deflection (e.g. speed humps or tables at intersections) or horizontal deflection (e.g. chicanes and traffic circles) (Figure 51). Traffic calming solutions can be combined with other measures to address other potential community goals, such as the addition of green infrastructure to a chicane, which creates a serpentine curve in a road to slow traffic (Figure 52).

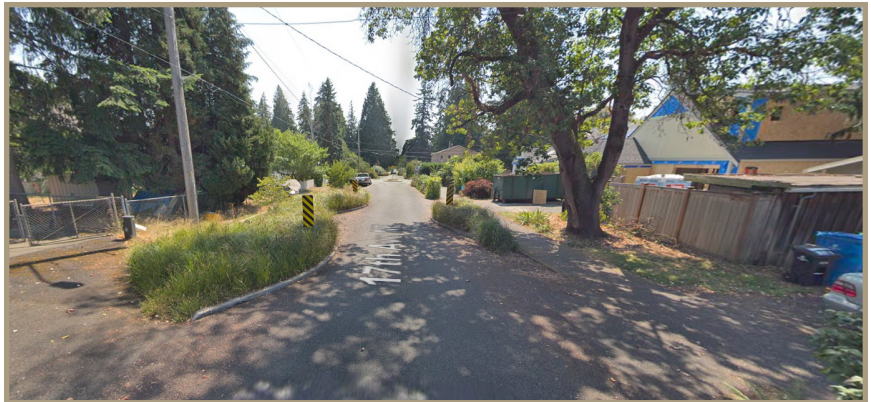
Figure 52. Traffic calming chicanes with green infrastructure in Shoreline, WA.

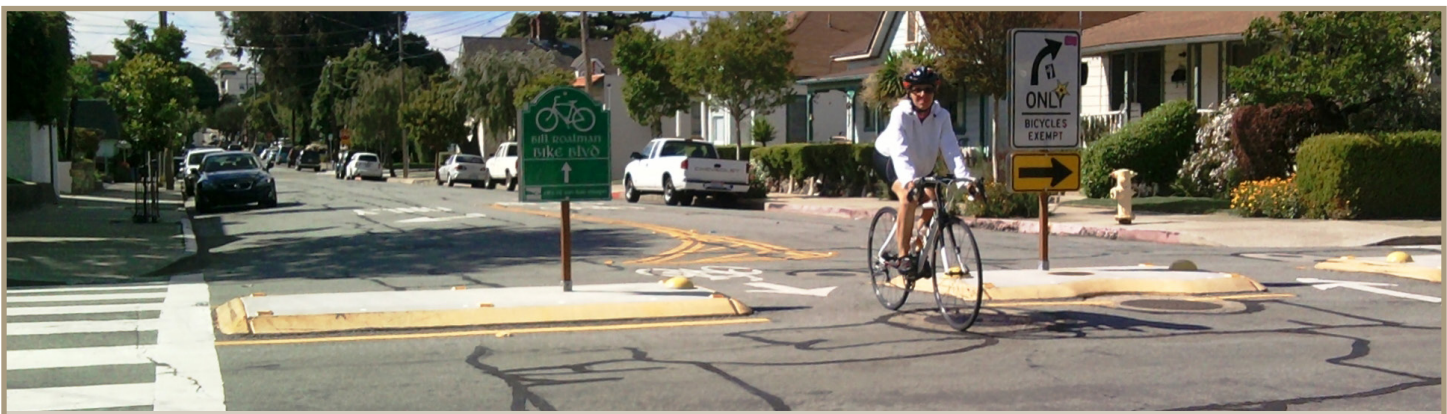
Figure 53. Diverters in San Luis Obispo, California, force automobile traffic to turn, while allowing bicyclists to continue straight.

Volume management is needed when the traffic volumes on the corridor exceed recommendations. This is especially true on residential streets being used as a cut-through. One common strategy to reduce traffic volumes is to prohibit cut-through traffic by forcing automobiles to turn off the boulevard every few blocks (Figure 53). Glen Rock has done this by closing off the section of Hamilton Avenue between Rock Road and Maple Avenue. Effective speed management will also discourage cut-through traffic as drivers look for the path of least resistance. Traffic data for Hamilton Avenue shows that additional diverters are not needed along the corridor at this time, but traffic volumes should be considered if planning additional bicycle boulevards.

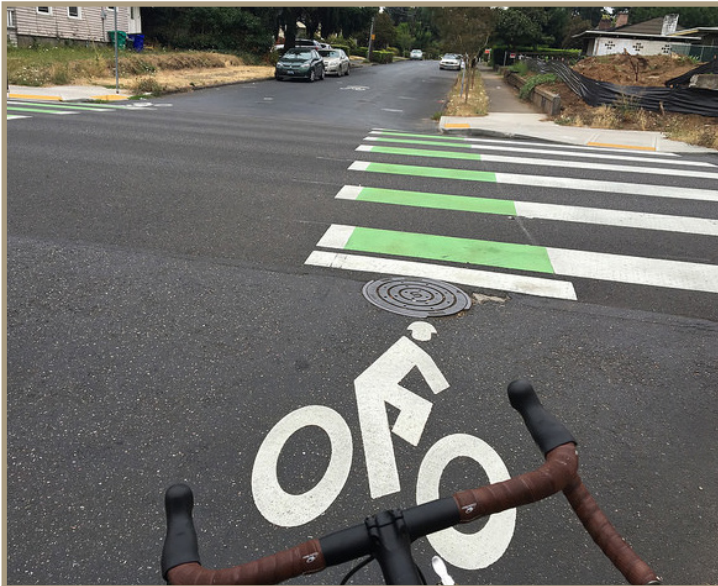
Figure 54. "Crossbike" in Portland, OR. Photo: J. Maus/BikePortland

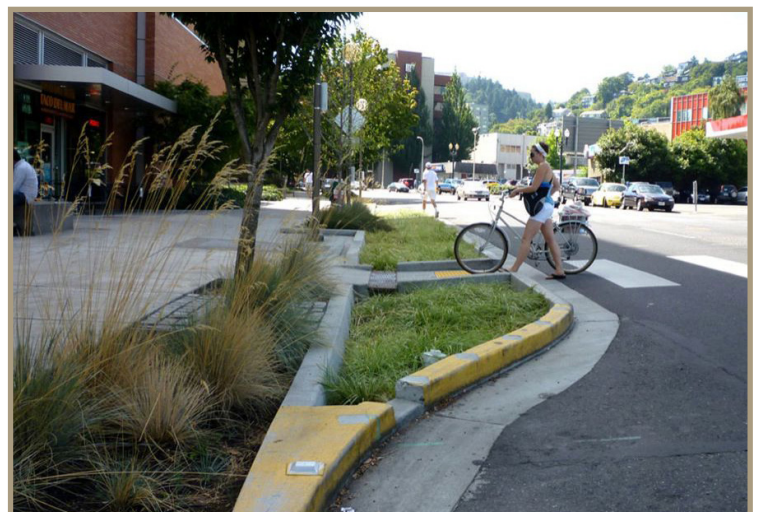
Figure 55. Green infrastructure used to narrow the roadway and provide a shorter crossing distance for pedestrians.

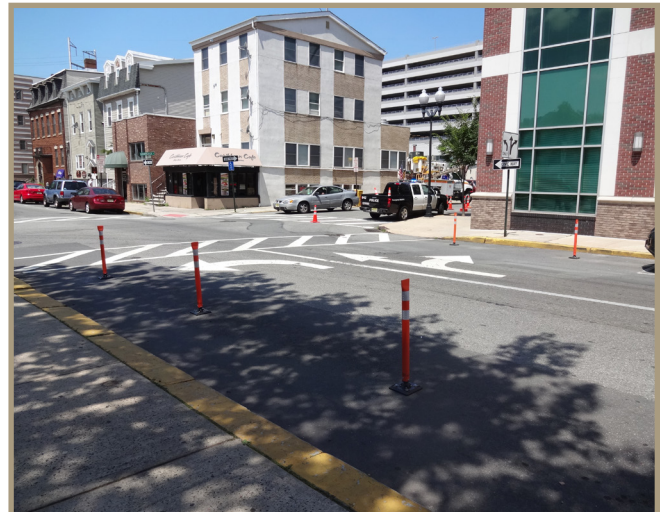
Figure 56. New Brunswick, NJ, uses plastic bollards to prevent illegal parking near intersections. After a successful trial at one intersection, the city has added them throughout the city.

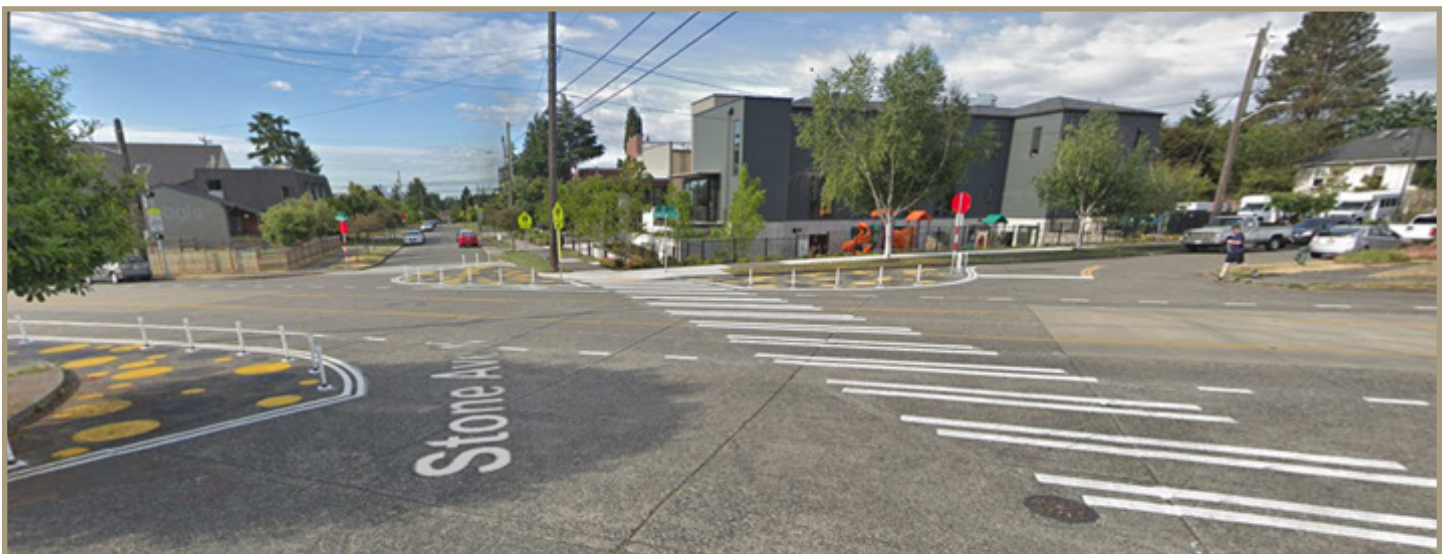
Figure 57. Curb extensions using plastic bollards and paint have been used in Seattle to realign confusing intersections, slow traffic, and add new pedestrian crossings.
