Hamilton Avenue Walkable Community Workshop

Borough of Glen Rock, Bergen County, NJ

2019

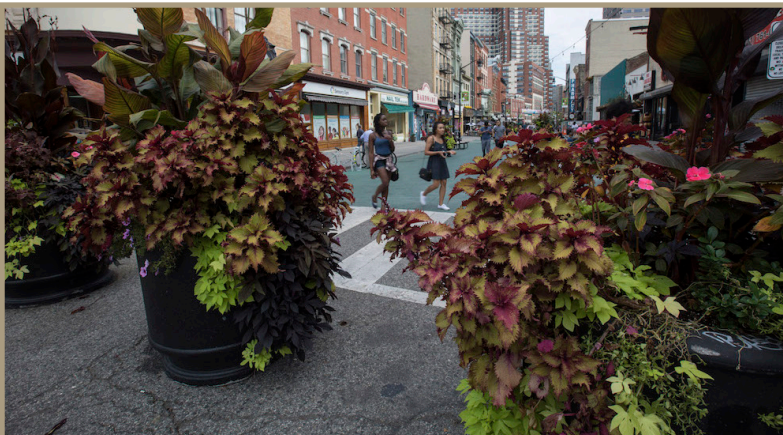
Figure 58. In 2015, Jersey City created a new pedestrian plaza using planters, paint, tables and chairs. The plaza was successful and extended in 2018. Now the city is designing a permanent plaza with stone pavers, larger planters, benches, pedestrian safety bollards, and other public space features.

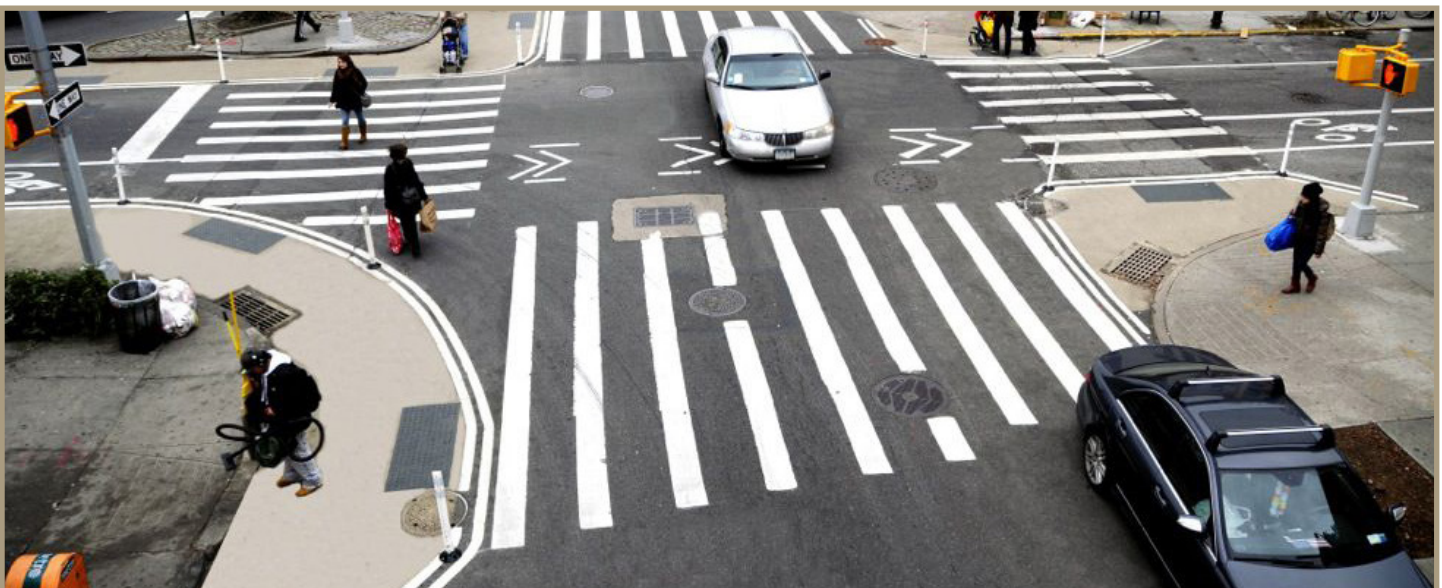
Figure 60. New York City has made extensive use of paint and plastic bollards to decrease turn radii at intersections throughout the city.

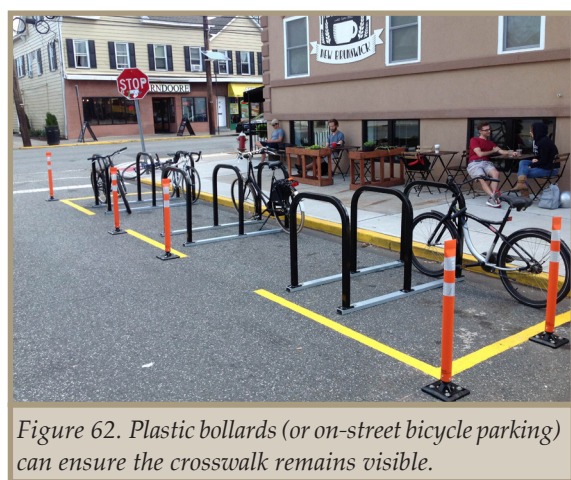
Figure 62. Plastic bollards (or on-street bicycle parking) can ensure the crosswalk remains visible.

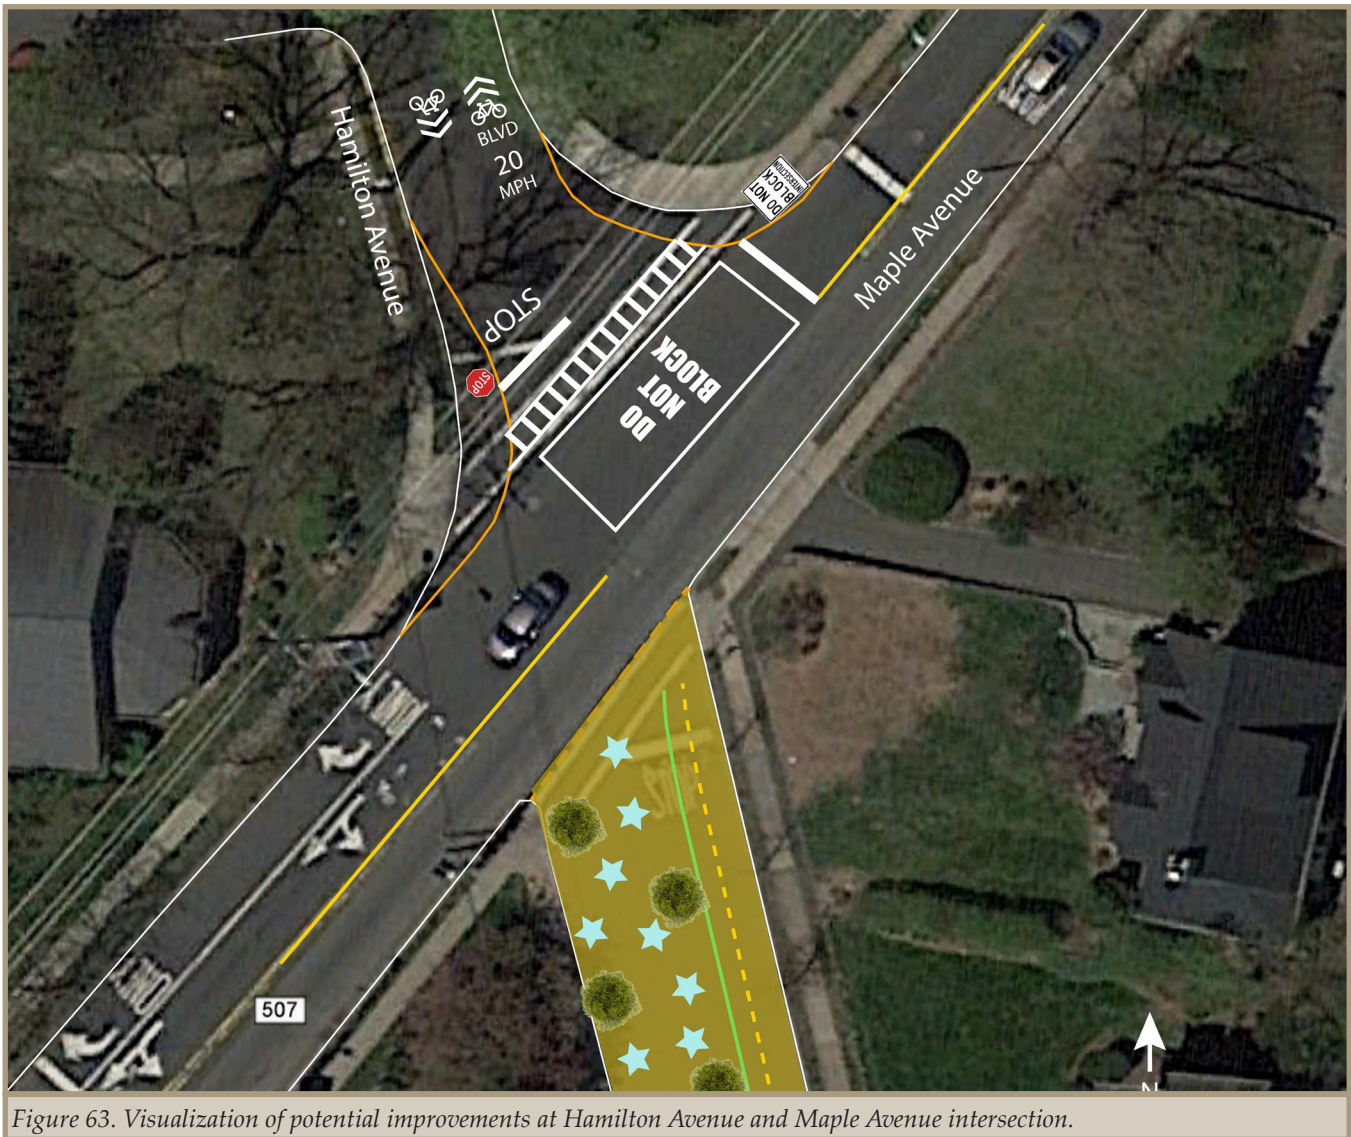
Figure 63. Visualization of potential improvements at Hamilton Avenue and Maple Avenue intersection.

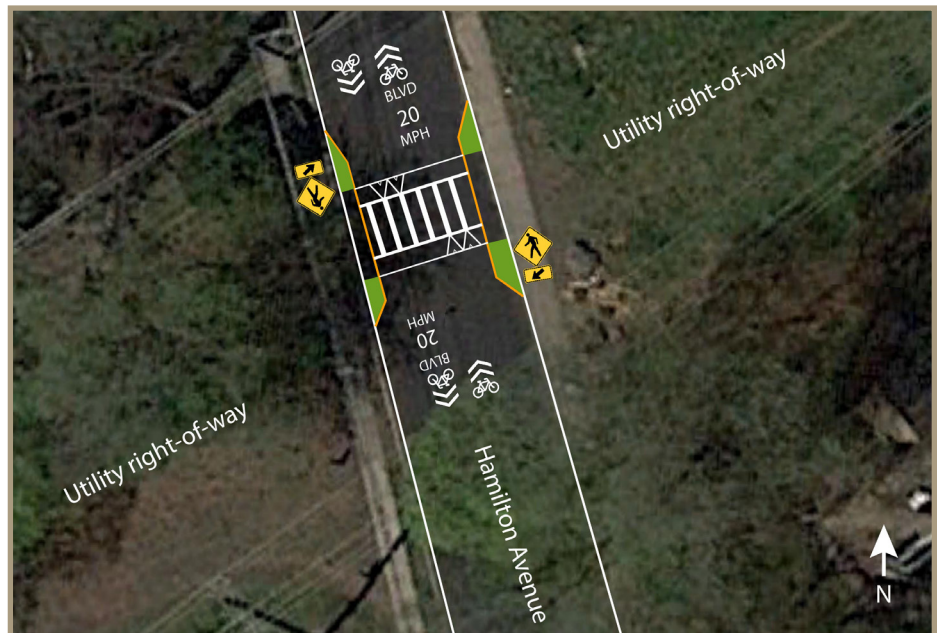
Figure 64. Visualization of potential improvements at Hamilton Avenue and PSE&G Access Road.

- If trail is built, crosswalk signage should be replaced with trail signage
 - Combination bike and pedestrian crossing (W11-15), post-mounted with a diagonal downward pointing arrow (W16-7P), and in-street pedestrian crossing sign (R1-6a) at the crosswalk location, in each direction

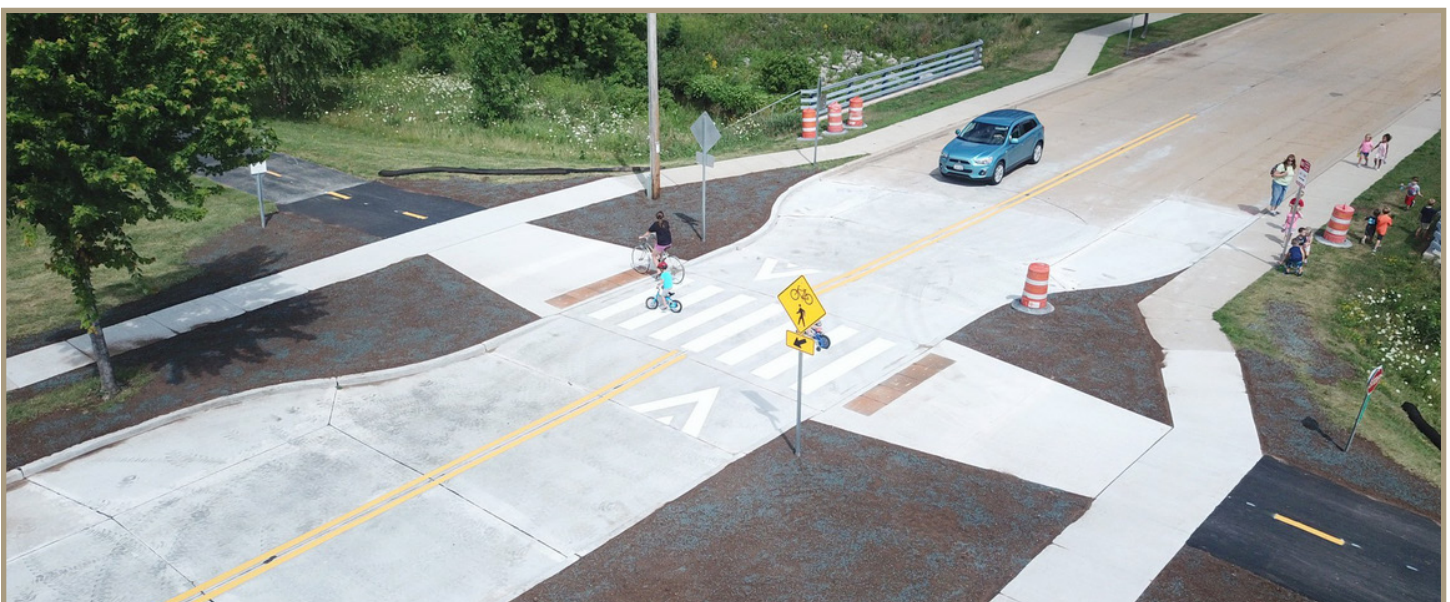
Figure 65. A raised crosswalk at a trail crossing in Appleton, WI.

Figure 65 shows an example of a similar trail crossing in Appleton, Wisconsin.

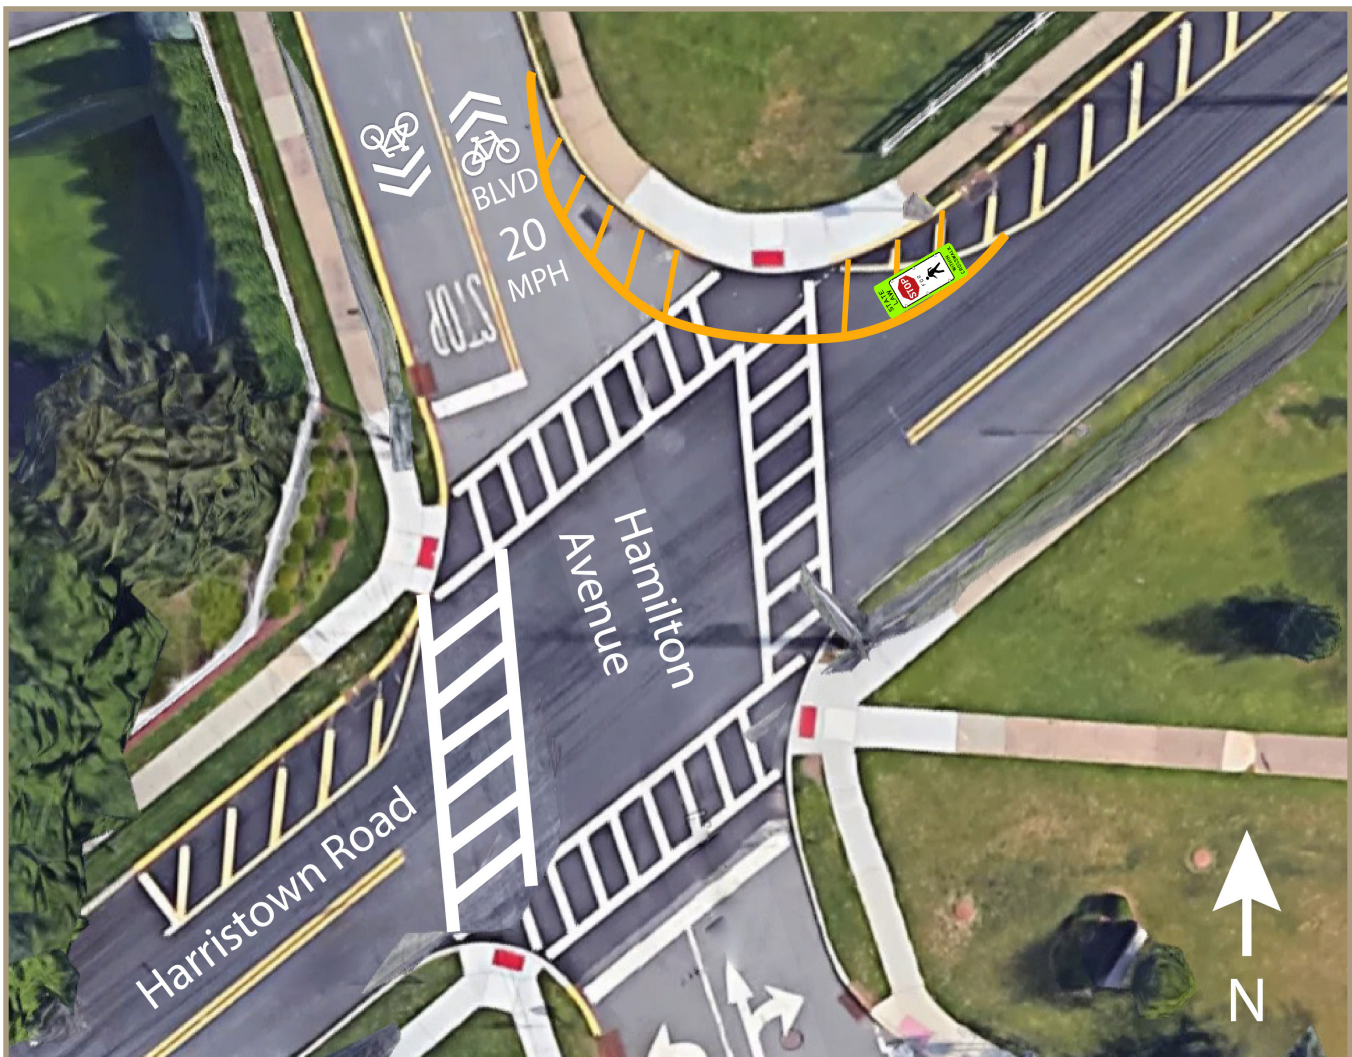
Figure 66. Visualization of potential improvements at Hamilton Avenue and Harristown Road intersection.

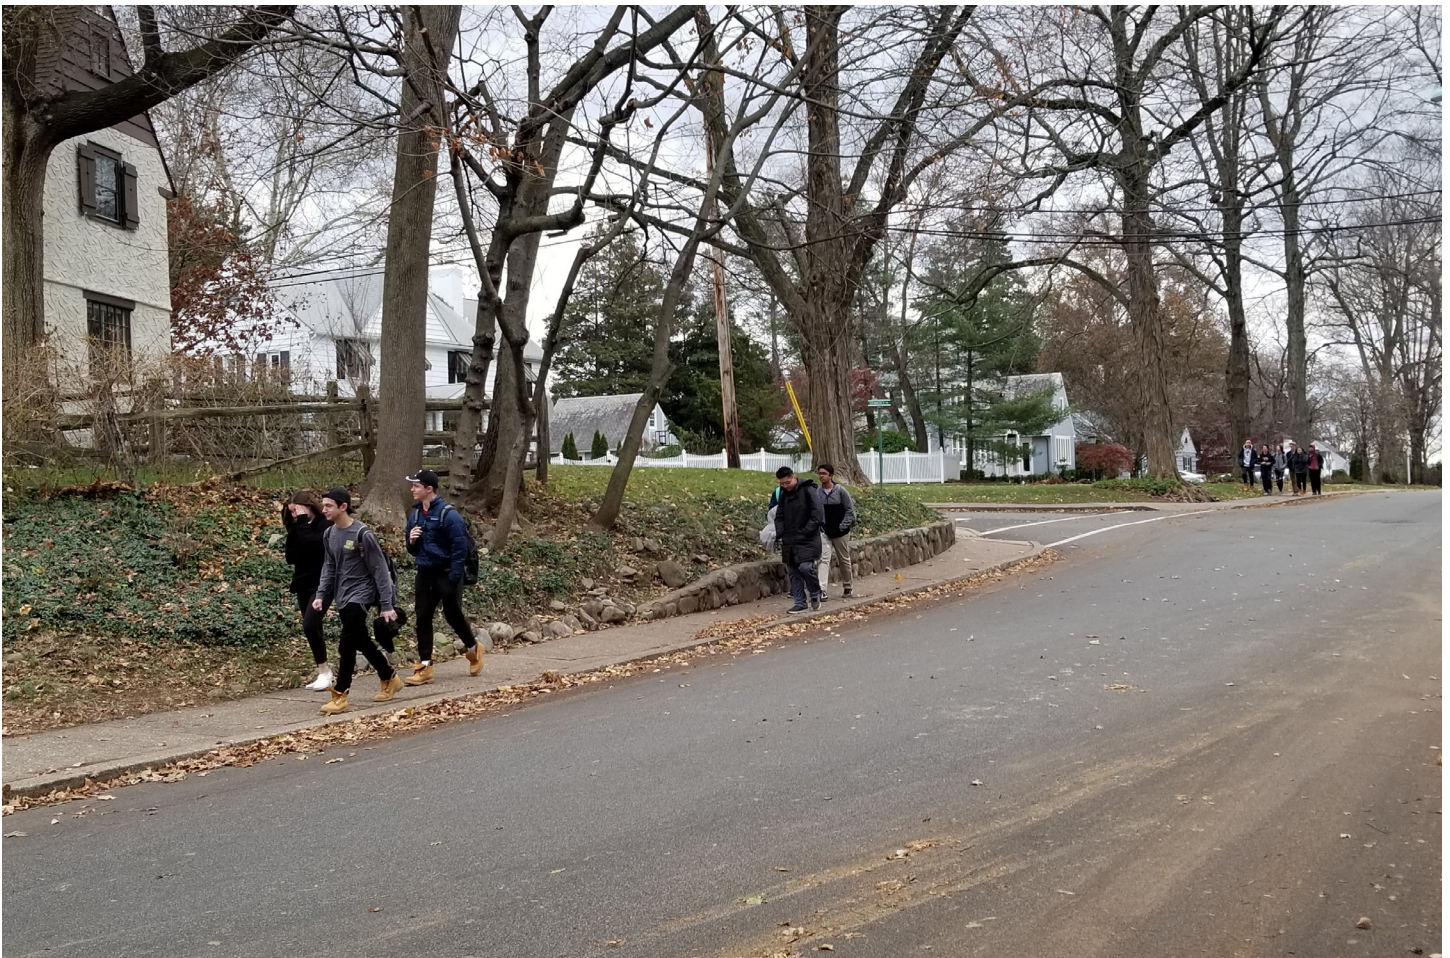
Figure 67. School dismissal time on Hamilton Avenue, looking south.
