Livingston Avenue Road Safety Audit

FINAL REPORT

May 2012

15. Supplementary Notes					
16. Abstract This report documents findings and recommendation made by the RSA team on June 27, 2011, on the Livingston Avenue Corridor in Middlesex County, New Jersey.

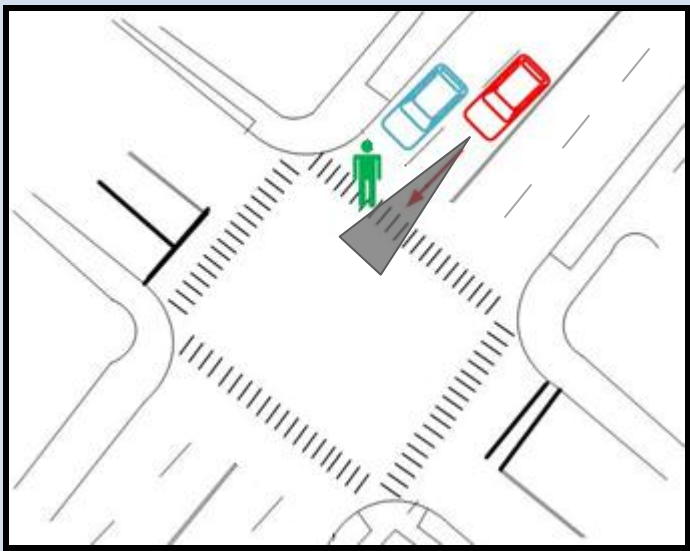
Issue: Pedestrian Crashes	Safety Risk
<p>Description: Twenty-three percent of all crashes involved pedestrians. Livingston Avenue has large amount of pedestrian traffic.</p> <p>The police department noted crash experience with pedestrian shadow crashes due to multiple lanes. Pedestrian shadow crashes occur when a vehicle stops for a pedestrian to cross and blocks the ability for a passing vehicle and pedestrian to see each other. The stopping vehicle is noted in blue and the passing vehicle in red in the diagram below.</p>	High

RSA Team’s Recommendation	Cost	Potential Safety Benefit
<p>⁴Investigate the feasibility of installation of bulb outs at corners of intersections that would lower the speed of turning vehicles and reduce crosswalk distance.</p>	Medium/High	High
<p>⁵Investigate the feasibility of a road diet, which can reduce speeding, create bike lanes for cyclists, and provide turn lanes to allow through traffic to continue without slowing or shifting lanes due to turning vehicles.</p>	Low	High
<p>⁶Sign no parking boundaries 25 feet from the crosswalk to designate no parking area to improve sight distance of both pedestrians and side-street traffic.</p>	Low	High
<p>⁷Trim tree limbs such to improve the sight distance of both pedestrians and side-street traffic from taller vehicles such as fire trucks, and to improve visibility of signal heads and signage.</p>	Low	Medium

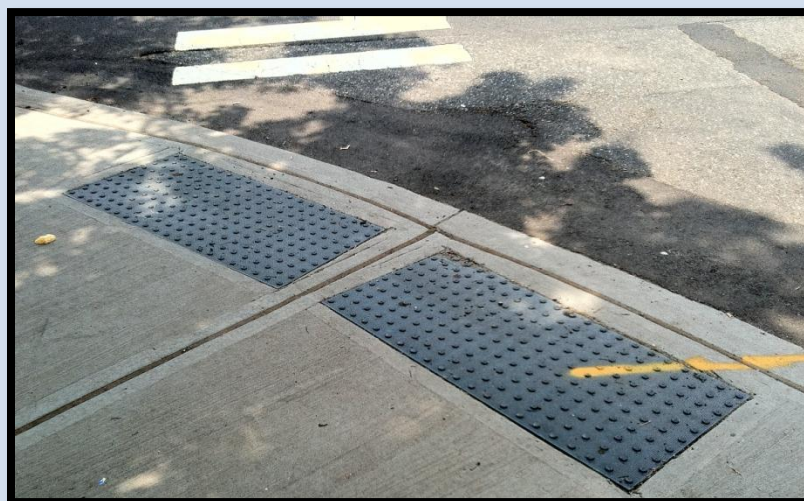
Issue: Accessible Curb Ramps	Safety Risk
Description: Accessible curb ramps are missing or installed incorrectly. This makes it very difficult for pedestrians with disabilities to cross the street.	Low

RSA Team's Recommendation	Cost	Potential Safety Benefit
¹³ Install curb ramps compliant to ADAAG/PROWAG standards.	Medium	High

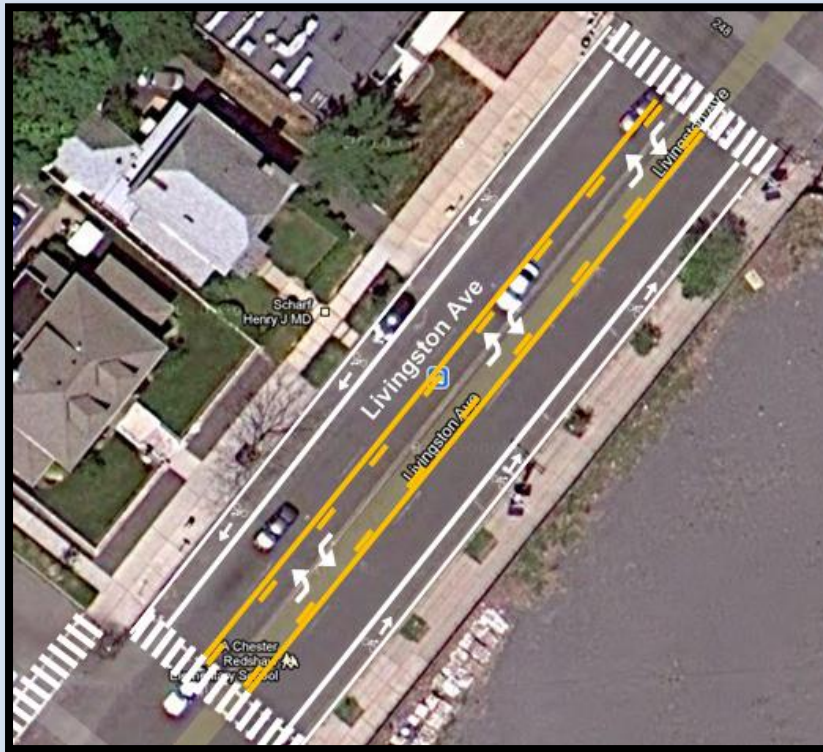
Issue: Speeding	Safety Risk
------------------------	--------------------

Description: Livingston Avenue has a posted speed limit of 25 mph while the experience of the police department and observed speeds of motor vehicles exceed that limit.

Note: Diagram not to scale.

RSA Team's Recommendation	Cost	Potential Safety Benefit
⁵ Investigate the feasibility of a road diet, which can reduce speeding, create bike lanes for cyclists, and provide turn lanes to allow through traffic to continue without slowing or shifting lanes due to turning vehicles. See diagram above.	Low	High
¹⁰ Investigate modifying the driver environment using pavement markings to reduce driver speed, potentially painting shoulders, narrowing lanes, or marking parking stalls.	Low	High
¹¹ Enhance visible enforcement of posted speed limits.	Low	High
¹² Install a VMS or Your Speed Is signage.	Low	High

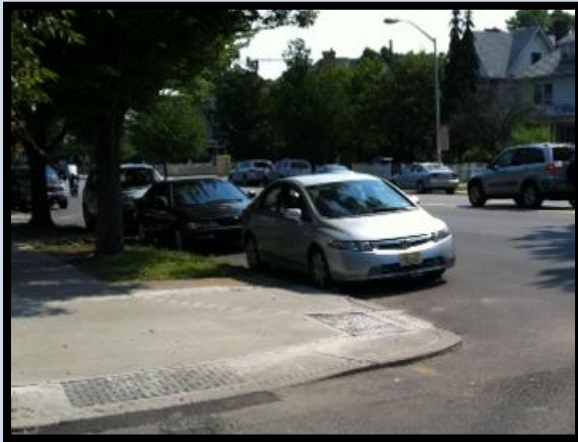
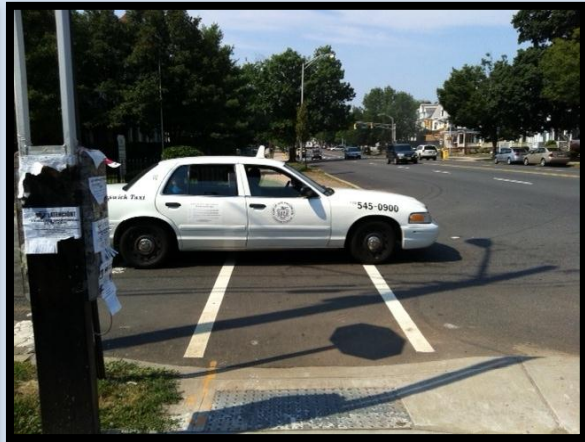
Issue: Sight Distance	Safety Risk
<p>Description: Many cars are parked extremely close to intersections and crosswalks throughout the Livingston Avenue Corridor, thereby limiting the sight distance for both motor vehicles trying to turn onto or cross Livingston Avenue as well as pedestrians. Also, tree branches and trees close to the curb reduce sight distance for large vehicles.</p>	<p>High</p>

RSA Team's Recommendation	Cost	Potential Safety Benefit
<p>⁶Sign no parking boundaries 25 feet from the crosswalk to designate no parking area to improve sight distance of both pedestrians and side-street traffic.</p>	<p>Low</p>	<p>High</p>
<p>⁷Trim tree limbs such to improve the sight distance of both pedestrians and side-street traffic from taller vehicles such as fire trucks, and to improve visibility of signal heads and signage.</p>	<p>Low</p>	<p>Medium</p>
<p>⁸Enhance visible enforcement of parking regulations and the Stop for Pedestrian Law.</p>	<p>Medium</p>	<p>High</p>

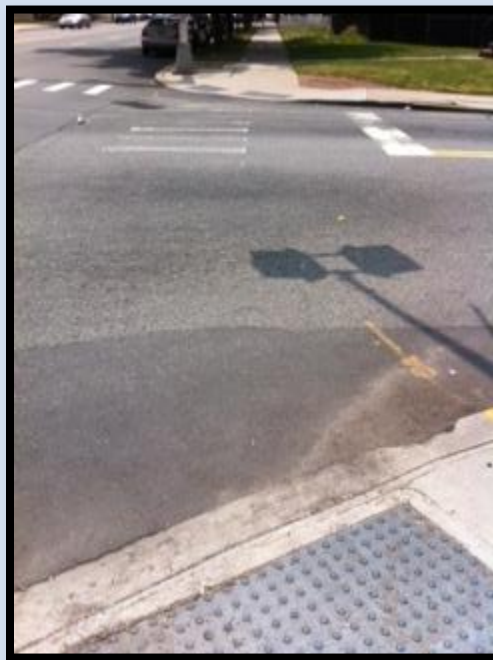
Issue: Unmarked/Worn Crosswalk Striping	Safety Risk
<p>Description: Multiple intersections are missing or have faded crosswalks, thereby reducing the visibility of the pedestrian crossing to motor vehicles. Note: Crosswalks throughout the corridor were not of a uniform, consistent type. Some had zebra striping while others had international striping, etc.</p>	<p>Medium</p>

RSA Team's Recommendation	Cost	Potential Safety Benefit
<p>¹⁶Replace worn and missing striping with pavement markings in conformance with the MUTCD while keeping style of crosswalk striping consistent throughout corridor.</p>	<p>Low</p>	<p>High</p>

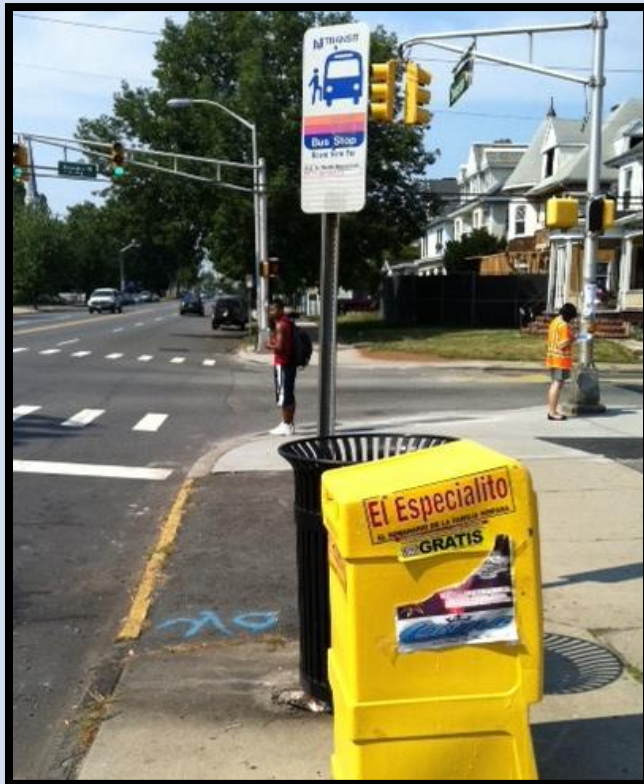
Description: Litter baskets mounted at the base of the bus stop sign, where most people wait for a bus to arrive, prevents access to the bus door from concrete aprons of existing street walkways.

RSA Team's Recommendation	Cost	Potential Safety Benefit
¹⁸ Relocate the litter baskets to make bus access more manageable.	Low	Low

18. Relocate the litter baskets to make bus access more manageable.
25. Remove the trip hazards.
27. Install additional striping to enhance bus stop in conformance to the MUTCD.

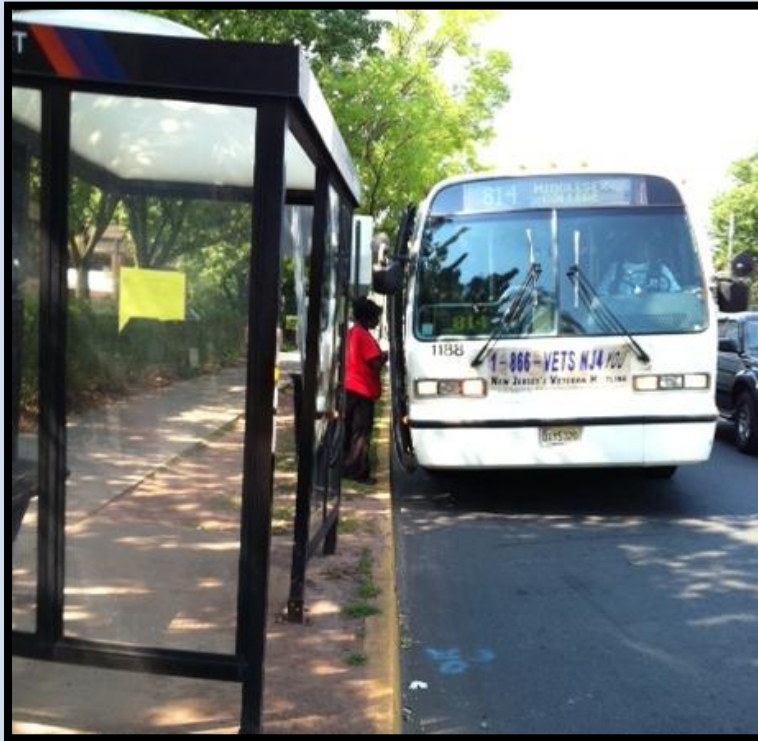
Issue: Worn Bus Shelter	Safety Risk
Description: Bus shelter is in poor condition. In addition, the uneven sinking of the concrete pad is a possible hazard for pedestrians and the disabled as shown below.	Low

RSA Team's Recommendation	Cost	Potential Safety Benefit
²² Replace bus shelter and fix concrete pad.	Medium	Medium

17. Install missing and/or replace signs.
22. Replace bus shelter and fix concrete pad.

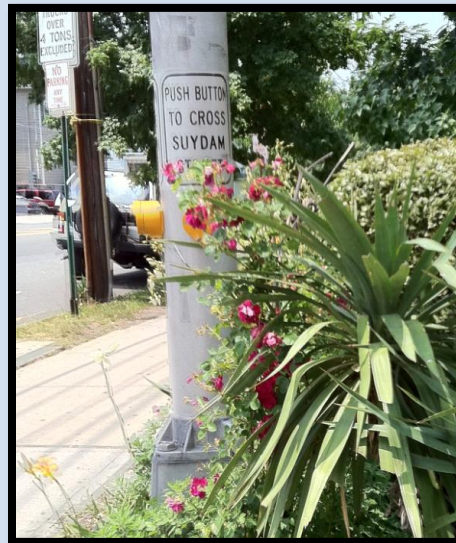
Issue: Pedestrian Accommodation at the Signal	Safety Risk
Description: Pedestrian pole in addition to push buttons in the northeast and northwest corner are located too far from the sidewalk and are obstructed by plants, making it inaccessible.	High
In the southwest corner, the pedestrian push button is broken.	High
Pedestrian push button signage on signals throughout the corridor is confusing to pedestrians as to which crosswalk they are for.	High

RSA Team's Recommendation	Cost	Potential Safety Benefit
^{19A} Investigate pedestrian accommodation at Suydam Street for possible upgrade, including the installation of countdown pedestrian signal indications, Leading Pedestrian Intervals (LPIs), exclusive pedestrian phases, graphical push button signage, and relocating pedestrian push buttons to be correctly oriented as well as accessible to pedestrians in conformance with the best practices as outlined in the MUTCD and ADAAG/PROWAG.	Medium	High
^{20A} Replace broken pedestrian push button in southwest corner at Suydam Street.	Low	High
²¹ Investigate accessible pedestrian accommodations including accessible pedestrian indications due to the proximity of the intersection to a rehabilitation center for the blind.	Medium	High
³⁵ Review signal timings, in conjunction with traffic counts, to ensure compliance with latest edition of MUTCD especially for pedestrian crossing time.	Low	Medium

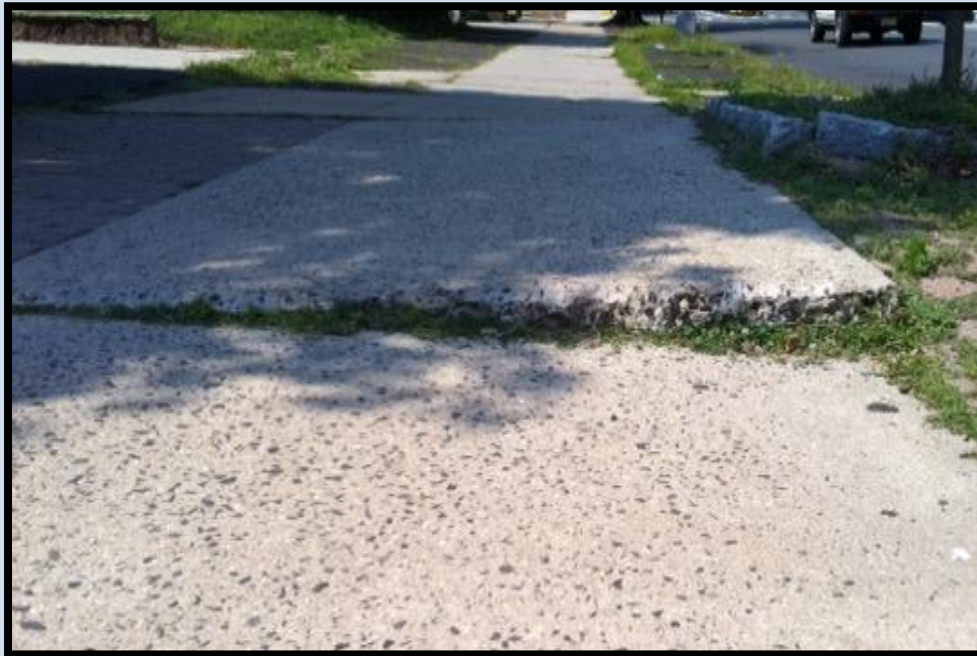
Issue: Trip Hazard	Safety Risk	
Description: Trip hazard in northwest, as well as southeast, corner.	Low

RSA Team's Recommendation	Cost	Potential Safety Benefit
²⁵ Remove the trip hazards.	Low	Medium

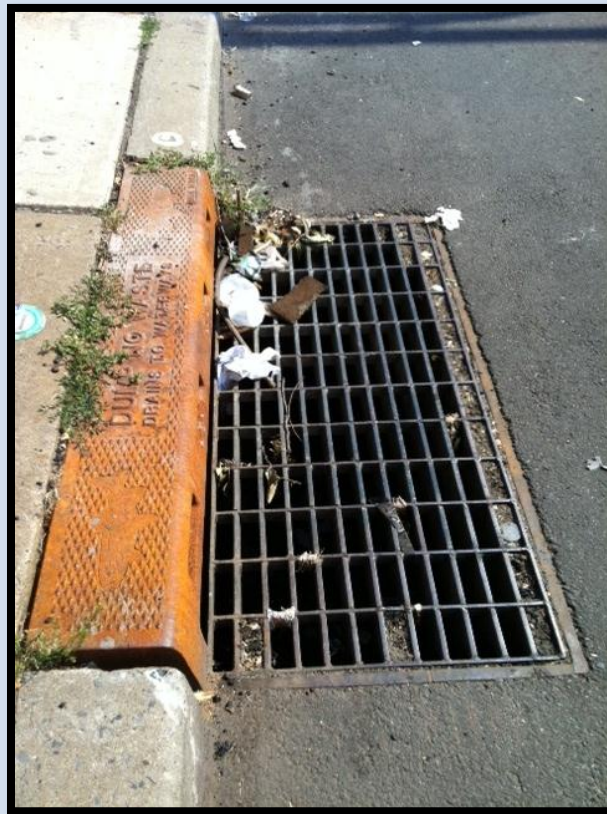
Issue: Non-Bike Friendly Grate	Safety Risk	
Description: Some drainage grates are not bicycle safe.	Medium

RSA Team's Recommendation	Cost	Potential Safety Benefit
²⁸ Replace with bicycle-safe grate	Low	Medium

28. Replace with bicycle-safe grate.
29. Install School Zone signage in conformance to the best practices as outlined in the MUTCD.
30. Update current signs to confirm to best practices in the MUTCD, including new fluorescence yellow-green school signs.
33. Upgrade one-way signage to confirm to the proper size, location, and retroreflectivity as per the MUTCD.
34. Investigate the feasibility of the implementation of pedestrian signal enhancements such as audible signaling devices, Lead Pedestrian Intervals (LPis), and exclusive pedestrian phases, if warranted, at all signals.
35. Review signal timings, in conjunction with traffic counts, to ensure compliance with latest edition of MUTCD especially for pedestrian crossing time.
36. Consider the adoption of a Complete Streets Policy

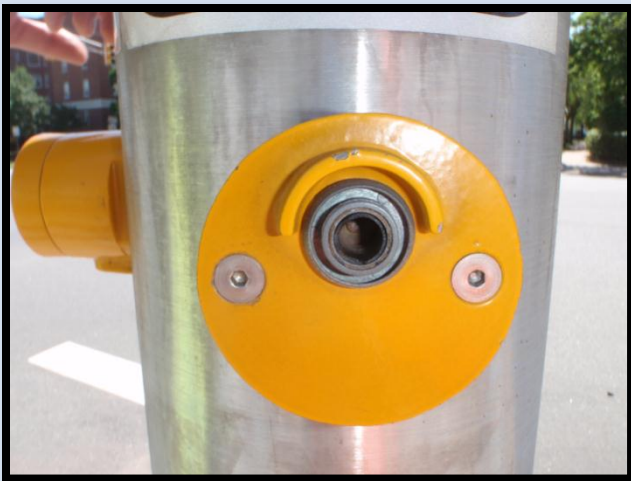
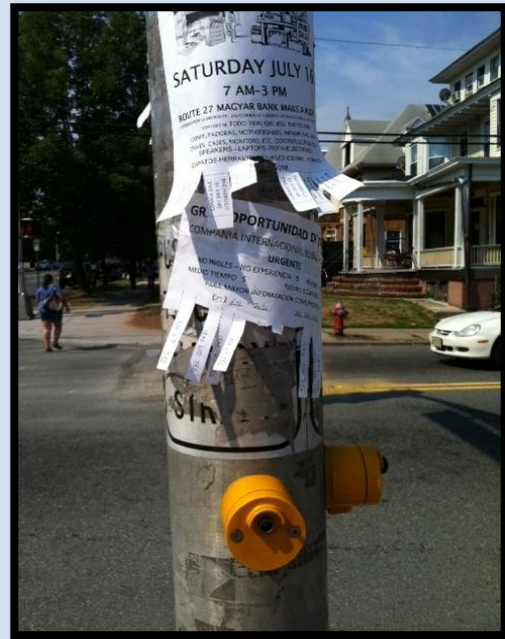
Issue: Pedestrian Signal Accommodations	Safety Risk
Description: In the northeast corner of the intersection, the push buttons are improperly located.	Low
In the southeast corner, the push button is broken as shown below.	Low
The pedestrian push button signs instructing pedestrians how to cross the intersections at all four corners are worn, peeled, and/or covered by advertisement posted by residents.	Medium

RSA Team's Recommendation	Cost	Potential Safety Benefit
^{19B} Investigate pedestrian accommodation at Handy Street for possible upgrade, including the installation of countdown pedestrian signal indications, leading pedestrian intervals (LPIS), exclusive pedestrian phases, graphical push button signage, and relocating pedestrian push buttons to be correctly oriented, as well as accessible, to pedestrians in conformance with the best practices as outlined in the MUTCD and ADAAG/PROWAG.	Medium	Medium
^{20B} Replace non-functioning push button in southeast corner at Handy Street.	Low	High
²⁶ Install new MUTCD compliant pedestrian push button signage and remove all advertisement.	Low	Medium
³⁵ Review signal timings, in conjunction with traffic counts, to ensure compliance with latest edition of MUTCD especially for pedestrian crossing time.	Low	Medium

- 20A. Replace broken pedestrian push button in southwest corner at Suydam Street.
- 20B. Replace non-functioning push button in southeast corner at Handy Street.

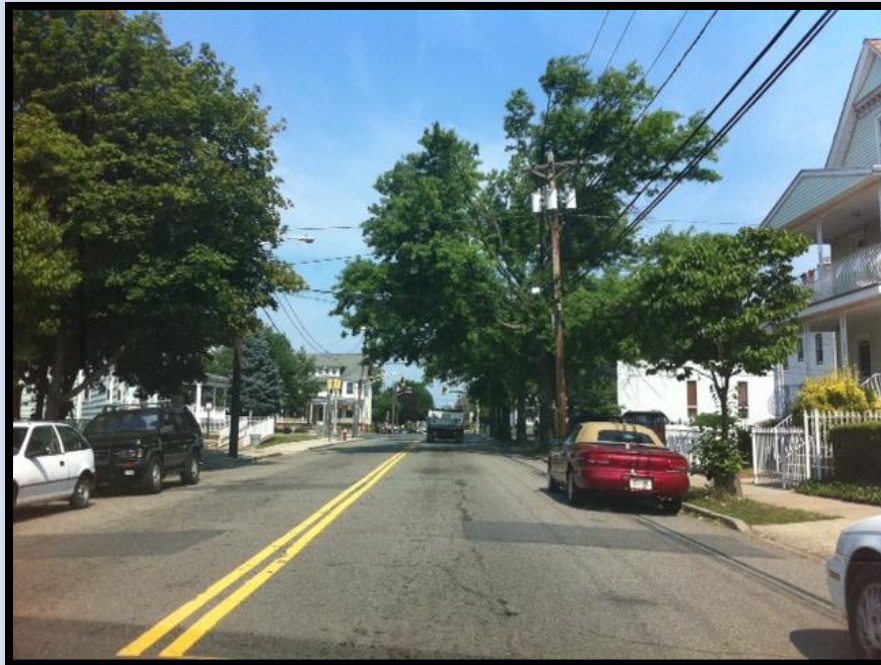
Issue: Traffic Signal Obstruction	Safety Risk
Description: Traffic signal in the south end approaching Livingston Avenue is obscured by trees.	High

RSA Team's Recommendation	Cost	Potential Safety Benefit
⁷ Trim tree limbs such to improve the sight distance of both pedestrians and side-street traffic from taller vehicles such as fire trucks; and to improve visibility of signal heads and signage.	Low	High

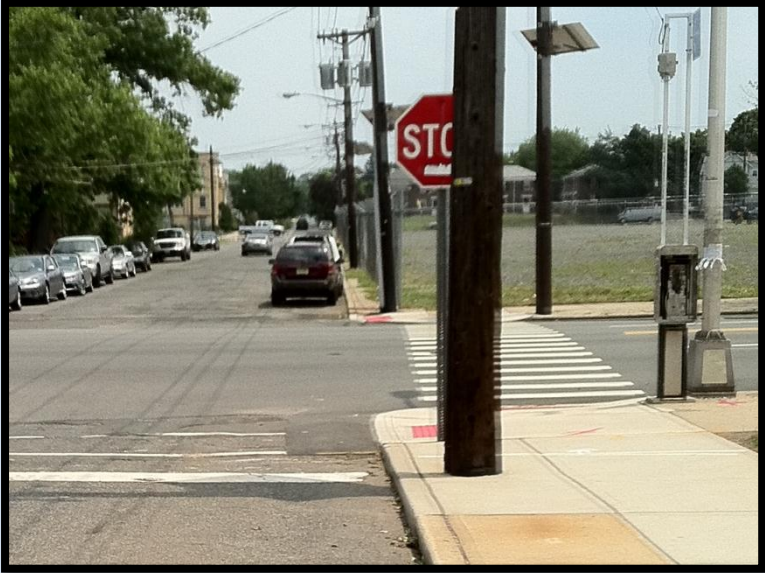
Issue: Stop Sign Obstruction	Safety Risk	
Description: The visibility of the stop sign on the Northeast corner of Comstock Street is limited by a utility pole.	Medium

RSA Team's Recommendation	Cost	Potential Safety Benefit
³¹ Relocate stop sign to a location in front of the utility pole.	Low	Medium

31. Relocate stop sign to a location in front of the utility pole.
32. Investigate the feasibility of installing proper width sidewalks confirming to ADAAG/PROWAG, including the removal of any trip hazards.
