Main Avenue (CR 601) Road Safety Audit

CITY OF PASSAIC, COUNTY OF PASSAIC

FINAL REPORT

November 2012

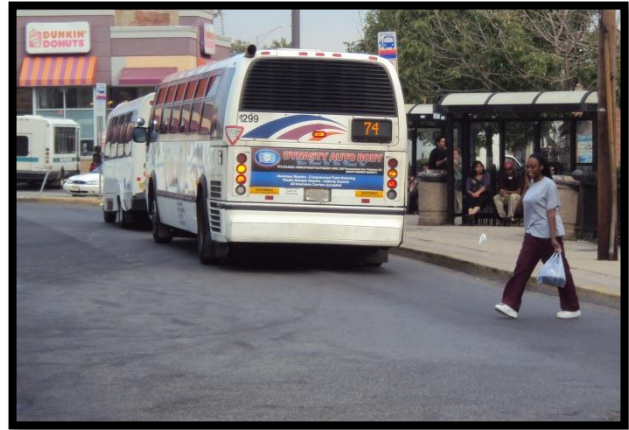
Figure 3—Passaic Bus Terminal

The land use throughout the corridor is predominantly commercial, ranging from fast food and nail salons to clothing stores, as observed in Figure 2. On the northerly end of the study area is the New Jersey Transit Passaic Bus terminal, which consists of a bus pull out area and shelters.

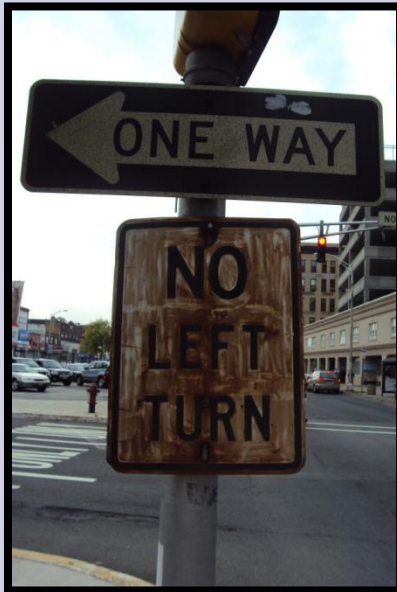
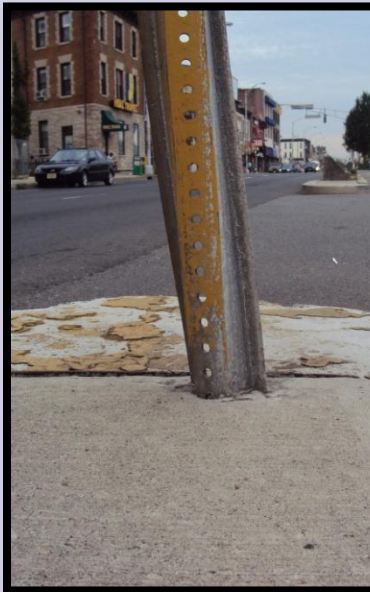
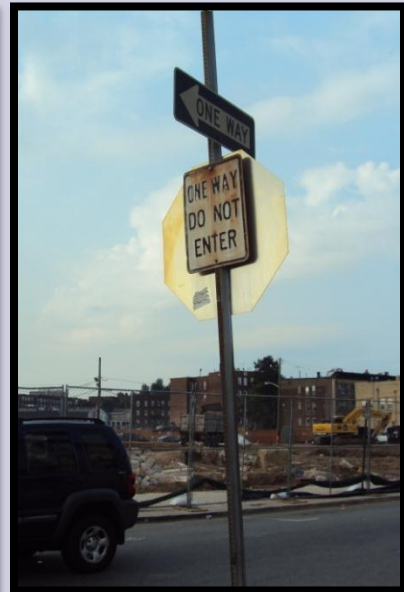
Issue: General Signage	Safety Risk
Description: Signs throughout Main Avenue corridor are old, faded, and have substandard retroreflectivity and non-breakaway posts. Poor sign orientation was observed as well.	Medium
Lack of pedestrian signs as well as school signs.	Medium
Missing street signs at certain intersections (as noted in the appropriate intersection section of this report.)	Low

RSA Team's Recommendation	Cost	Potential Safety Benefit
¹ Signage throughout the corridor should be updated to meet current standards.	Low	High
² A sign study should be conducted by professional engineering staff to upgrade the signage and add needed signs throughout the corridor.	Low	Medium

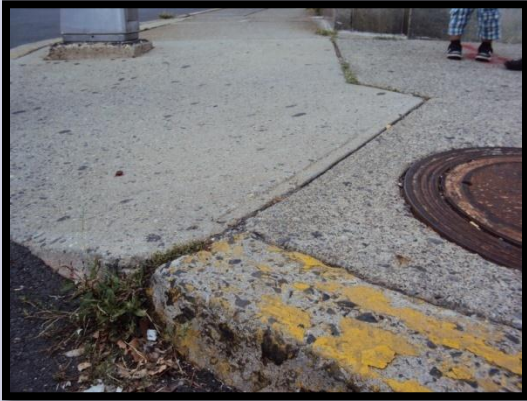
Issue: Sidewalk Condition	Safety Risk	
Description: Sidewalks within corridor are worn and in poor condition.	Low

RSA Team's Recommendation	Cost	Potential Safety Benefit
⁴ Replace sidewalks in conformance with ADAAG/PROWAG standards.	Medium	Low

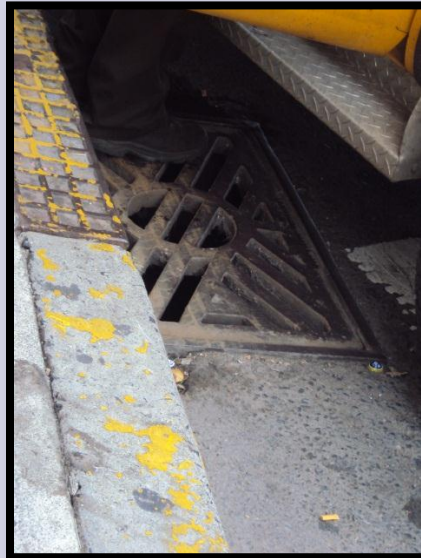
Issue: Non-bike-friendly Grate	Safety Risk	
Description: Some drainage grates are not bicycle safe/compatible.	Medium	
RSA Team's Recommendation	Cost	Potential Safety Benefit
⁹ Replace with bicycle-safe grates.	Low	Medium

9. Replace with bicycle safe grates.
11. Replace worn and missing striping with pavement markings in conformance with the MUTCD, while keeping style of crosswalk striping consistent throughout corridor.

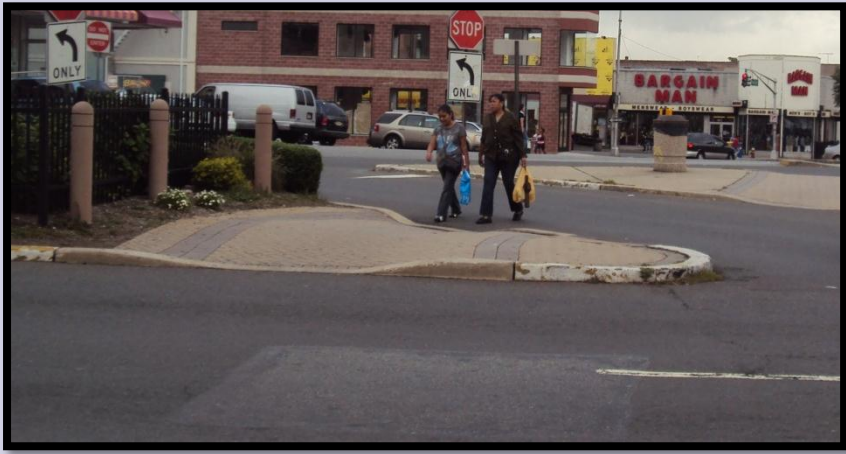
Issue: Unmarked/Worn Crosswalk Striping	Safety Risk	
Description: Multiple intersections are missing or have faded crosswalks, thereby reducing the visibility of the pedestrian crossing to motor vehicles.	Medium

RSA Team's Recommendation	Cost	Potential Safety Benefit
¹¹ Replace worn and missing striping with pavement markings in conformance with the MUTCD, while keeping style of crosswalk striping consistent throughout corridor.	Low	High

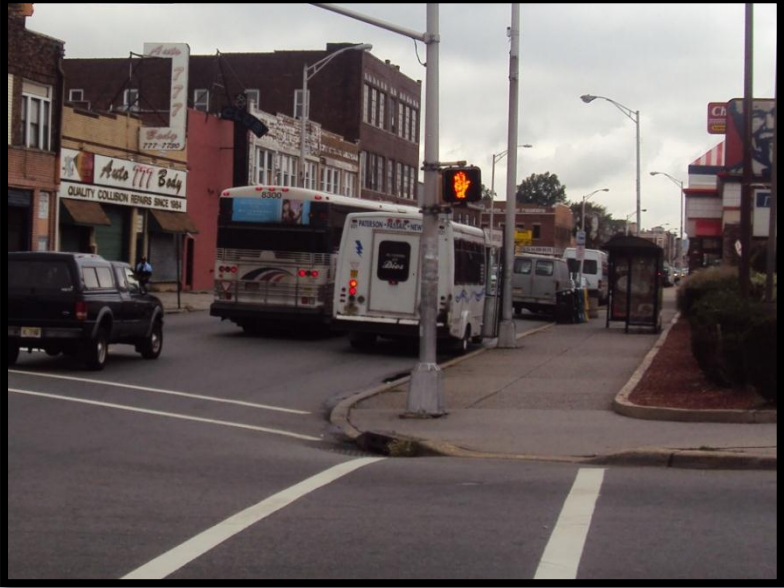
Issue: Jitneys	Safety Risk	
<p>Description: Jitneys operate throughout Main Avenue in conjunction with NJ Transit buses. The team observed the jitneys stopping for fares causing traffic and blocking access for other buses.</p>	High

RSA Team's Recommendation	Cost	Potential Safety Benefit
<p>¹² Initiate conversation with state regulatory agencies regarding the regulatory policies, allowable operations, and enforceability of jitney buses.</p>	Low	Medium
<p>¹³ Extend bus stop/no parking zone to better accommodate jitney operations along bus routes.</p>	Low	Medium/Low

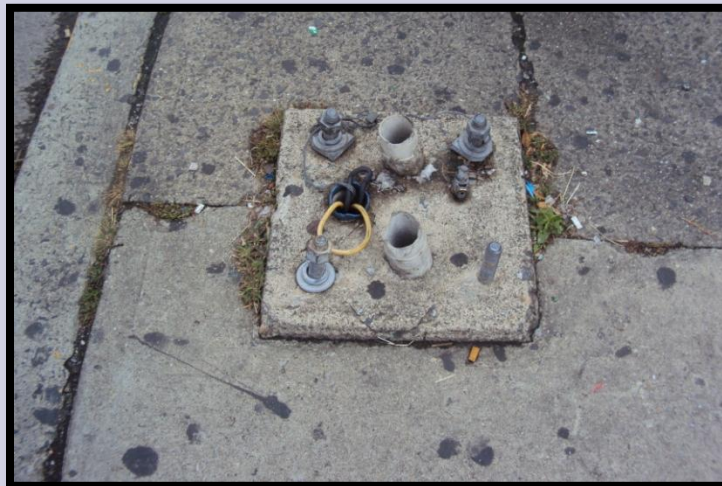
Issue: Trip Hazard	Safety Risk	
Description: Trip hazard in southwest corner from missing light pole.	Low

RSA Team's Recommendation	Cost	Potential Safety Benefit
¹⁹ In the short-term, the knocked down equipment should be replaced.	Low	Medium
²⁰ Additionally, a design engineer should be consulted to review and perform a lighting study at the intersection. The engineer should prepare a plan indicating the appropriate location of any proposed lighting improvement, and a contractor should be hired to install the lighting improvement.	Medium	Medium/Low

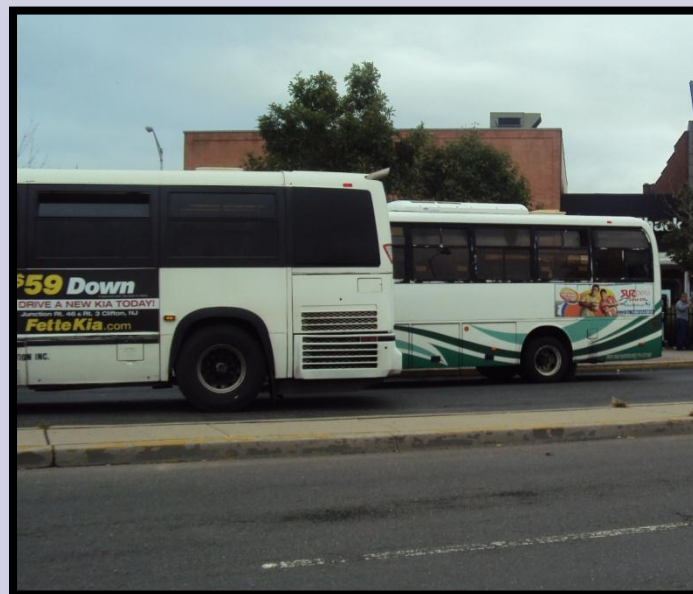
Issue: Bus Conflict	Safety Risk	
Description: Many bus lines service the Main Avenue corridor with inadequate bus accommodation, causing traffic.	Low

RSA Team's Recommendation	Cost	Potential Safety Benefit
²² Investigate the feasibility of expanding the bus stop length by implementing a no parking zone to reduce road blockage due to buses, improve pedestrian safety, and allow through traffic to continue.	Low	Low

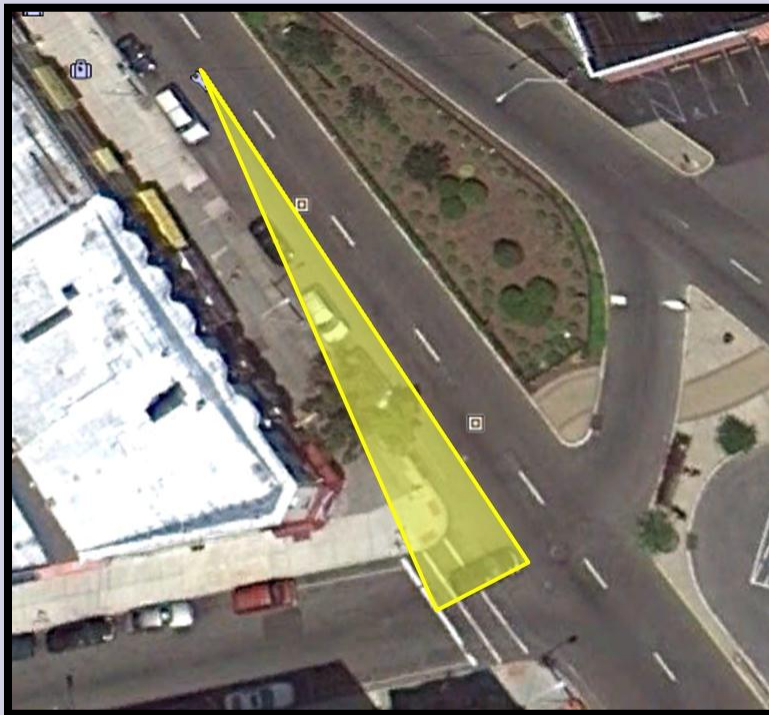
Issue: Sight Distance	Safety Risk
Description: On-street parking on Main Avenue reduces sight triangle distance for both vehicles and pedestrians who must creep out in order to see oncoming vehicles.	Low

RSA Team's Recommendation	Cost	Potential Safety Benefit
²⁵ Investigate the feasibility of reducing Main Avenue to one lane and then open to two lanes after the intersection with bulb outs before Madison Street, which would improve sight distance as well as safety for pedestrians as seen above.	Medium	Medium

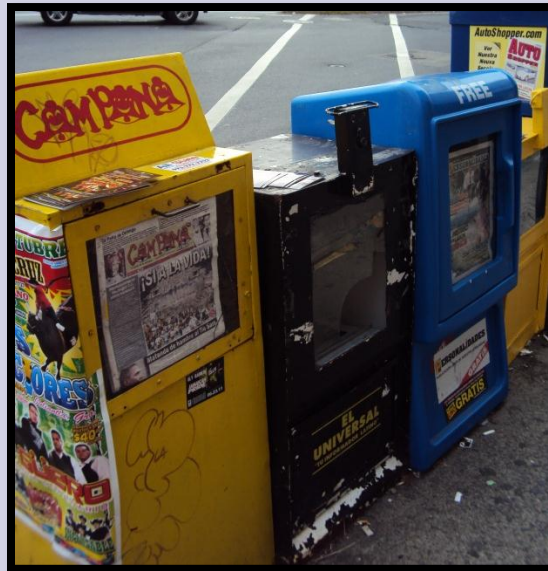
Issue: Location of Newspaper	Safety Risk	
Description: Newspaper kiosks are located too close to the curb on the corner of Garden Street, as well as on the curb ramp, hindering pedestrian access and sight distance for drivers.	Medium

RSA Team's Recommendation	Cost	Potential Safety Benefit
²⁹ Relocate the newspaper kiosks further back to allow pedestrian access and improve sight distance.	Low	Medium

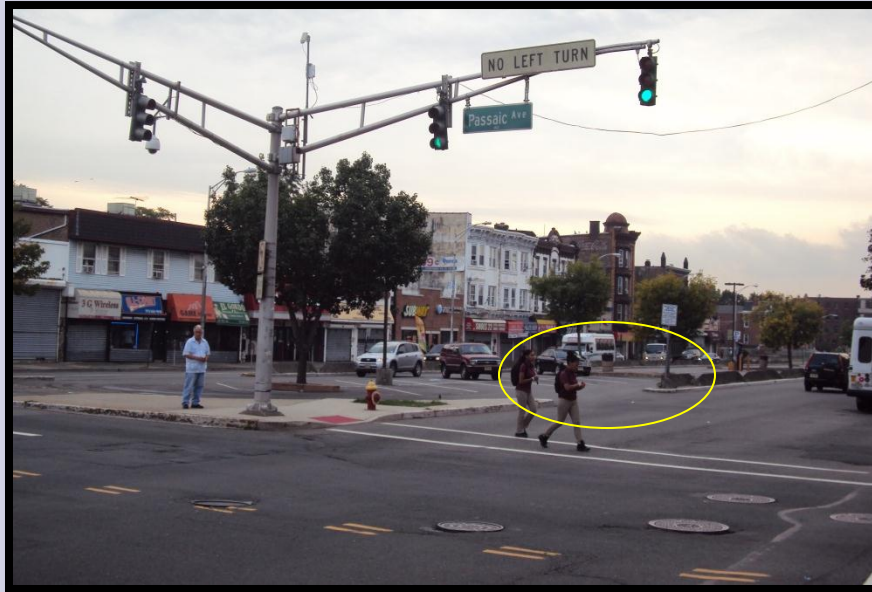
Issue: Parking Islands	Safety Risk
Description: Entrances and exits of center parking island are too close to traffic signals.	Medium

RSA Team's Recommendation	Cost	Potential Safety Benefit
³⁴ Modify vehicle access to center parking islands.	Medium	Medium

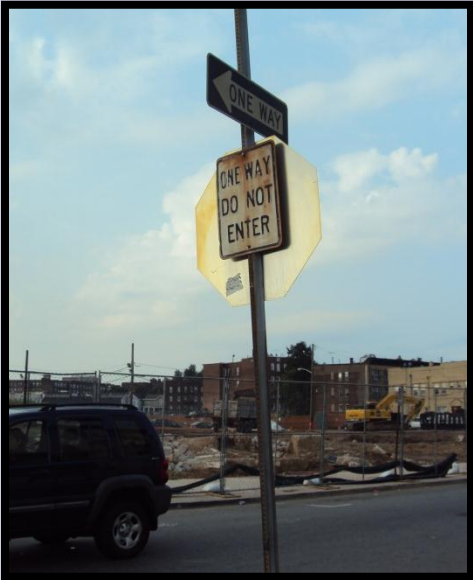
Issue: Signage	Safety Risk	
<p>Description: Signs are old, faded, non-retroreflective, and non-breakaway at Prospect Street and Jefferson Street.</p>	<p>Medium</p>

RSA Team's Recommendation	Cost	Potential Safety Benefit
<p>² A sign study should be conducted by professional engineering staff to upgrade the signage and add needed signs throughout the corridor.</p>	<p>Low</p>	<p>Medium</p>

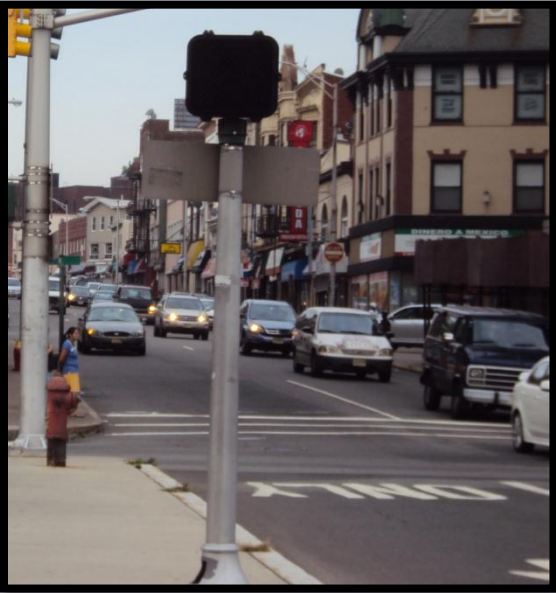
Issue: Pedestrian Signal	Safety Risk	
Description: Pedestrian signal in the northeast corner of Washington Place is not functional. Also, pedestrian signal on both southeast and southwest corners of Main Avenue are malfunctioning.	Medium

RSA Team's Recommendation	Cost	Potential Safety Benefit
³⁷ Fix malfunctioning pedestrian signal.	Low	Medium
⁷ Engage an engineer to upgrade pedestrian accommodation at Washington Place, including the installation of countdown pedestrian signal indications, leading pedestrian intervals (LPIs), exclusive pedestrian phases, and relocation of pedestrian push buttons to be correctly oriented as well as accessible to pedestrians in conformance with the best practices as outlined in the MUTCD and ADAAG/PROWAG.	Medium	Medium

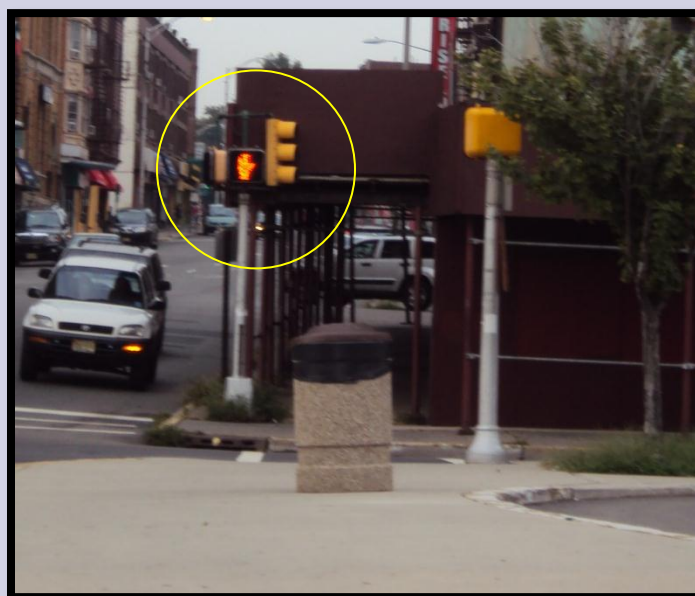
Issue: Blocked Signal	Safety Risk	
Description: Near side signal head on southeast corner of Main Avenue is blocked by scaffolding, poles, and trees.	High

RSA Team's Recommendation	Cost	Potential Safety Benefit
³⁹ Remove obstructions.	Low/Medium	High

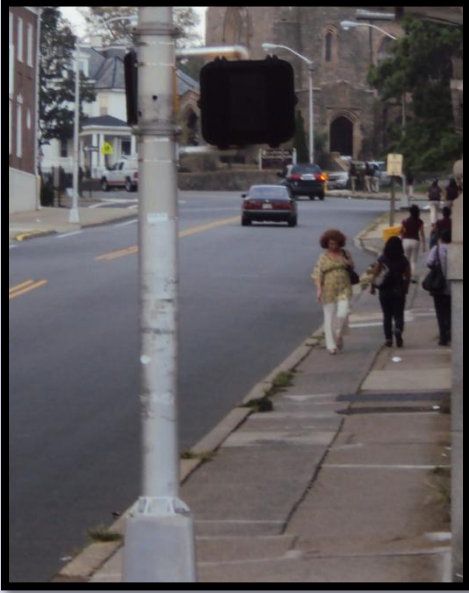
Issue: Pedestrian Signals	Safety Risk	
Description: Pedestrian signals in all four corners of intersection are not functioning.	Medium

RSA Team's Recommendation	Cost	Potential Safety Benefit
³⁷ Fix malfunctioning pedestrian signals.	Low	Medium
⁷ Upgrade pedestrian accommodation at Passaic Avenue, including the installation of countdown pedestrian signal indications, leading pedestrian intervals (LPIs), exclusive pedestrian phases, and relocation of pedestrian push buttons to be correctly oriented as well as accessible to pedestrians in conformance with the best practices as outlined in the MUTCD and ADAAG/PROWAG.	Medium	Medium

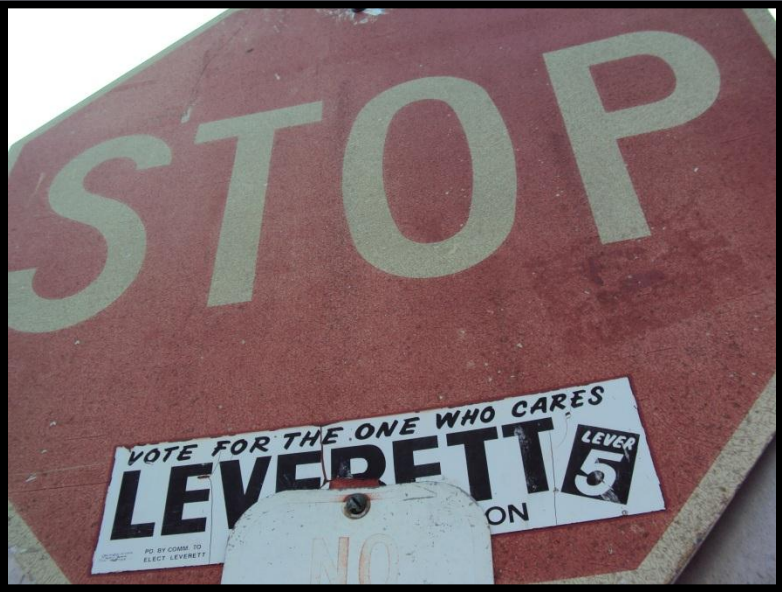
Issue: Signage	Safety Risk	
<p>Description: Signs are old, faded, non-retroreflective, and non-breakaway at Passaic Avenue.</p>	<p>Medium</p>

RSA Team's Recommendation	Cost	Potential Safety Benefit
<p>² A sign study should be conducted by professional engineering staff to upgrade the signage and add needed signs throughout the corridor.</p>	<p>Low</p>	<p>Medium</p>
