# East Main Street (CR 510) – Mendham Borough

## Road Safety Audit

August 2013

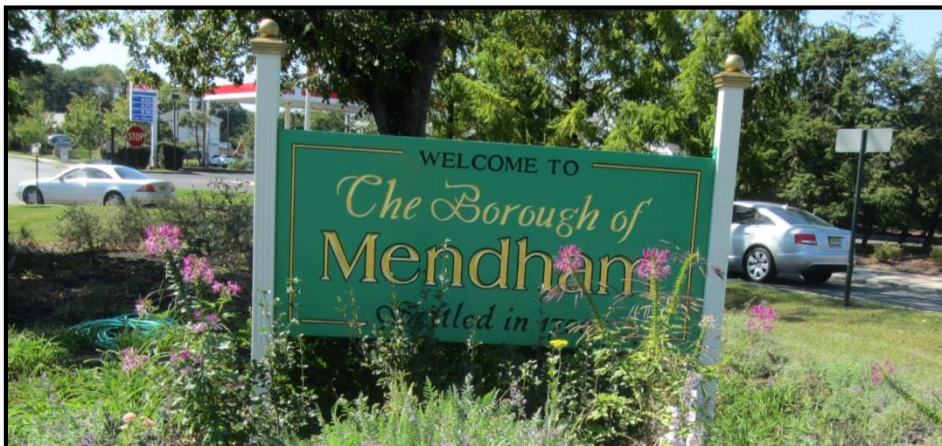
Figure 1 – Map of Intersections in RSA Study

The audit focused on six intersections on East Main Street (CR 510), as shown in Figure 1 below, located within Morris County, in Mendham Borough:

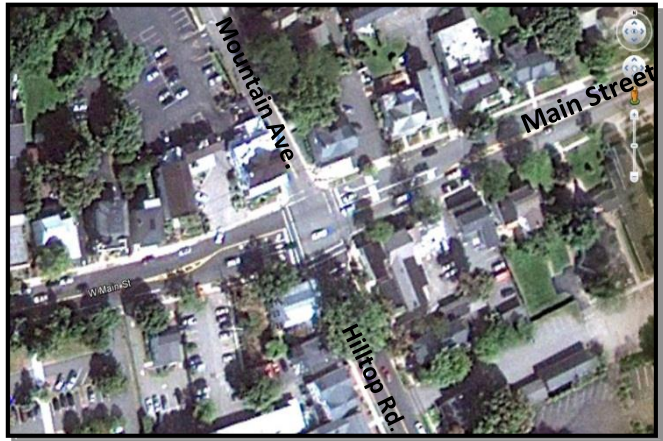
Figure 2 – Hilltop Road/Mountain Avenue and East Main Street

The intersection of **Hilltop Road (CR 525)/Mountain Avenue (CR 614)** is a right angle, four-legged, signalized intersection with **East Main Street (CR 510)**; West Main Street begins west of this intersection. The buildings include the municipal offices, a restaurant, and other small commercial buildings. There are dedicated left turn, right turn, and straight ahead lanes on East Main Street in both directions. There is also significant turning traffic from Hilltop Road and Mountain Avenue, which causes excessive queuing. The buildings are located close to the intersection, being a historic area, and sight distance is restricted. Also, there are significant accessibility issues at this intersection. The southeast corner has stairs accessing the sidewalk with no ramp.

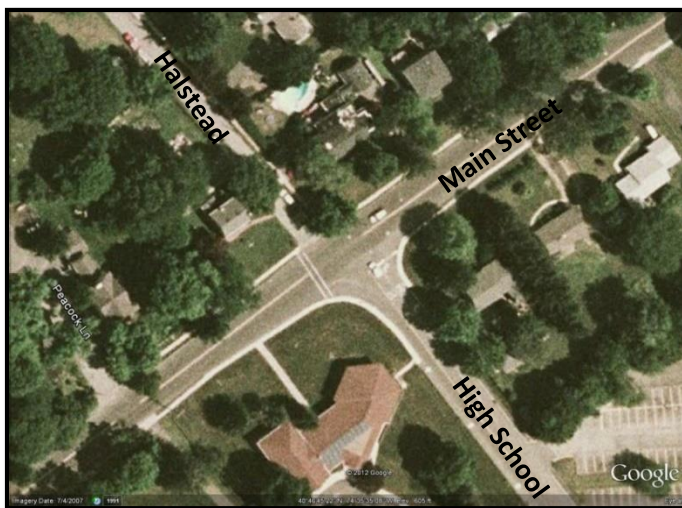
Figure 3 – Halstead Rd., entrance to high school and East Main Street

**Halstead Road and the entrance to the High School** are slightly offset from each other where they meet Main Street, and they are both stop-controlled. There are dedicated turning lanes from the high school but not on East Main Street. This is a two-lane roadway with shoulders. There is extremely heavy traffic with many pedestrians at the beginning and the end of the school day. A police officer is on site during those times to direct traffic.

High School Entrance		CRASH TYPE		
		Same Direction-Rear End	Right Angle	TOTAL
SEVERITY	Property Damage	1		1
	Injury		1	1
	TOTAL	1	1	2

High School Entrance		LIGHT CONDITIONS			
		Daylight	Dark (Street Lights Off)	Dark (No Street Lights)	TOTAL
SURFACE CONDITIONS	Dry	2			2
	Wet				
	Snowy				
	Icy				
TOTAL		2			2

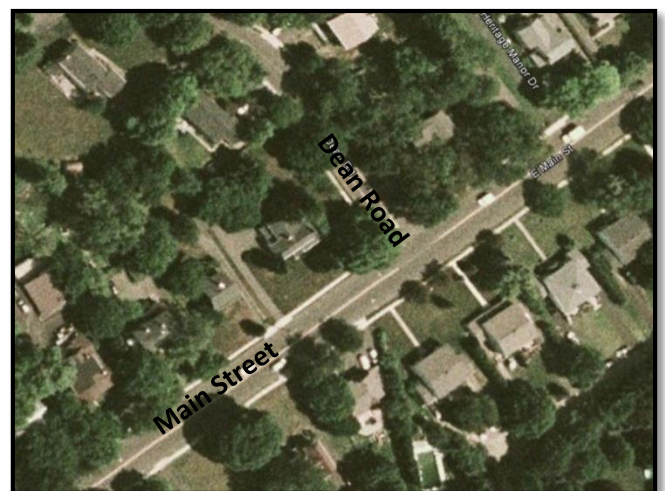
Figure 4 – Dean Road and East Main Street

The intersection of **Dean Road and East Main Street** is a stop-controlled T-intersection with free flow on Main Street. Especially during heavy volume at the beginning and end of the school day, vehicles have difficulty making the left turn from Dean Road.

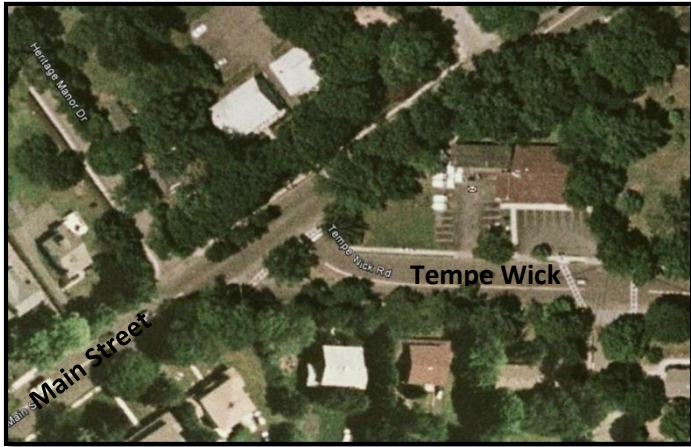
Figure 5 – Tempe Wick Road and East Main Street

The intersection of **Tempe Wick Road and East Main Street** is a skewed T-intersection with Heritage Manor Drive offset 100 feet to the west. There is an island on Tempe Wick Road with a wide turning radius from Main Street eastbound to Tempe Wick Road. The intersection of Tempe Wick Road at Main Street is very wide and even with the island, the crosswalks are quite long.

Tempe Wick Road		CRASH TYPE				
		Same Direction-Rear End	Same Direction-Side Swipe	Right Angle	Animal	TOTAL
SEVERITY	Property Damage	6	1	3	1	11
	Injury			1		1
	<b>TOTAL</b>	<b>6</b>	<b>1</b>	<b>4</b>	<b>1</b>	<b>12</b>

Tempe Wick Road		PRE CRASH VEHICLE ACTION						
		Going Straight Ahead	Making Right Turn (not turn on red)	Making Left Turn	Making U Turn	Slowing or Stopping	Stopped in Traffic	TOTAL
CONTRIBUTING CIRCUMSTANCES	Driver Inattention	4	2	2				8
	Failed to Yield Right of Way to Vehicle/Pedestrian			1				1
	Improper Turning				1			1
	Following Too Closely	1						1
	None (Driver/Pedcycle)	5	1	2		1	2	11
	Animals in Roadway	2						2
<b>TOTAL</b>		<b>13</b>	<b>12</b>	<b>3</b>	<b>5</b>	<b>1</b>	<b>1</b>	<b>2</b>

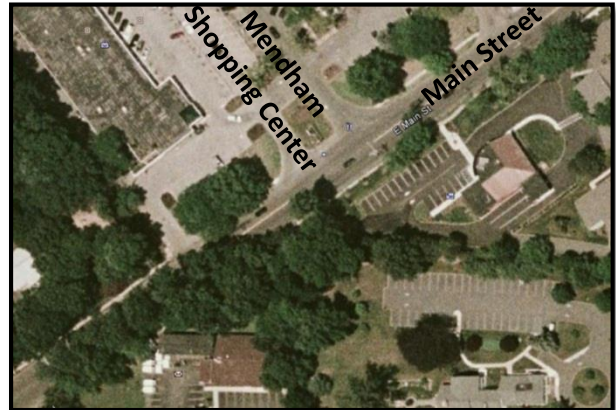
Figure 6 – Mendham Shopping Center and East Main Street

The intersection of the **Mendham Shopping Center and East Main Street** is located a few hundred feet east of Tempe Wick Road. The entrance and exit driveways are separated by a median. The roadway width of East Main Street is wide enough for two lanes of traffic in each direction but is not striped. Left turn movements into and out of the shopping center are difficult due to traffic volume. There is a police officer stationed at the intersection to facilitate left turns on Fridays from 4 to 7 p.m. and Saturdays from 10 a.m. to 2 p.m.

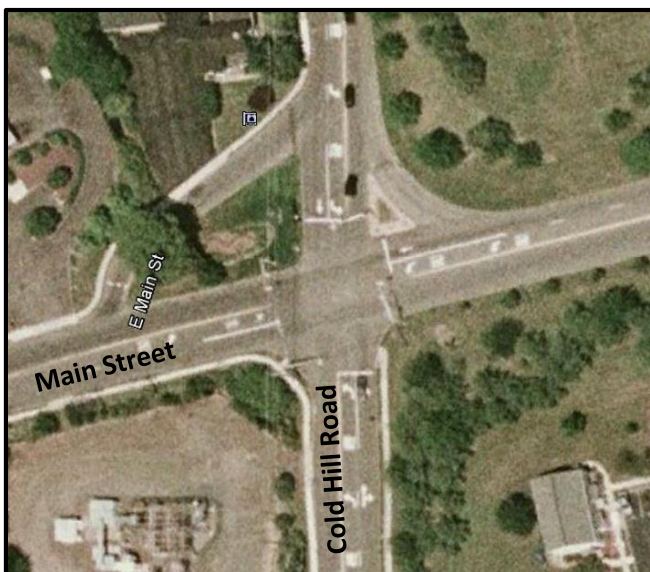
Figure 7 – Cold Hill Road and East Main Street

The intersection of **Cold Hill Road and East Main Street** is a signalized intersection. The four segments each have a dedicated left turn lane and one through lane. There are right turn ramps from East Main Street to Cold Hill Road northbound and from Cold Hill Road southbound to East Main Street westbound.

As can be seen from the tables below, the majority of the crashes at the intersection of East Main Street and Cold Hill Road were “Same Direction-Rear End” crashes. Most of the crashes occurred during daylight and almost all occurred in dry conditions. The predominant pre-crash vehicle actions were “Going Straight Ahead” or “Stopped in Traffic.”

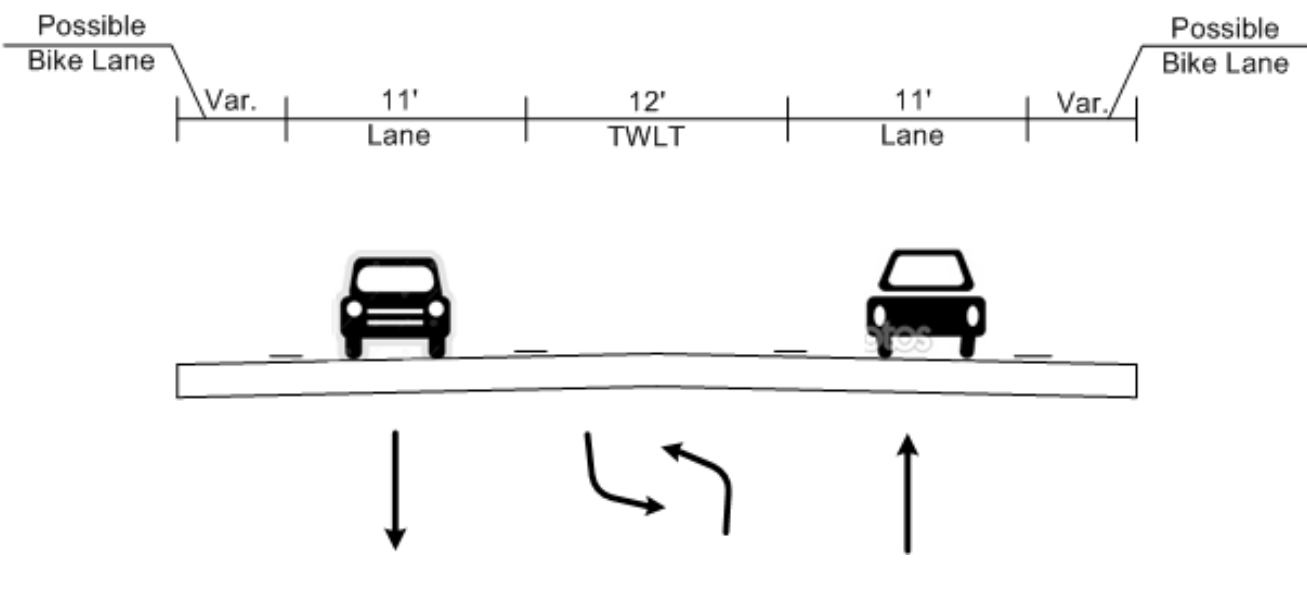
Issue: Traffic Operations (Corridorwide)	Safety Risk	
<b>Description:</b> There is a significant number of left turn crashes along the project corridor.	Medium/High	
RSA Team's Recommendation	Cost	Potential Safety Benefit
Evaluate adding a two-way left turn lane throughout the project corridor.(1)	Medium/Low	Medium/High

<p>The diagram illustrates a proposed roadway cross-section. From left to right, it consists of: a 'Possible Bike Lane' (indicated by a dashed line and a 'Var.' label), an 11' Lane, a 12' TWLT (Two-Way Left Turn Lane), another 11' Lane, and another 'Possible Bike Lane' (indicated by a dashed line and a 'Var.' label). Below the roadway, a car is shown in the left lane with a downward arrow, and a bicycle is shown in the right lane with an upward arrow. In the center, two curved arrows indicate left-turning traffic from both directions into the TWLT.</p>		
Proposed Cross Section

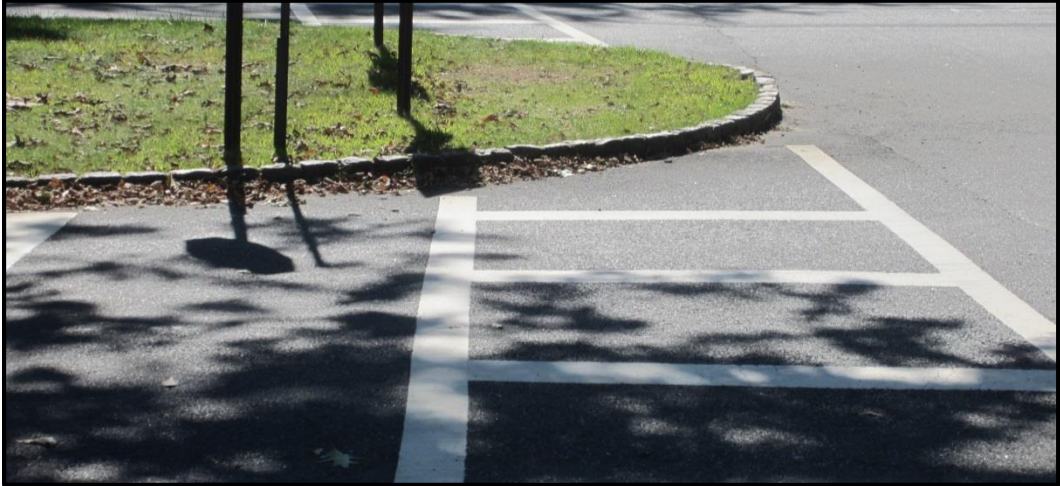
<b>Issue: Pedestrian Accommodations (Corridorwide)</b>	<b>Safety Risk</b>	
<b>Description:</b> Pedestrian accommodations, such as ramps and detectable warning surfaces, are not fully ADA compliant.	Medium

<b>RSA Team's Recommendation</b>	<b>Cost</b>	<b>Potential Safety Benefit</b>
Plan for full ADA compliance by scheduling upgrades of existing ramps and curbs at crosswalks. (2)	Medium	Medium

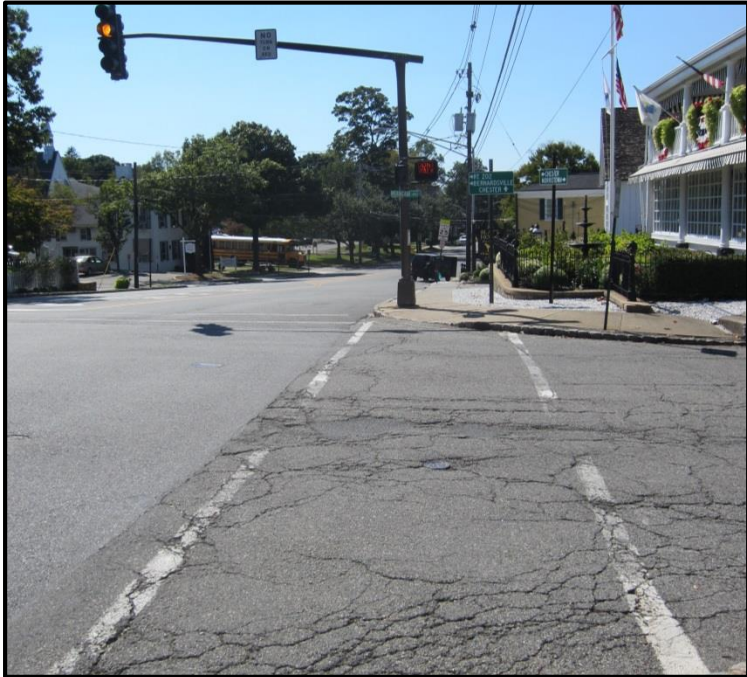
Issue: Roadway Markings (Corridorwide)	Safety Risk	
<p><b>Description:</b> Many of the roadway markings and striped crosswalks are faded and not clearly visible to vehicles and pedestrians.</p>	<p>Medium/High</p>

RSA Team's Recommendation	Cost	Potential Safety Benefit
<p>Regular maintenance should keep the roadway markings clearly visible to pedestrians and vehicles.(3)</p>	<p>Low</p>	<p>Medium/High</p>

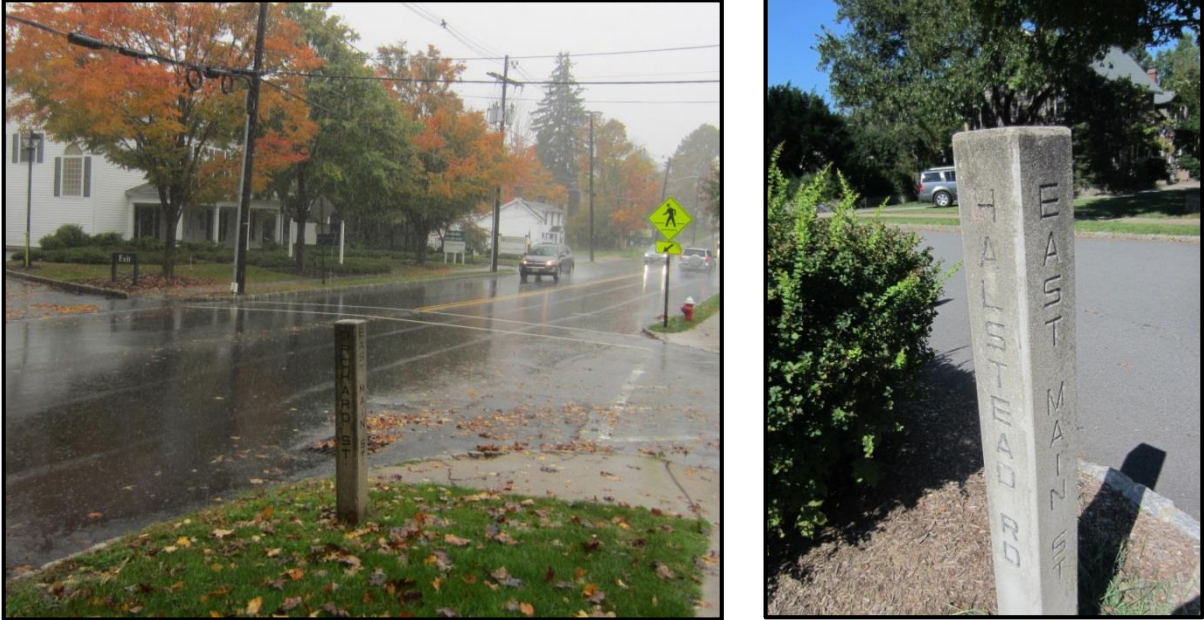
Issue: Street Name Signs (Corridorwide)	Safety Risk	
<b>Description:</b> The concrete street identification markers are not easily readable.	Medium

RSA Team's Recommendation	Cost	Potential Safety Benefit
Consider replacing the concrete name markers with standard MUTCD-compliant street signs. (6)	Low	Medium

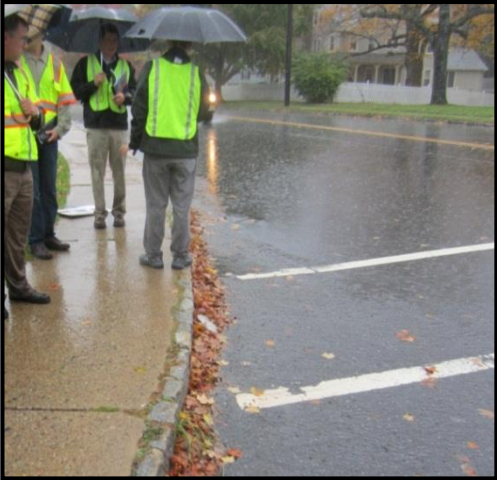
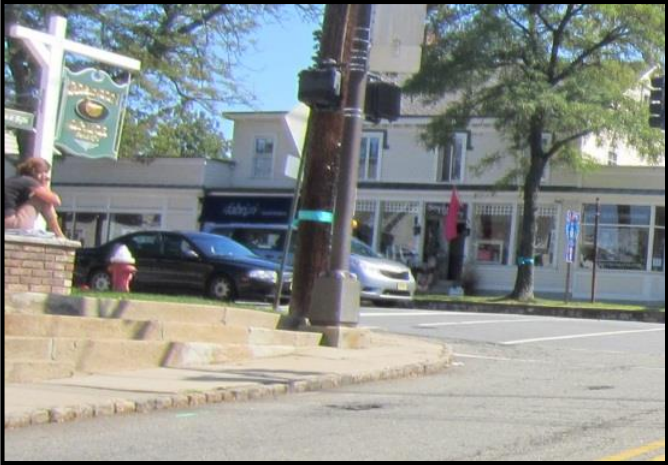
Issue: Pedestrian Accommodations (Hilltop Road)	Safety Risk
<b>Description:</b> Pedestrian accommodations, such as ramps and detectable warning surfaces, are not fully ADA compliant.	Medium
<b>Description:</b> Southeast corner of the intersection is not ADA compliant as there is a set of stairs required to access the sidewalk.	Medium/High
<b>Description:</b> The orientation and direction of pedestrian push buttons are not correct.	Medium/Low
<b>Description:</b> The pedestrian accommodations in the northeast corner are not ADA compliant.	Medium/High
<b>Description:</b> There are no countdown pedestrian heads.	Medium

RSA Team's Recommendation	Cost	Potential Safety Benefit
Plan for full ADA compliance by scheduling upgrades of existing ramps and curbs at crosswalks. (2)	Medium	Medium
Evaluate possible solutions for pedestrian accessibility in order to ensure full ADA compliance at the stairs on the southeast corner of the intersection. (8)	High	Medium/High
Consider realignment of the pedestrian push buttons. (9)	Low	Medium
Ensure that pedestrian push button signage conveys clear information for pedestrians in the crosswalk. (10)	Low	Medium
Evaluate possible solutions for pedestrian accessibility in order to ensure full ADA compliance at the stairs on the northeast corner of the intersection. (11)	High	Medium/High
Consider the installation of countdown pedestrian heads. (12)	Low	Medium

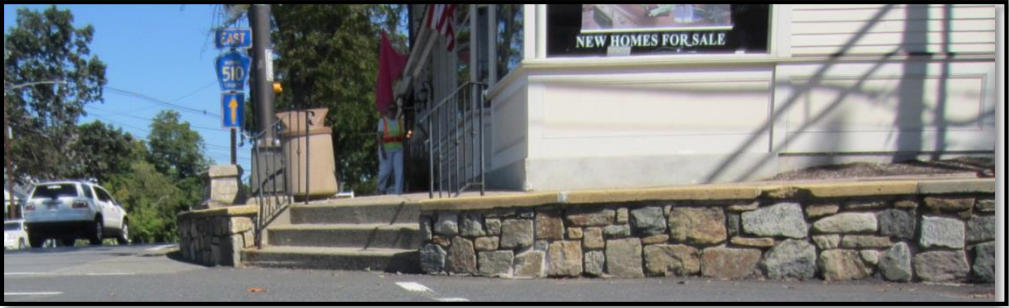
Issue: Parking (Hilltop Road)	Safety Risk	
<b>Description:</b> Parking adjacent to the intersection can interfere with sight distance.	Medium-High

RSA Team's Recommendation	Cost	Potential Safety Benefit
Consider the installation of additional roadway marking to delineate areas of parking prohibition at the intersection. (13)	Low	Medium/High
Review signage adjacent to the intersection to determine if "NO PARKING" zones are clearly marked. (14)	Low	Medium

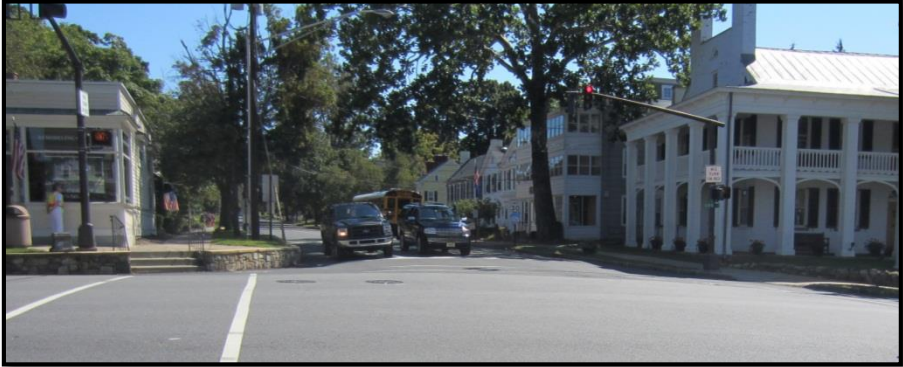
Issue: Traffic Operations (Hilltop Road)		Safety Risk	
<b>Description:</b> There is a high volume of left turning vehicles at Hilltop Road northbound to Main Street westbound, which creates significant queuing.		Medium	
<b>Description:</b> There is excessive vehicle speed on right turn from Main Street eastbound to Hilltop Road southbound.		Medium/High	
<b>Description:</b> Left turns from restaurant on northwest corner are often difficult to make.		Medium/High

RSA Team's Recommendation		Cost	Potential Safety Benefit
Investigate revising the signal timing in order to reduce the backup by allowing for a lead left. (15)		Medium	Medium/High
Consider installing split phasing to the traffic signal timing. (16)		Medium	Medium/High
Improvement to the geometry of the southwest corner would decrease the turning radius and, consequently, would encourage a slower turning speed. (17)		High	Medium/High

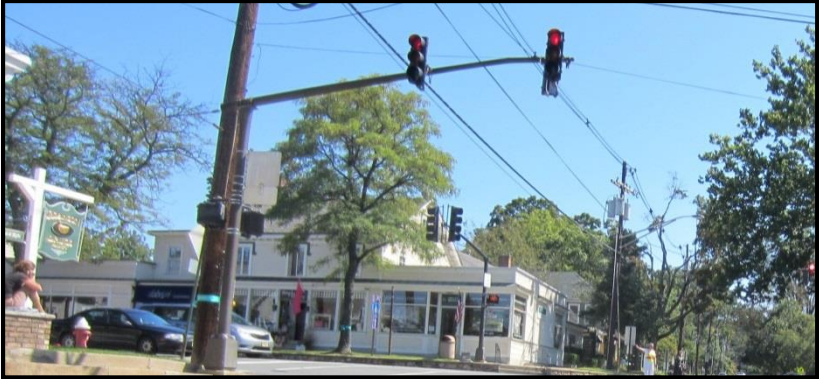
Issue: Traffic Signals (Hilltop Road)		Safety Risk	
<b>Description:</b> The traffic signals are antiquated and may be contributing to a significant number of crashes.		Low	
<b>Description:</b> Sun glare may increase traffic crashes.		Medium

RSA Team's Recommendation		Cost	Potential Safety Benefit
Consider upgrading the traffic signals including the addition of traffic cameras for image detection. (18)		Medium/High	Medium/Low
Increased visibility of signal heads would be enhanced by installing retro-reflective backplates. (19)		Low	Medium

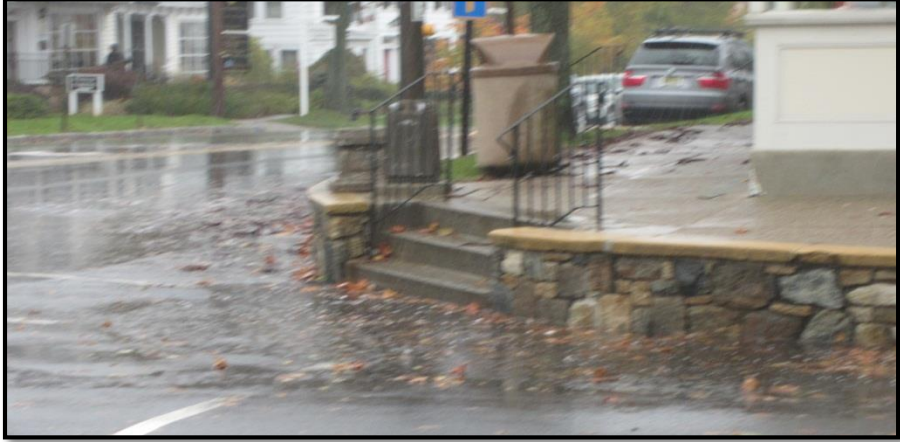
Issue: Drainage (Hilltop Road)	Safety Risk	
<b>Description:</b> There is severe puddling at base of steps (as seen on day of heavy rain).	Medium-Low

RSA Team's Recommendation	Cost	Potential Safety Benefit
Maintenance of the drainage basins and keeping them free of debris will facilitate drainage and improve safety. (20)	Low	Medium

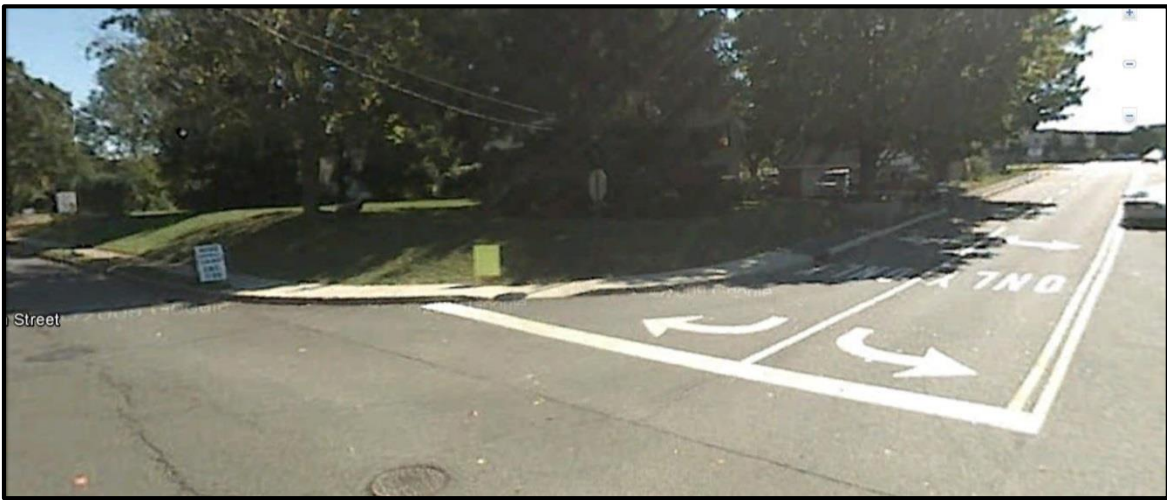
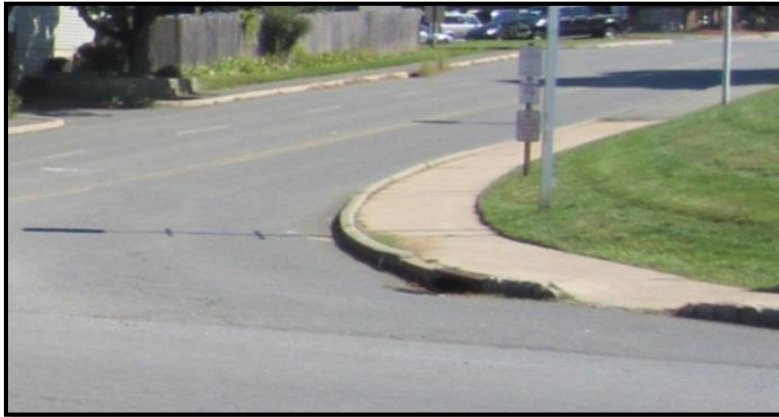
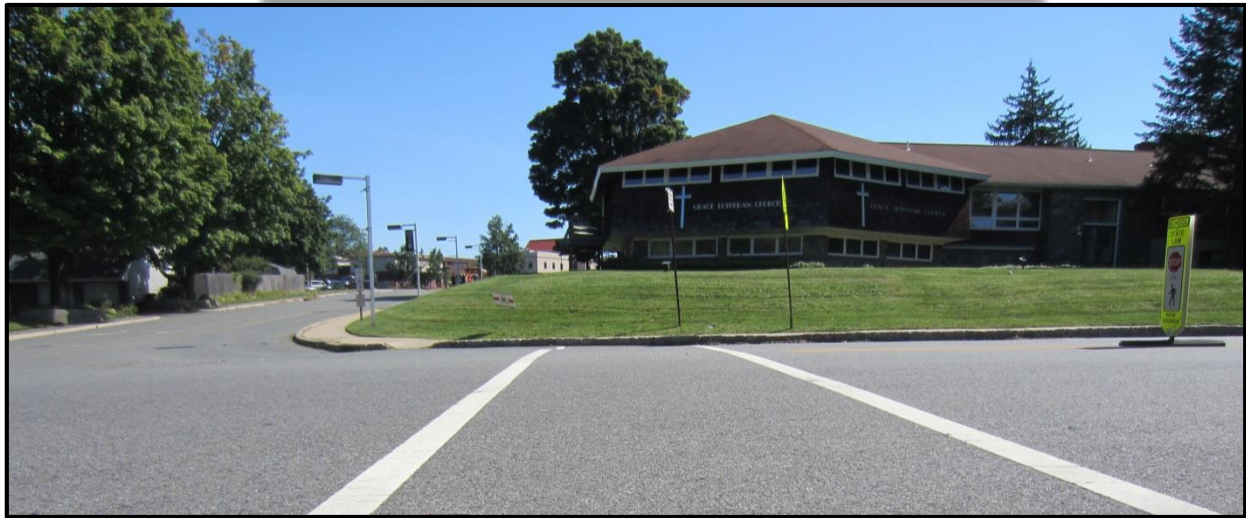
Issue: Pedestrian Accommodations (High School)	Safety Risk
<b>Description:</b> The access ramps on the southwest corner of the intersection are not ADA compliant.	Medium
<b>Description:</b> The ramp is not aligned with the crosswalk in the southwest corner.	Medium/Low
<b>Description:</b> There is no marked crosswalk across Halstead Road or the high school driveway.	Medium
<b>Description:</b> The stop bar across the high school entrance is too close to the crosswalk.	Medium/High

RSA Team's Recommendation	Cost	Potential Safety Benefit
Plan for full ADA compliance by scheduling upgrades of existing ramps and curbs at crosswalks. (2)	Medium	Medium
Consider the installation of a pedestrian refuge island (painted or permanent) with a painted crosswalk and a delineated left turn lane into the high school. (21)	Low (Painted); Med/High (Permanent)	High
Ensure that the crosswalk is aligned with the ramps. (28)	Medium	Medium
Consider installation of a marked crosswalk across Halstead Road.(29)	Low	Medium/High
Consider installation of a marked crosswalk at the entrance to the high school and ensure that the stop bar is aligned with the crosswalk in compliance with the MUTCD. (30)	Low	Medium

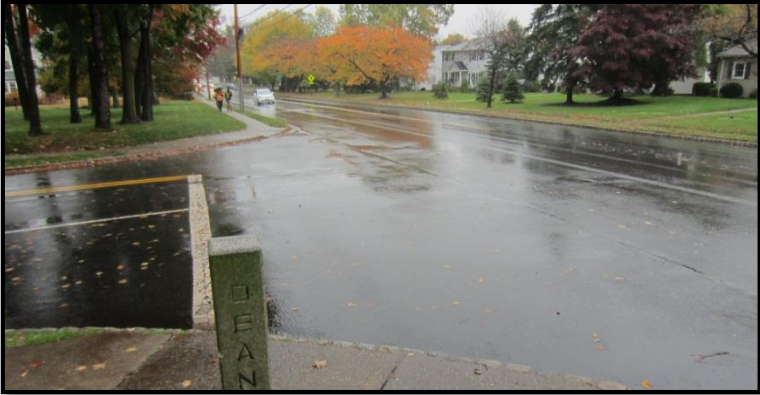
Issue: Traffic Operations (Dean Road)		Safety Risk	
<b>Description:</b> Left turns from Dean Road are difficult due to few gaps in traffic during peak periods.		Medium	
<b>Description:</b> The lane use on Dean Road is unclear and confusing.		Medium

RSA Team's Recommendation		Cost	Potential Safety Benefit
Consider the delineation of right and left turn lanes on Dean Road. (31)		Low	Medium/Low
Consider the installation of two-way left turn lanes in order to provide for pedestrian refuge from through traffic on East Main Street. (32)		Low	Medium/High

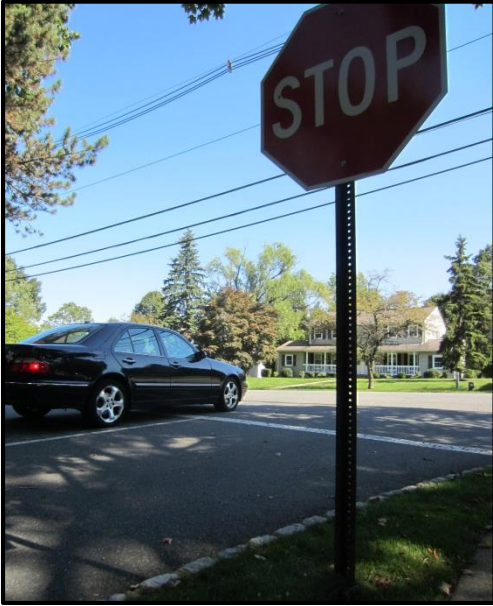
Issue: Signs (Dean Road)	Safety Risk	
<b>Description:</b> The stop sign is not aligned with the stop bar.	Medium

RSA Team's Recommendation	Cost	Potential Safety Benefit
Ensure proper alignment of the stop sign and stop bar according to the MUTCD. (33)	Low	Medium/High

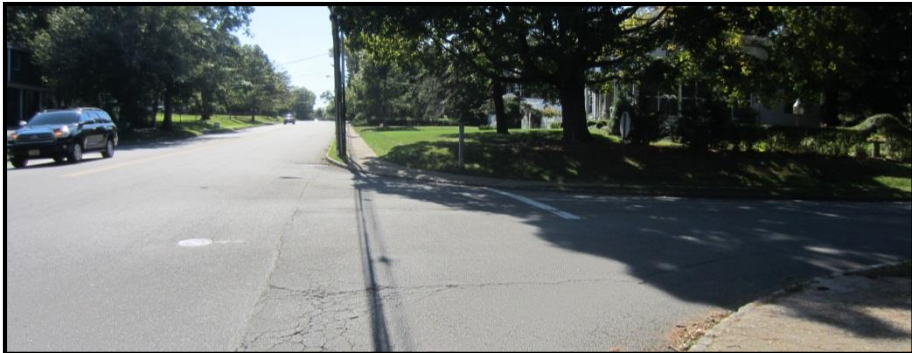
Issue: Pedestrians (Dean Road)	Safety Risk	
<b>Description:</b> There are no delineated crosswalks across either East Main Street and on Dean Road.	Medium-High

RSA Team's Recommendation	Cost	Potential Safety Benefit
The addition of marked crosswalks would alert drivers for possible pedestrian activity. (34)	Low	Medium/High
Consider the installation of two-way left turn lanes in order to provide for pedestrian refuge from through traffic on East Main Street. (32)	Low	Medium/High

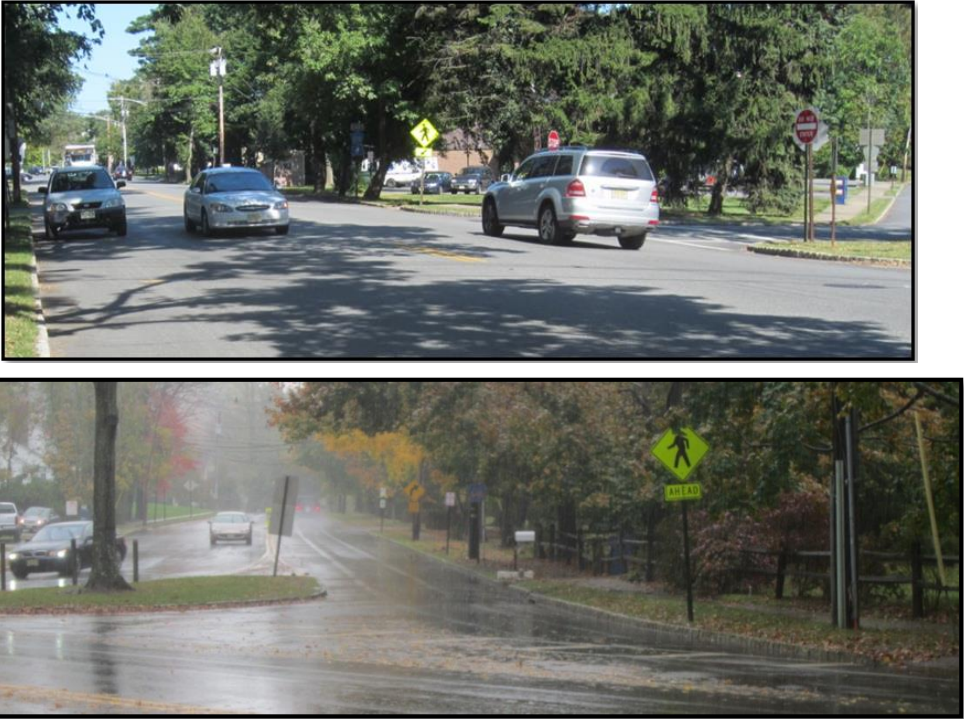
Issue: Traffic Operations (Tempe Wick Road)	Safety Risk	
<b>Description:</b> A significant number of right turns from Main Street eastbound to Tempe Wick Road are made with excessive speed.	High	
<b>Description:</b> The crash history indicates a significant number of right angle crashes.	Medium/High

RSA Team's Recommendation	Cost	Potential Safety Benefit
Improvement to the geometry, by reducing the turning radius, would promote decreased turning speed. (35)	High	Medium/High
Consider the installation of a dedicated left turn lane from westbound East Main Street. (36)	Low	Medium/High

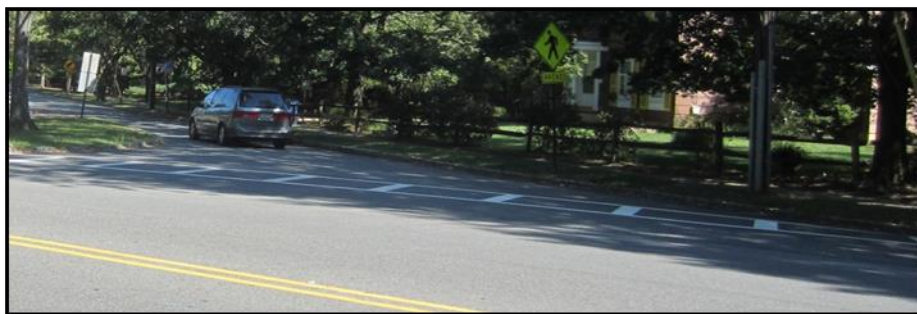
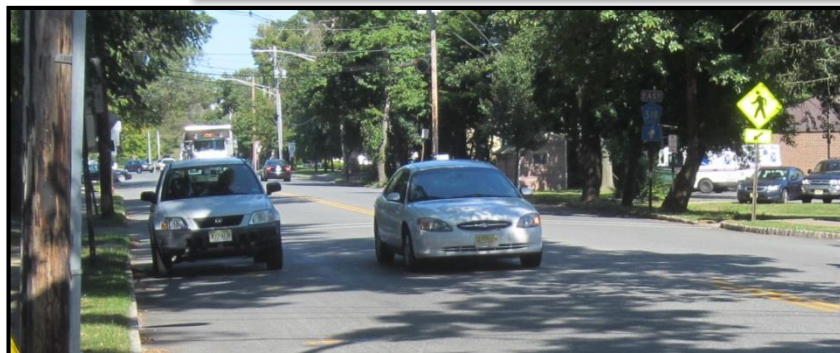
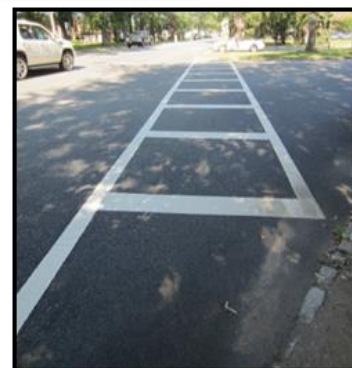
Issue: Pedestrians (Tempe Wick Road)	Safety Risk
<b>Description:</b> Crash history indicates a significant number of pedestrian crashes at this intersection, especially crossing East Main Street.	High
<b>Description:</b> The length of the crosswalk on Tempe Wick Road makes it difficult for pedestrians to cross.	Medium/High
<b>Description:</b> Pedestrian accommodations, such as ramps and detectable warning surfaces, are not fully ADA compliant.	Medium

RSA Team's Recommendation	Cost	Potential Safety Benefit
Evaluate moving the East Main Street crosswalk away from the intersection and closer to the shopping center. (37)	Low	Medium/High
Consider adding a crosswalk across East Main Street west of the intersection and the installation of a refuge island (painted or permanent). (38)	Low (Painted); Med/High (Permanent)	Medium/High
Investigate the installation of active warning beacons, such as the Rectangular Rapid Flash Beacon, in order to increase pedestrian visibility. (22)	Medium	High
Consider prohibiting left turns from Tempe Wick Road to East Main Street and reorienting them to the signalized intersection of Cold Hill Road as per the town's master plan. (39)	Low	Medium/High

RSA Team's Recommendation (continued)	Cost	Potential Safety Benefit
The length of the pedestrian crosswalk across Tempe Wick Road could be reduced by decreasing the radius on the western side of the crossing. (40)	High	High
Plan for full ADA compliance by scheduling upgrades of existing ramps and curbs at crosswalks. (2)	Medium	Medium

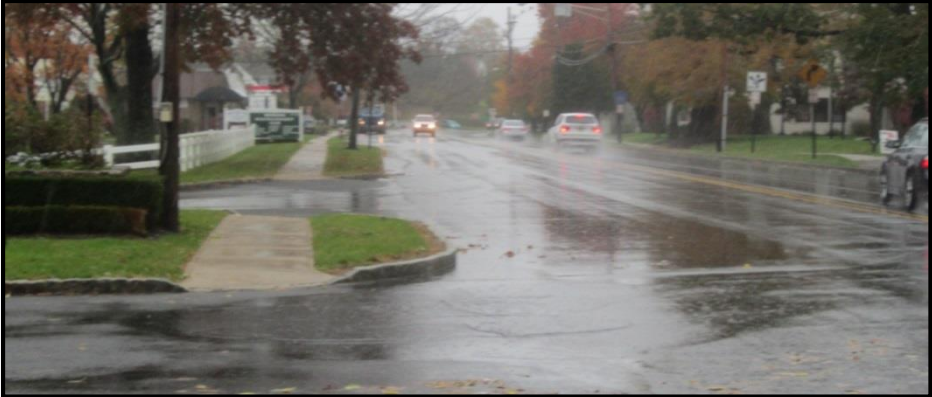
Issue: Traffic Operations (Shopping Center)	Safety Risk	
<b>Description:</b> Main Street is wide, and there isn't clear lane use for through traffic and for turning traffic.	Medium/High	
<b>Description:</b> There is no lane delineation for turning vehicles into and out of the shopping center driveways.	Medium

RSA Team's Recommendation	Cost	Potential Safety Benefit
Evaluate instituting a road diet on Main Street by clearly delineating the travel lane. (41)	Low	Medium/High
Delineation of the right and left turn lanes into and out of the shopping center driveway would more clearly direct drivers. (42)	Low	Medium
In addition to two-way left turn lanes, as noted in the corridorwide section, consider dedicated right and left turn lanes into the shopping center if traffic volumes warrant. (43)	Low	Medium/High

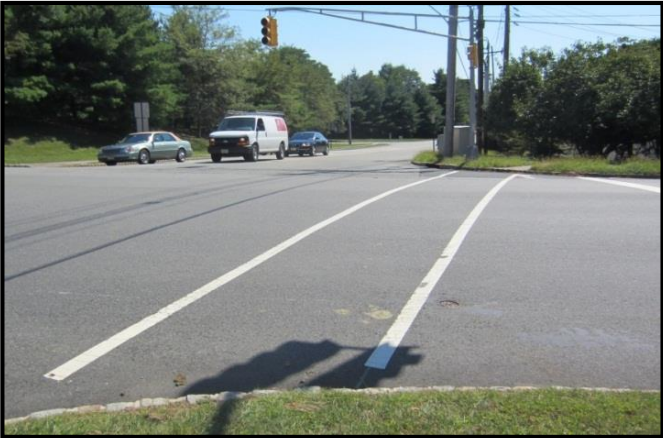
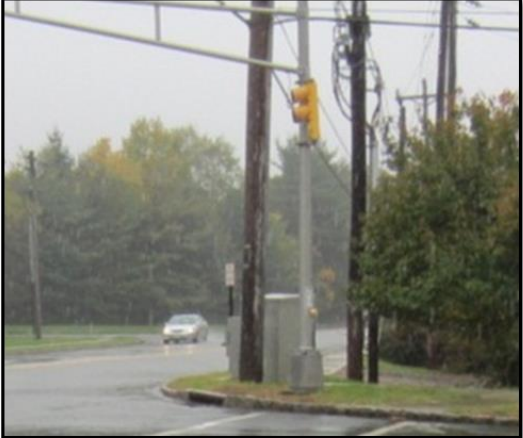
Issue: Pedestrians (Cold Hill Road)		Safety Risk	
<b>Description:</b> The intersection is not ADA compliant as there are no pedestrian ramps.		Medium	
<b>Description:</b> There are no pedestrian heads.		Medium

RSA Team's Recommendation		Cost	Potential Safety Benefit
Plan for full ADA compliance by scheduling upgrades of existing ramps and curbs at crosswalks. (2)		Medium	Medium
Consider the installation of pedestrian heads. (44)		Medium	Medium/High

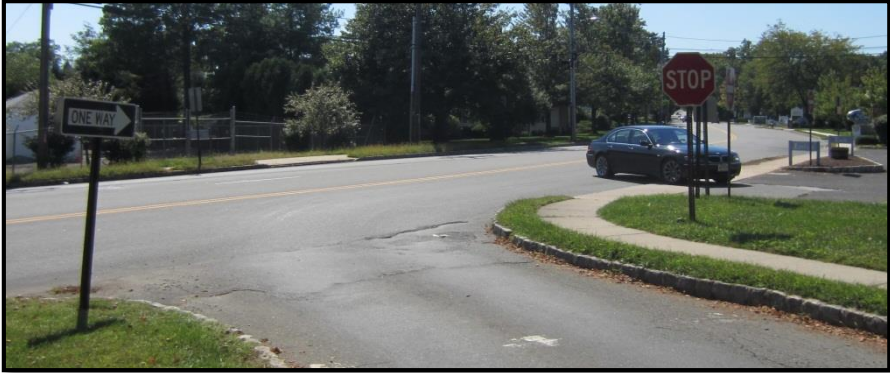
Issue: Slip Ramp (Cold Hill Road)	Safety Risk	
<b>Description:</b> The stop bar is missing on the ramp from Cold Hill Road southbound to East Main Street westbound.	Low	
<b>Description:</b> There are no curb ramps or marked crosswalk.	Medium

RSA Team's Recommendation	Cost	Potential Safety Benefit
The stop bar on ramp from Cold Hill Road to Main Street westbound should be added. (46)	Low	Low/Medium
Install curb ramps and a marked crosswalk. (47)	Medium	Medium

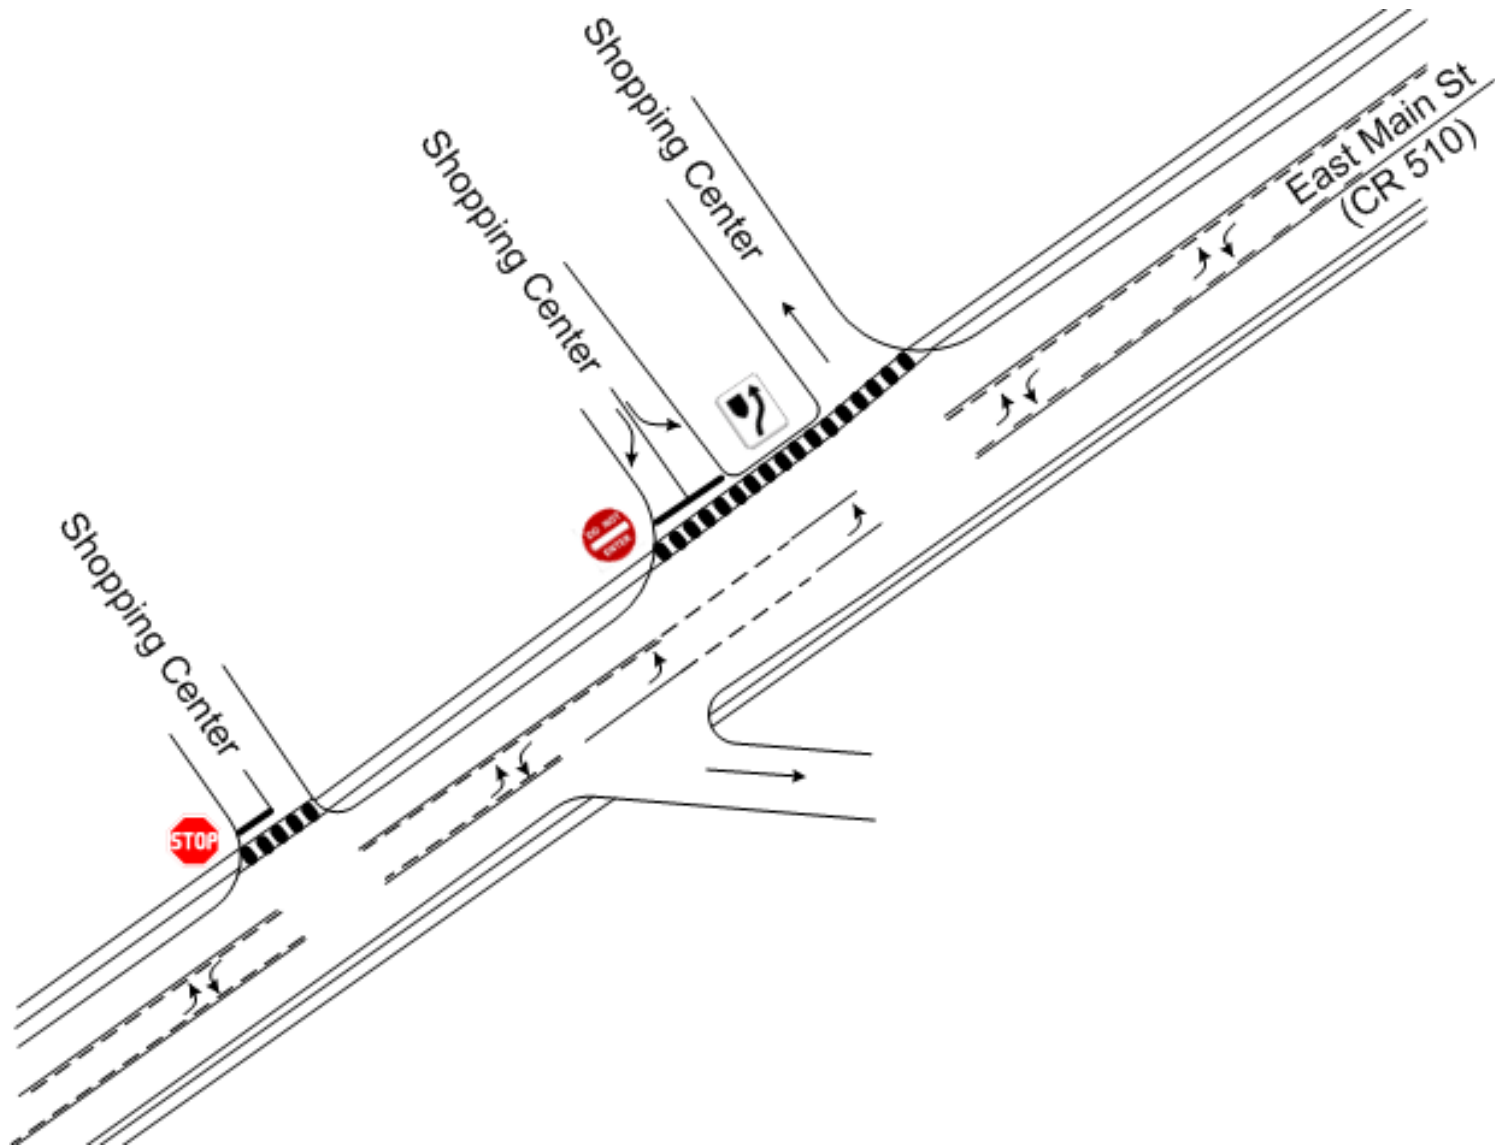
*Institute a Road Diet, Two-Way Left Turns and Right and Left Turn Lanes out of Mendham Shopping Center*
