MORRIS AVENUE & MOUNTAIN AVENUE ROAD SAFETY AUDIT

Summit, Union County, New Jersey

REPORT

>> November 2014

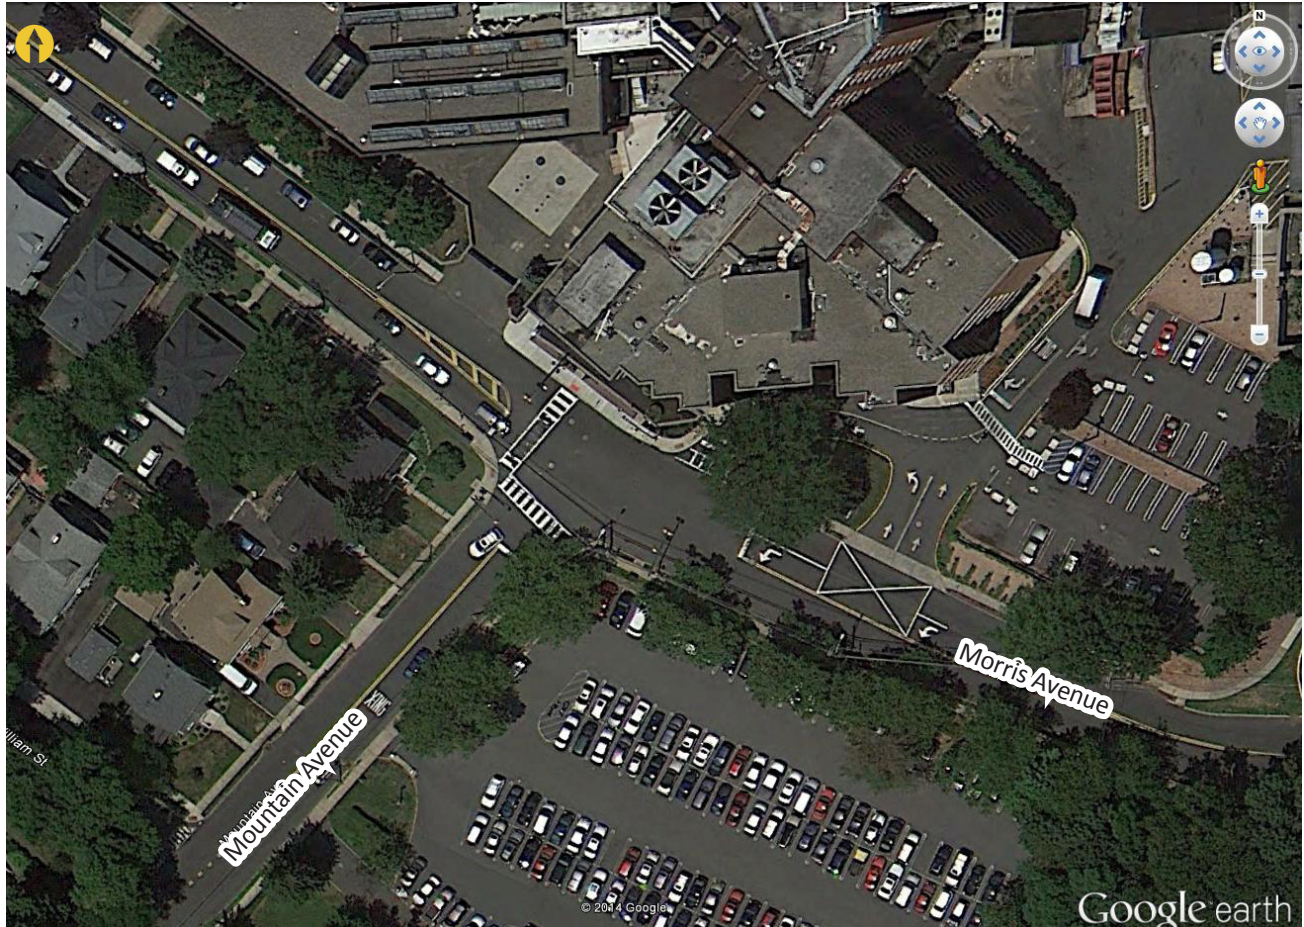
Figure 5 – Intersection of Morris Avenue and Mountain Avenue

Morris Avenue and Mountain Avenue

Signalized intersection

Morris Avenue – one lane in each direction, no shoulders

Morris Avenue westbound – dedicated left turn lane

Mountain Avenue – one lane in each direction, no shoulders

Ends at Morris Avenue as T-intersection (although the driveway exit functions as part of intersection)

Sidewalks on all sides

Westbound stop bar is set far back

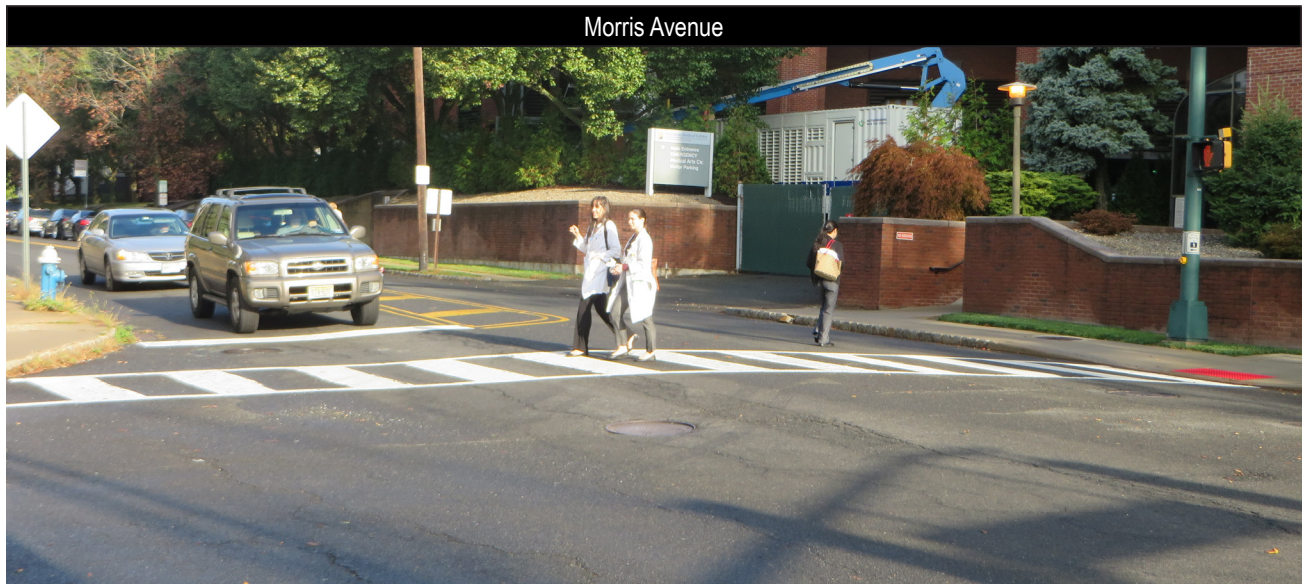
Figure 17 – Morris Avenue cross section

Morris Avenue

- One lane in each direction
- Left turn lane for Morris Avenue westbound
- Very wide eastbound roadway east of the intersection
- Curbed cross section
- Sidewalks on both sides
- Parking on westbound Morris Avenue west of the intersection; no parking on either side east of the intersection

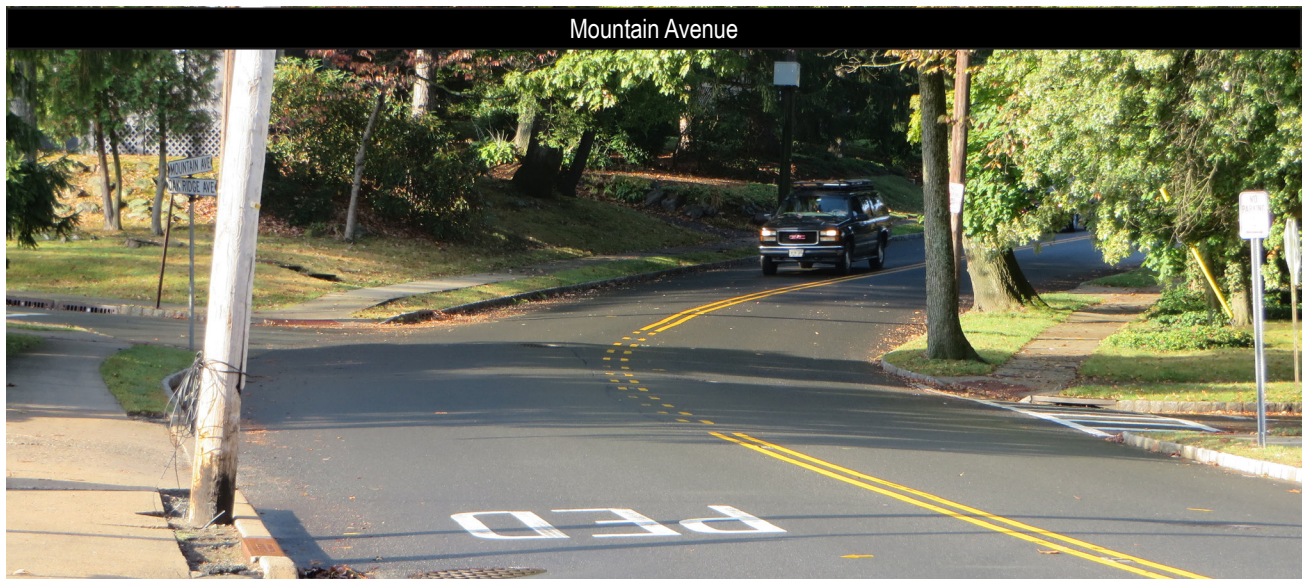
Figure 16 – Mountain Avenue cross section

Mountain Avenue

- One lane in each direction
- No shoulders
- No parking
- Curbed cross section
- Sidewalks on both sides

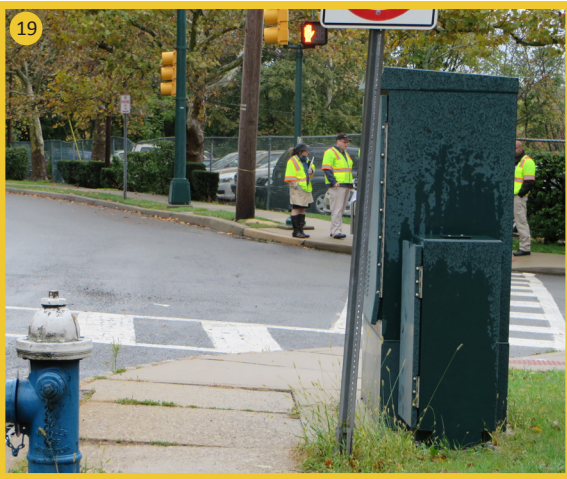
Figure 20 – Controller box limits visibility

2	Relocate the controller box to improve eastbound Morris Avenue driver's ability to see pedestrians crossing Mountain Avenue, and Mountain Avenue driver's ability to see eastbound traffic on Morris Avenue.	High	Long	\$\$\$	Union County	17, 19
3	Professional staff should conduct a formal engineering review of existing lighting conditions to evaluate where both vehicles and pedestrian level lighting can be enhanced.	Medium	Medium	\$\$	Union County	18
4	Replace existing signs with retroreflective signs.	Medium	Short	\$	Union County	20

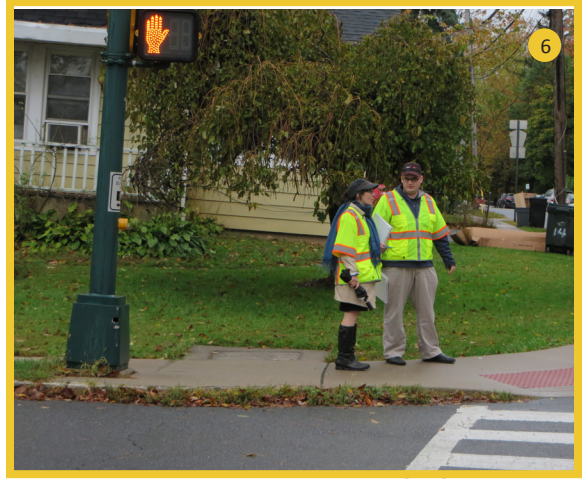
Figure 21 – Pedestrian push button far from landing

Ref #	MORRIS AVENUE & MOUNTAIN AVENUE	Safety Benefit	Time Frame	Cost	Jurisdiction	Issue Ref #
A - Pedestrians and Bicycles						
1	Replace W11-2 sign with "TURNING VEHICLES MUST STOP FOR PEDESTRIANS" sign.	Low	Short	\$	Union County	9,22
2	Relocate the push buttons adjacent to the crosswalk landings.	Medium	Medium	\$\$	Union County	6
3	Realign walkway from the employee parking lot so that it exits at the marked crosswalk.	High	Medium	\$\$	Summit & Overlook Medical Center	1
4	Add a painted pedestrian refuge island (colored and/or textured) on the western crosswalk across Morris Avenue.	Medium/Low	Medium	\$	Union County	21
5	Changing the signal phasing to lag left will discourage pedestrians from crossing in conflict with existing lead arrow.	High	Short	\$	Union County	23
6	Investigate if pedestrian phasing can operate in recall such that the pedestrian push buttons can be removed.	Medium/High	Short	\$	Union County	2,6

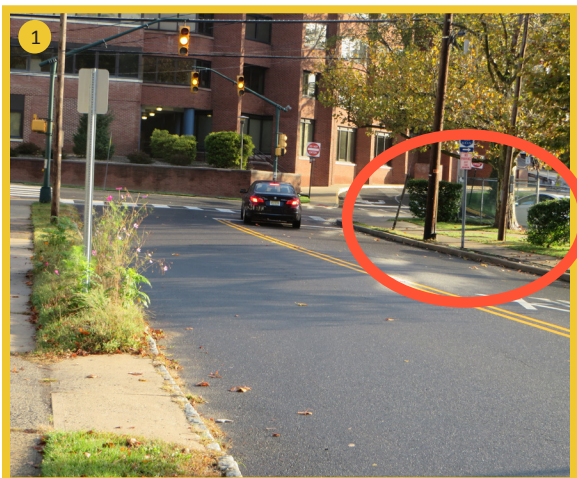
Figure 18 – Exit from employee parking lot

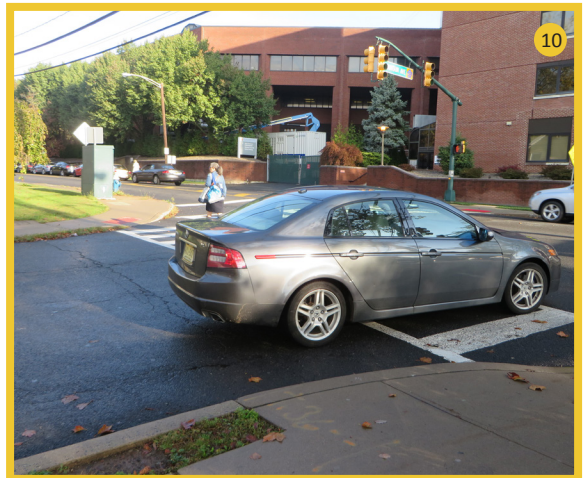
Figure 19 – Pulling up onto crosswalk for better visibility

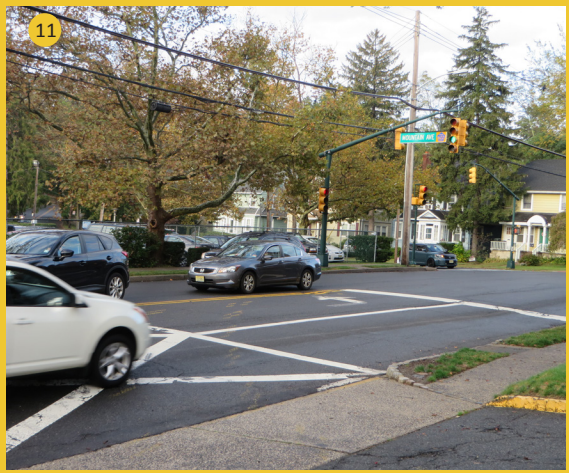
Figure 22 – Stop bar located back from intersection

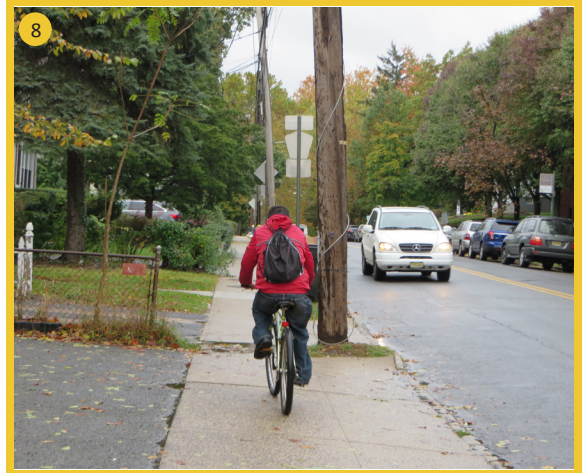
Figure 23 – Riding a bicycle on street is difficult

7	Considerations should be made for bicyclists to safely navigate the roadway.	Medium/High	Long	\$	Union County	8
B - Driver Behavior						
1	Install lane line extensions for left turning movements from Morris Avenue.	Low	Short	\$	Union County	14
2	Install lane line extensions for eastbound Morris Avenue as the lanes are not aligned before and after the intersection.	Low	Short	\$	Union County	13
3	Consider the installation of a "NO TURN ON RED" sign on Mountain Avenue.	High	Short	\$	Union County	22
4	Consider the installation of a sign "STOP HERE ON RED" at the stop bar on Mountain Avenue.	Medium	Short	\$	Union County	10
5	Paint edge of lane striping (and hatch between striping and curb line) on Morris Avenue at the southeast corner, creating an aligned travel lane.	Medium	Short	\$	Union County	13
C - Visibility						
1	Remove tree foliage and bush on southeast corner that is blocking driver visibility.	Medium/High	Short	\$	Summit	20

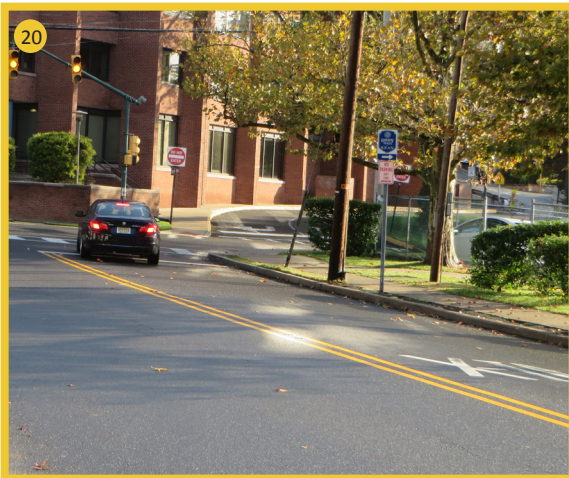
Figure 24 – Foliage blocks visibility

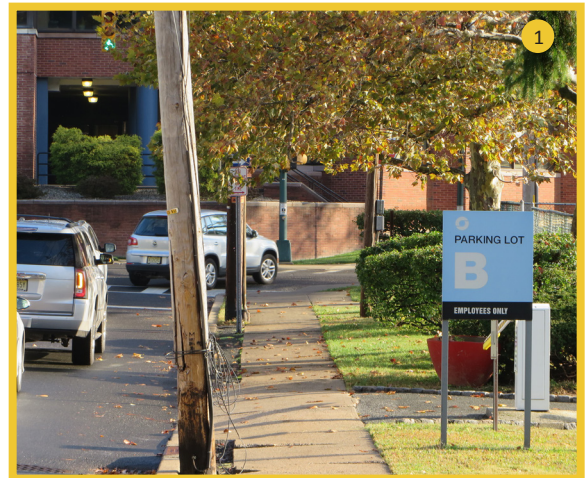
Figure 25 – The exit from employee parking lot walkway encourages midblock crossing

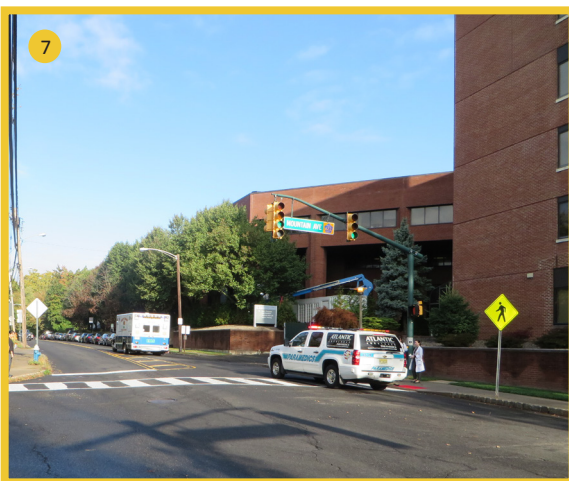
Figure 26 – The pedestrian sign could lead to a false sense of being allowed to cross

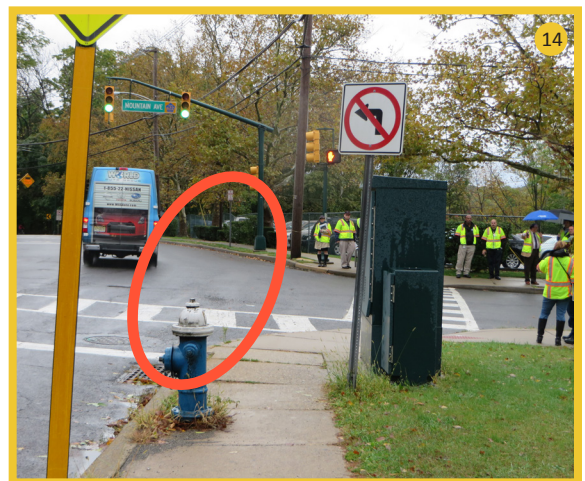
Figure 27 – The southern curb line isn't aligned

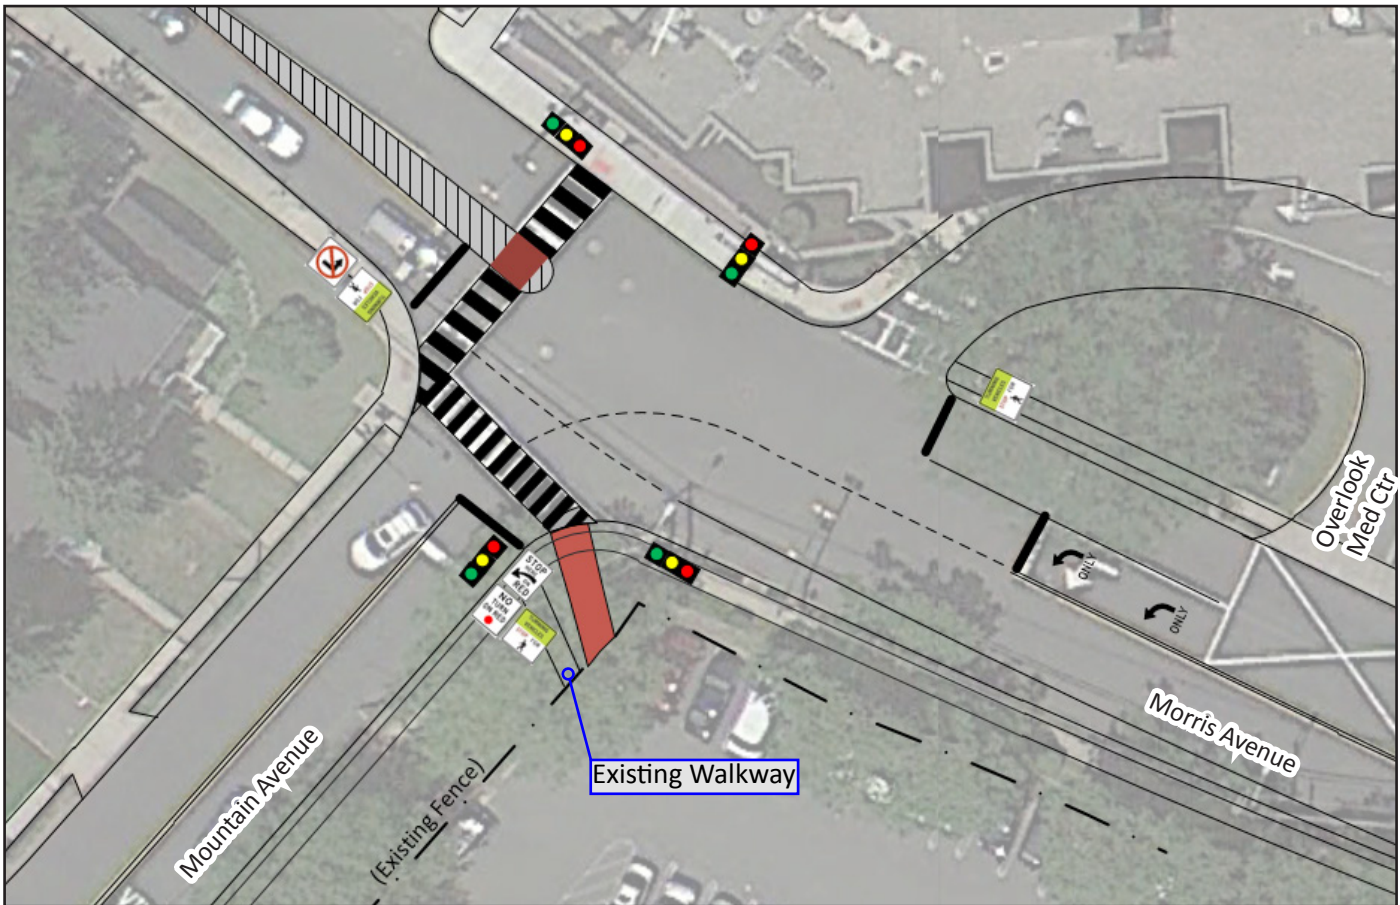
Summary of Recommendations

- Install lane line extensions
- Visually align southern curblines on southeast corner with edge of travelway striping
- Install improved signage
- Move stop bar forward on Morris Avenue westbound for through traffic
- Revise walkway from employee parking lot to align it with the crosswalk on Mountain Avenue
- Evaluate signal phasing to improve safety for all roadway users
- Improve visibility with improved lighting, removing obstacles, better retroreflectivity of signs
- Improve access to pedestrian push buttons
- Painted pedestrian refuge island on Morris Avenue

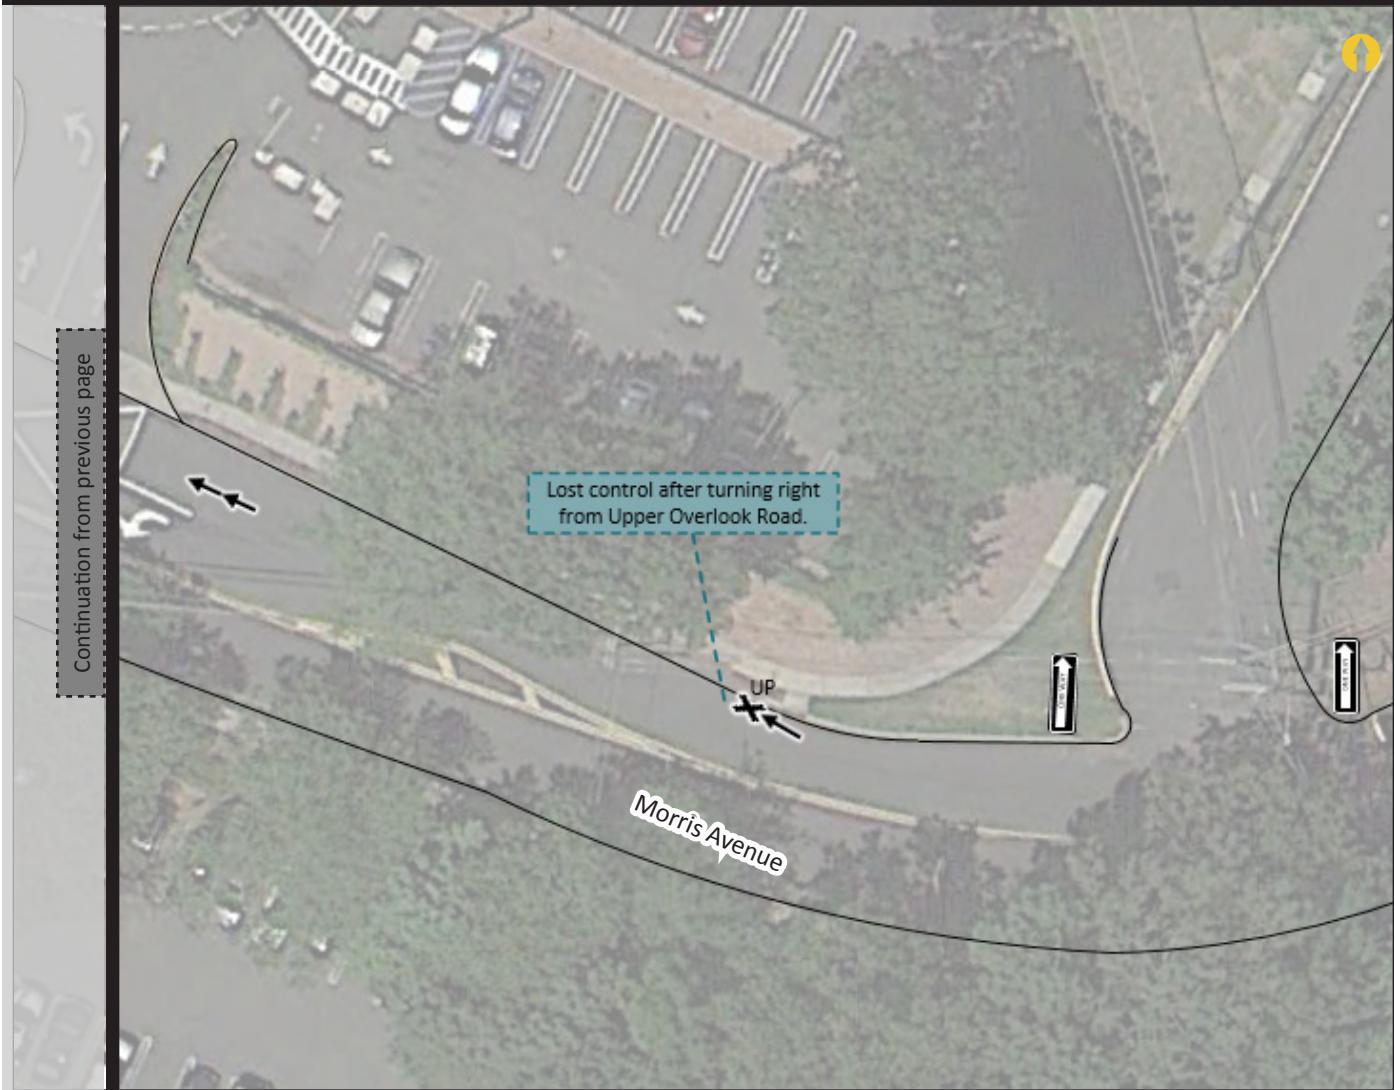
All pedestrian and cyclist crashes from 2008 to 2012 have a brief crash narrative included in the diagram and are color coded by severity. Additionally, any crash from 2010 to 2012 that has a severity of “moderate injury” or greater has a color-coded narrative.

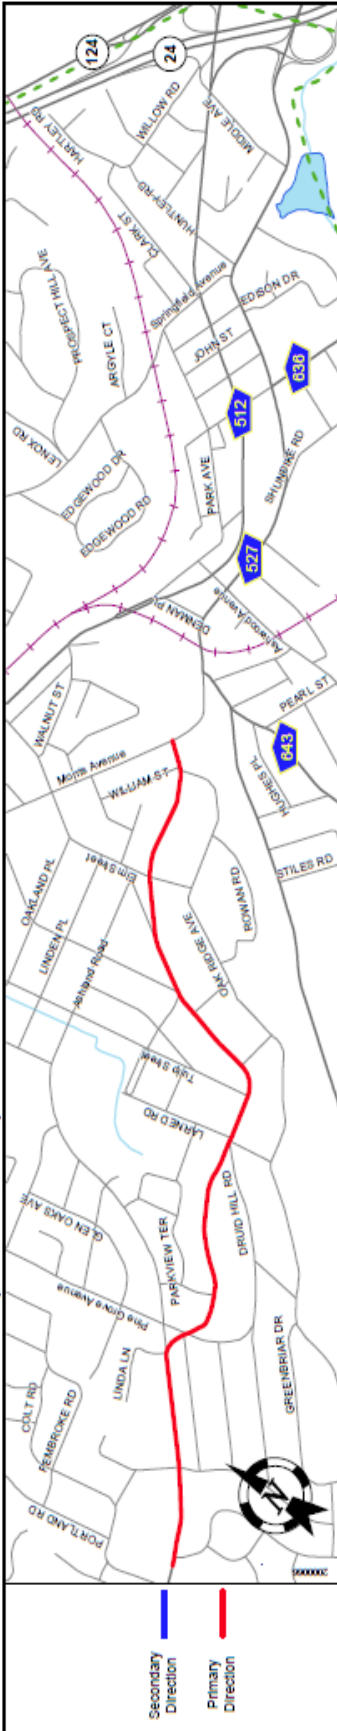
UNION COUNTY 622 (West to East)

Mile Posts: 5.000 - 6.600

Street Name	Mountain Avenue
Jurisdiction	County
Functional Class	Urban Minor Arterial
Federal Aid - NHS Sys	STP
Control Section	
Speed Limit	35
Number of Lanes	2
Med. Type	None
Med. Width	0
Pavement	29
Shoulder	0
Traffic Volume	
Traffic Sta. ID	
Structure No.	
Enlarged Views
