ESSEX COUNTY INTERSECTIONS

ROAD SAFETY AUDIT

Newark, New Jersey

REPORT

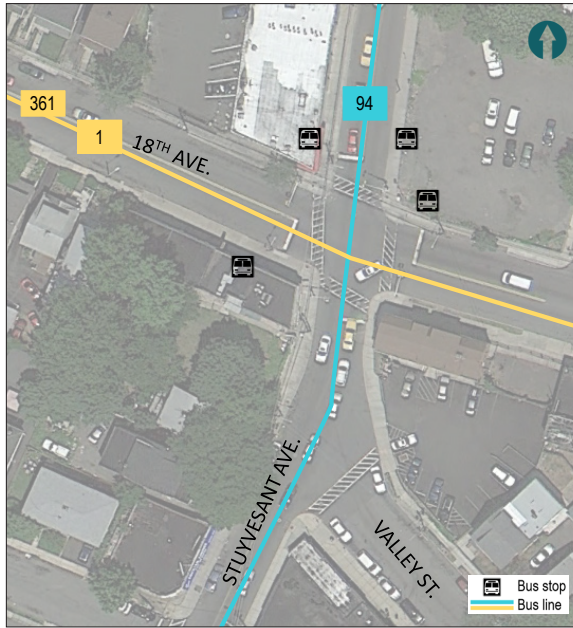
Figure 4 – Stuyvesant Avenue & 18th Avenue

Stuyvesant Avenue and 18th Avenue

- **NJ Transit #1:** Daily service to Irvington, Newark, Kearny, and Jersey City with headways of approximately 2 to 15 minutes, excluding late night services.
- **NJ Transit #94:** Daily service to Bloomfield, East Orange, Newark, Irvington, Union, Roselle Park, and Linden with headways of approximately 4 to 20 minutes, excluding late night services.
- **NJ Transit #361:** Weekday peak service to Irvington and Newark (express service) with headways of approximately 10 to 45 minutes.

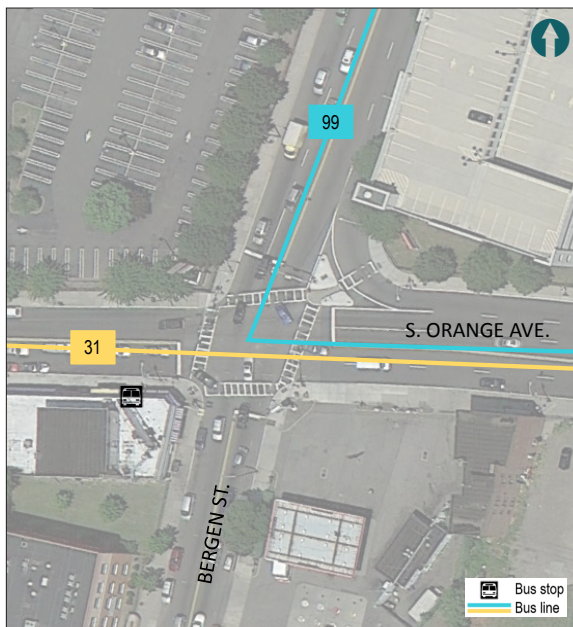
Figure 5 – Bergen Street & South Orange Avenue

Bergen Street and South Orange Avenue

- **NJ Transit #99:** Serving Newark and Hillside with headways of approximately 10 to 20 minutes, excluding late night services.
- **NJ Transit #31:** Schedule unavailable, though frequent service observed during site visit.

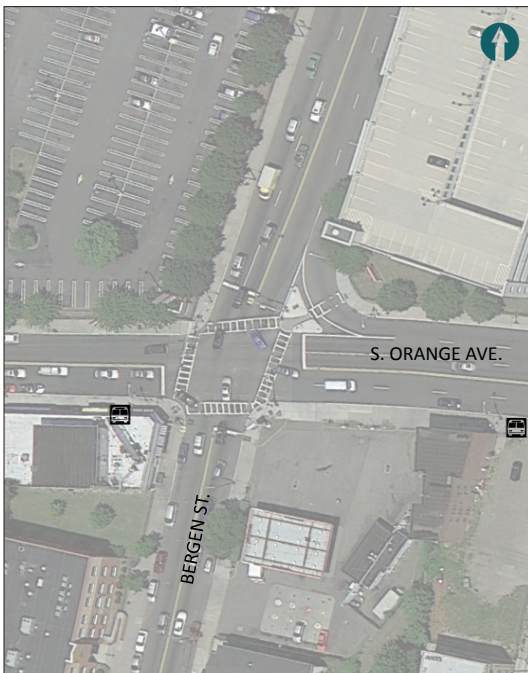
Figure 9 – Bergen Street & South Orange Avenue

- Signalized
- Slightly skewed
- South Orange Avenue: County owned, Urban principal arterial
 - West leg:
 - Pavement: 40'
 - 1 lane each direction
 - Curbside parking
 - East leg:
 - Pavement: 60'
 - 2 lanes in each direction + slip ramp onto Bergen St.
- Bergen Street: Municipal owned, Urban minor arterial
 - North leg:
 - Pavement: 70'
 - 2 receiving lanes after slip ramp from S. Orange Ave.
 - 1 through/right-turn lane, 1 left-turn lane (protected/permitted)
 - South leg:
 - Pavement: 40'
 - 1 lane each direction
 - Curbside parking

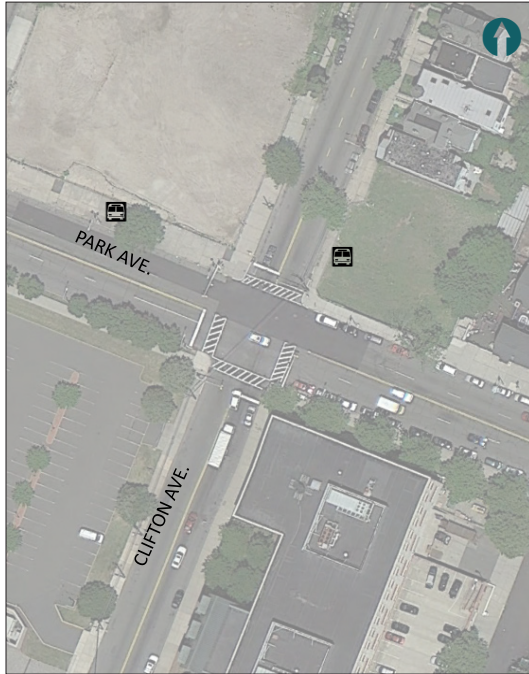
Figure 10 – Clifton Avenue & Park Avenue

- Signalized
- Park Avenue:
 - County owned
 - Urban principal arterial
 - Pavement: 50'
 - 2 lanes each direction
 - Curbside parking
 - Vertical westward incline
- Clifton Avenue:
 - Municipal owned
 - Urban minor arterial
 - Pavement: 44'
 - 1 lane each direction
 - Curbside parking

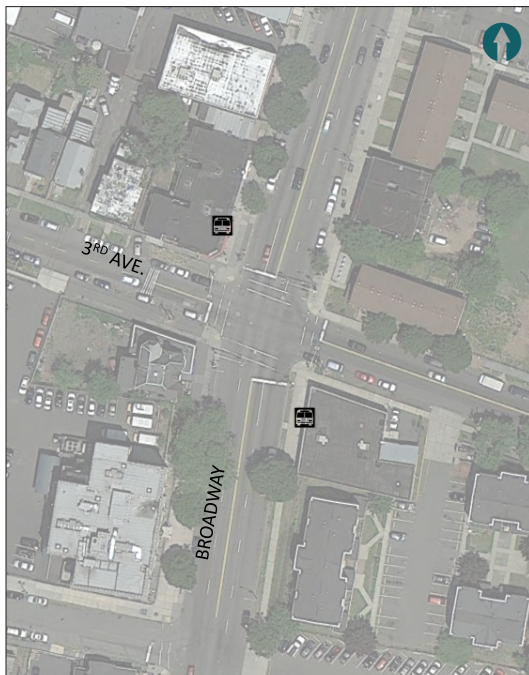
Figure 11 – Broadway & 3rd Avenue

Broadway and 3rd Avenue

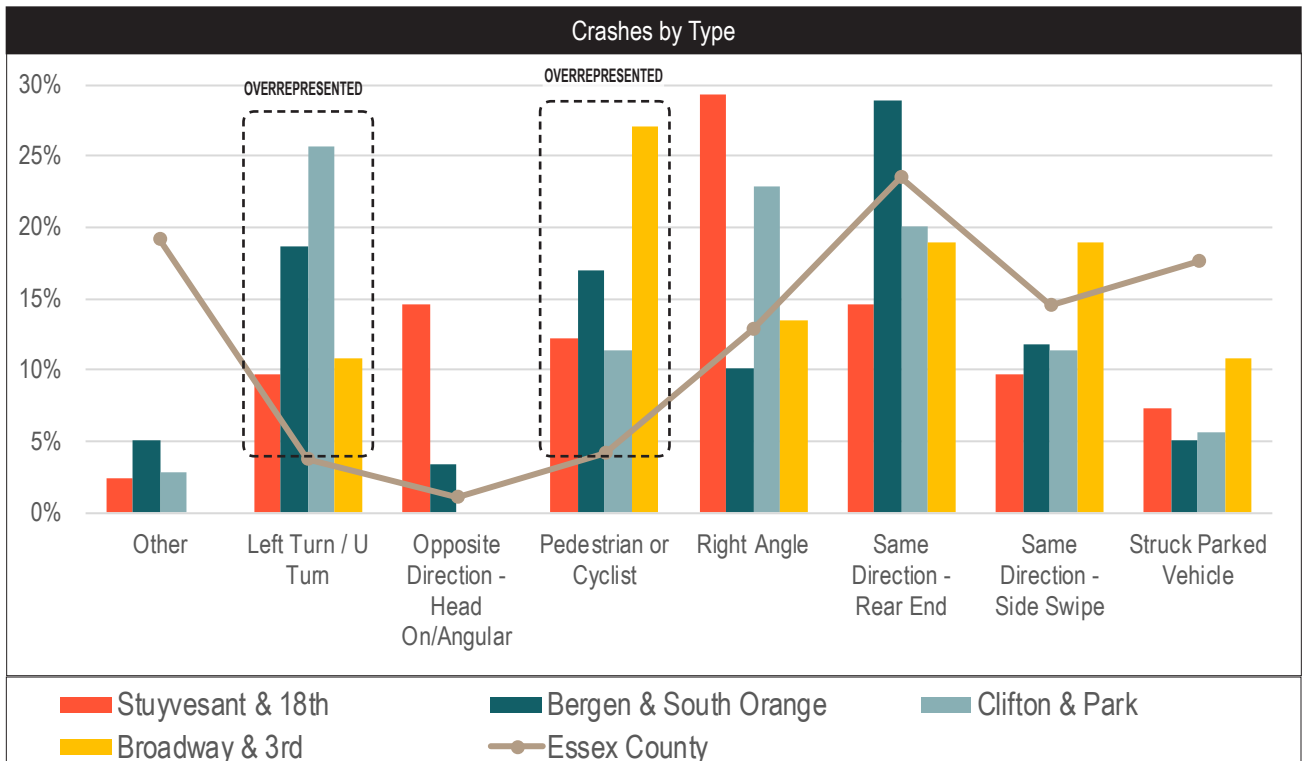
Figure 13 – Crash by Type

Left-turn crashes and pedestrian crashes were both overrepresented, at every intersection in the study area. The Stuyvesant Avenue intersection and the Park Avenue intersection also had notable overrepresentation of right-angle crashes. The Stuyvesant Avenue intersection had a high overrepresentation of opposite-direction head-on/angular crashes. More detailed crash type information is available in Appendix D—Table 1.

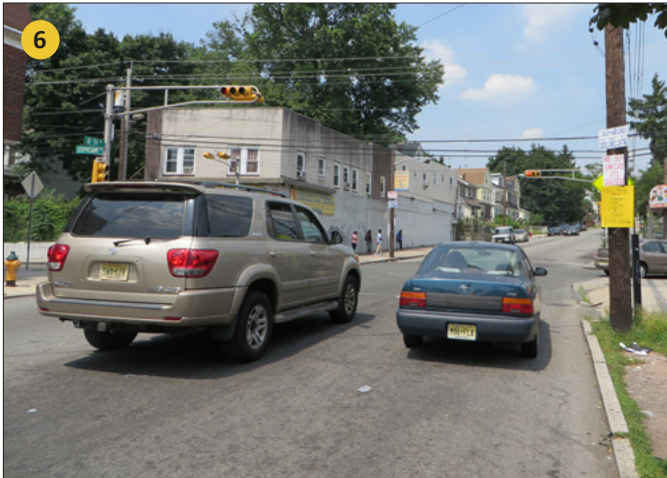
Unclear lane delineation and extra width of the single lane in each direction along 18th Avenue leads motorists to treat it as two lanes.

Rec. #	RECOMMENDATIONS LIST	Safety Benefit	Time Frame	Cost	Jurisdiction	Issue Ref. #
6.1 STUYVESANT AVENUE AND 18TH AVENUE						
Roadway Operations & Geometry						
1	Paint edgelines to visually narrow the travel lane on 18th Avenue.	Medium	Short	\$	Essex Co.	6
2	Consider relocating the stop bar to Valley Street, and increase the left-turn radius from westbound 18th Avenue (in conjunction with #3).	Medium	Med. / Long	\$\$	Essex Co.	7
3	Consider relocating the signal to Valley Street to better control traffic.	Medium	Medium	\$\$	Essex Co.	2
4	Install rumble strips on the 18th Avenue vertical curve.	Medium	Medium	\$\$	Newark	3
Traffic Signal						
5	Full signal upgrade on all signal heads to include 12-inch heads and backplates with retroreflective borders. Uniform, vertical signal heads are better, if possible.	Med. / High	Medium	\$\$	Essex Co.	8, 9, 10
6	Install pedestrian-countdown signal heads.	Medium	Short	\$\$	Essex Co.	17

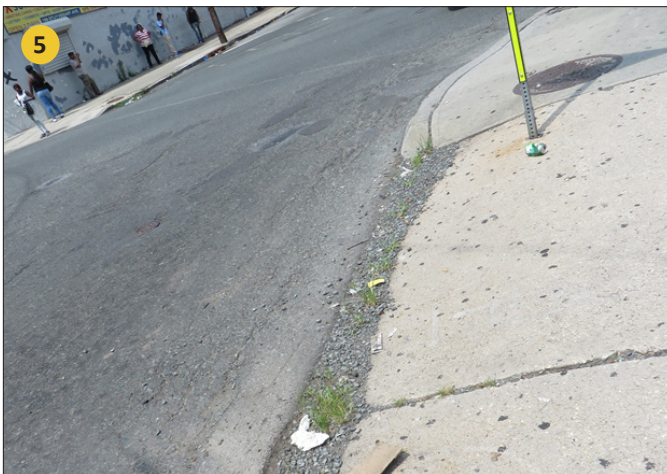
Unnecessary depressed curbs.

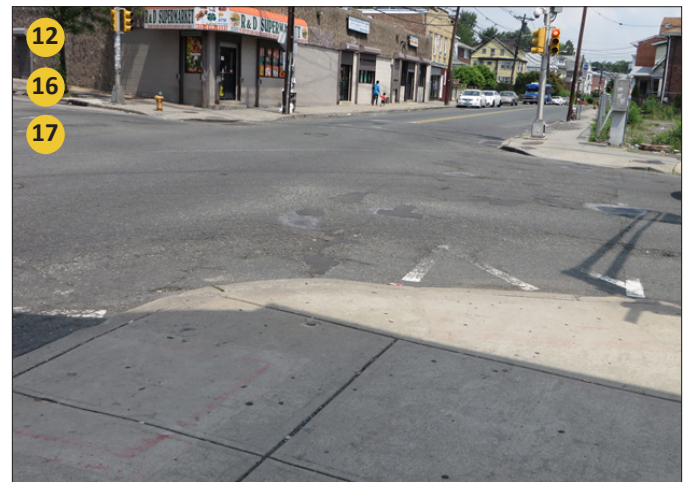
Faded crosswalks; Lack of truncated domes; No pedestrian signal heads.

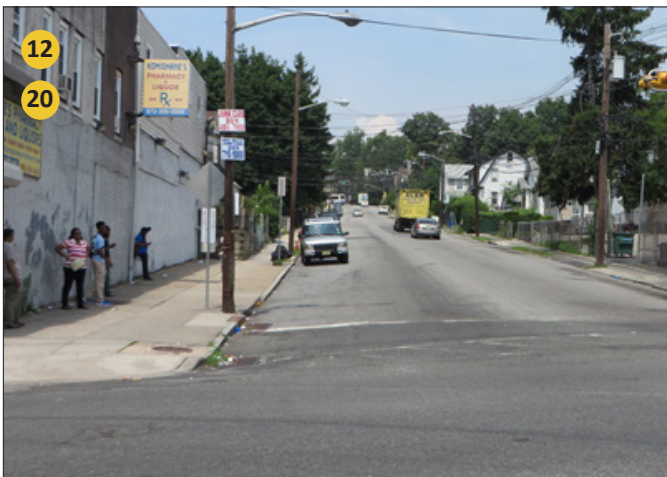
Faded crosswalks and centerline; No bus shelter or benches.

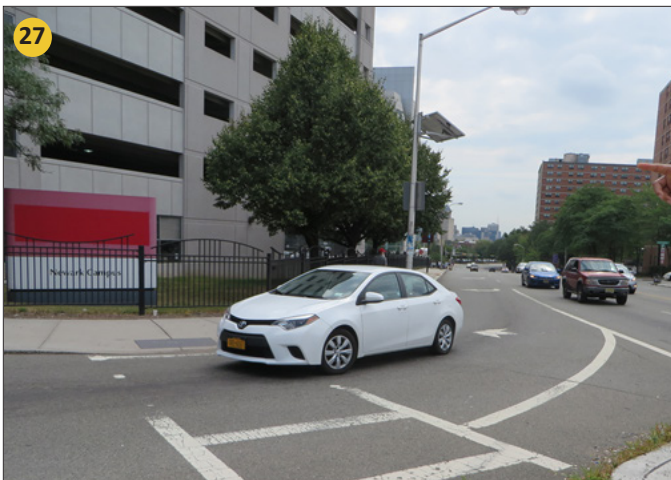
Wide slip ramp allows vehicles to access Bergen Street at high speeds. Motorists were observed not yielding to pedestrians. There is no advance warning sign of pedestrians on the slip ramp, and the sight triangle on approach is limited by fencing.

Rec. #	RECOMMENDATIONS LIST	Safety Benefit	Time Frame	Cost	Jurisdiction	Issue Ref. #
6.2 BERGEN STREET AND SOUTH ORANGE AVENUE						
Roadway Operations & Geometry						
1	Consider implementing a roadway diet on the eastbound approach.	Medium	Long	\$\$	Essex Co.	26, 25
2	Revise the northeast corner: a. Consider removing the island, eliminating the slip ramp and squaring the intersection; or b. Alternatively, the radius could be tightened on the northeast corner, without removing the island.	Medium	Long	\$\$\$	Essex Co.	30, 34, 35
3	Evaluate the warrant for implementing No-Turn-on-Red on the northwest corner	Medium	Medium	\$\$	Essex Co.	29
4	Consider the installation of head-to-head left-turn lanes on Bergen Street.	Med/High	Medium	\$\$	Essex Co.	28
5	Consider head-to-head left-turn alignment on South Orange Avenue.	High	Long	\$\$	Essex Co.	24
6	Conduct a formal speed study to evaluate lowering the speed limit to 25 mph.	Medium	Short	\$\$	Essex Co.	27, 28

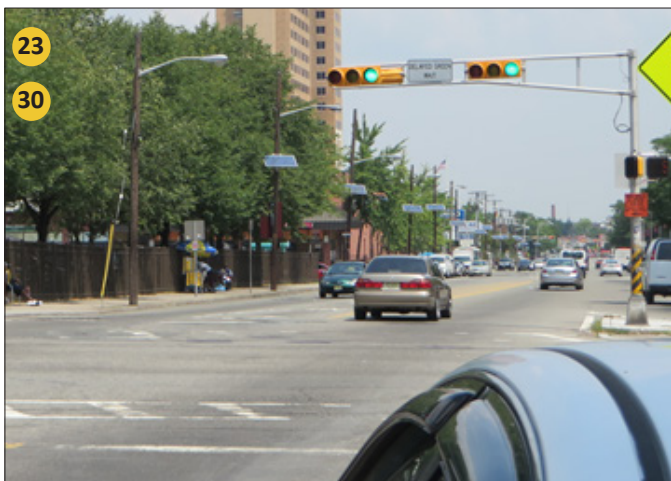
Wide receiving lane with the 2 signal heads may confuse drivers as to how many receiving lanes exist.

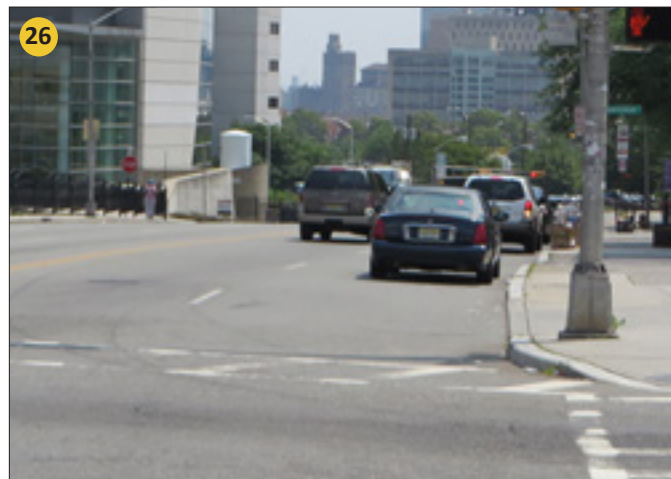
Multiple vehicles were parked in the eastbound travel lane.

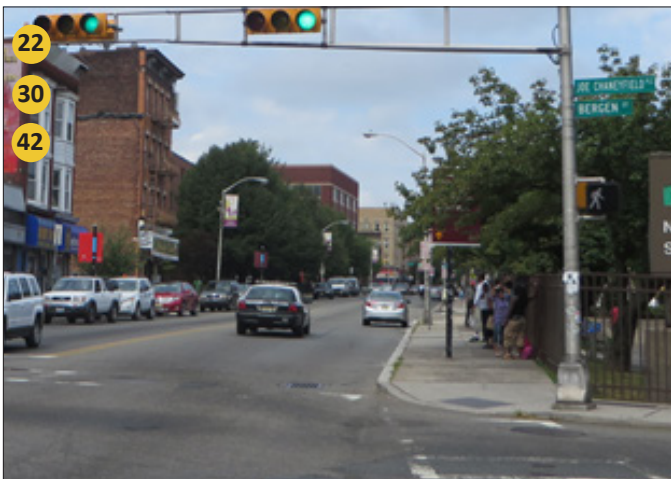
Wide receiving and bus lane is a confusing merge point for motorists. Lack of bus shelters or benches, despite high ridership.

Rec. #	RECOMMENDATIONS LIST	Safety Benefit	Time Frame	Cost	Jurisdiction	Issue Ref. #
23	Consider installing a bike box to coincide with incoming Bergen Street improvements.	Medium	Medium	\$\$	Essex Co.	41
24	Install bicycle-safe inlet grates.	Medium	Short	\$	Essex Co.	41
25	Install bicycle sharrows on the southern approach of Bergen.	Medium	Short	\$	Essex Co.	41
26	Implement a Street Smart campaign.	Medium	Short	\$ / \$\$	Newark	40
Bus Facilities & Operations						
27	Clearly delineate bus stops with hatching pavement marking.	Medium	Medium	\$\$	Newark	42
28	Install bus shelters and other amenities for waiting passengers.	Low	Medium	\$\$	Newark	43
29	Relocate the eastbound bus stop to the far side of the intersection (east leg) [if driveway modifications are made - see #8]	Med/High	Medium	\$\$	NJ Transit & Newark	42
30	Relocate westbound bus stop further west to minimize merge conflicts.	High	Long	\$\$	Newark	42

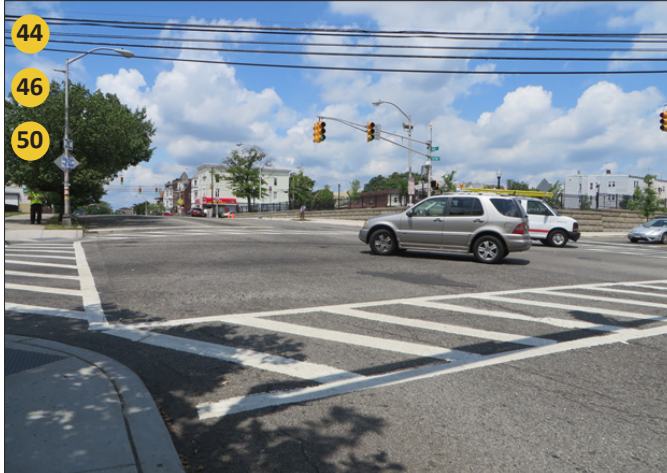
Vertical curve may limit motorist visibility; long crosswalks across Park Avenue; negative offset on Park Avenue.

Rec. #	RECOMMENDATIONS LIST	Safety Benefit	Time Frame	Cost	Jurisdiction	Issue Ref. #
6.3 CLIFTON AVENUE AND PARK AVENUE						
Roadway Operations & Geometry						
1	Consider head-to-head left turns on Park Avenue.	High	Long	\$\$	Essex Co.	46
2	Conduct a road diet study to possibly narrow or reduce lanes on Park Avenue.	Medium	Short	\$\$	Essex Co.	45
3	Install rumble strips on the westbound leg of the Park Avenue hill.	Medium	Medium	\$\$	Essex Co.	44
4	Conduct a traffic study analyzing the turning movements.	Medium	Medium	\$	Essex Co.	46
Pedestrian/Bicyclist Behavior & Facilities						
5	Plan for full ADA compliance by scheduling upgrades of existing ramps and curbs at crosswalks	Medium	Medium	\$\$	Essex Co.	50
6	Consider the installation of pedestrian bulb-outs to shorten crosswalks.	Medium	Med. / Long	\$\$ / \$\$\$	Essex Co.	49
7	Either remove or reorient pedestrian push buttons.	Low	Short	\$	Essex Co.	52

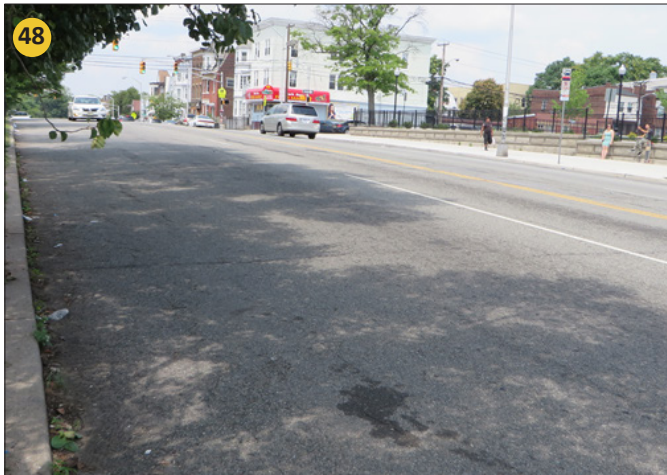
Wide outer lanes (~18') may contribute to increased speeds, especially as the curbside parking spaces seem underutilized; lack of bus shelters or benches.

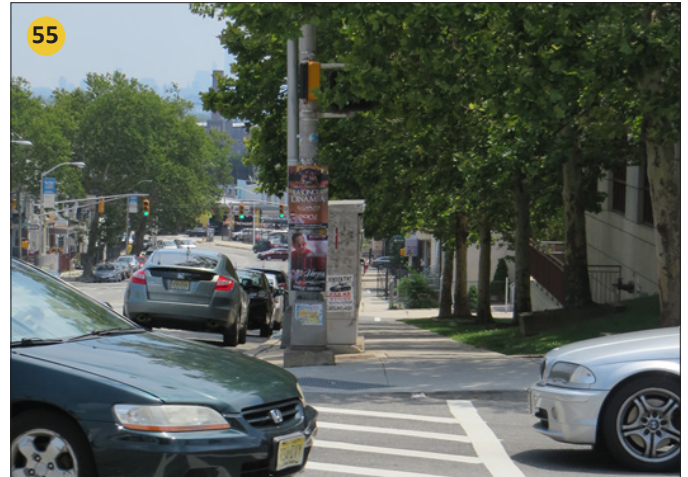
Foliage blocks pedestrian signal head.

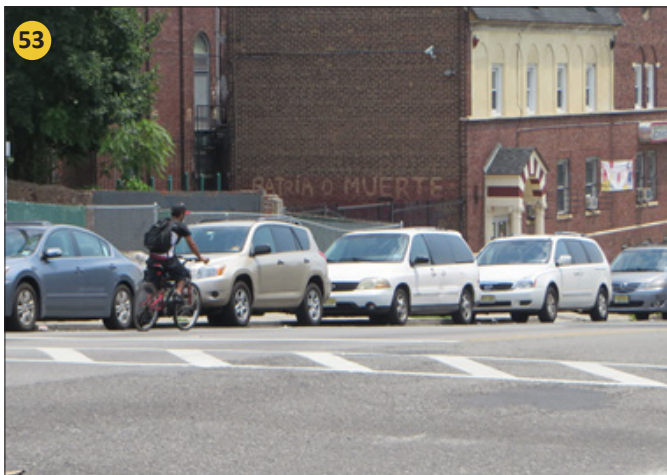
Lack of cyclist facilities.

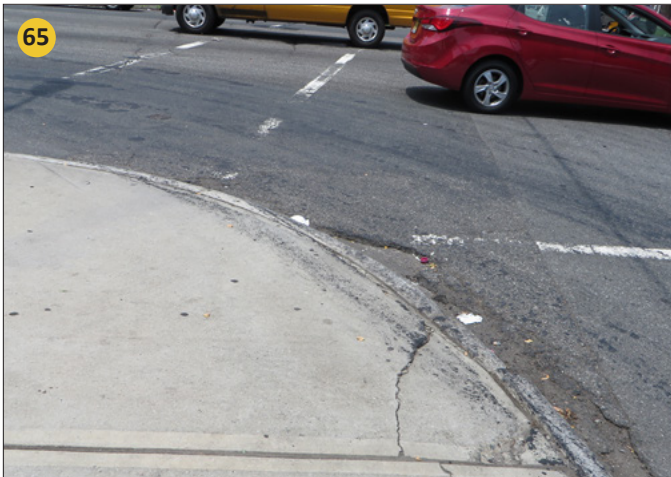
Missing curb cut on northeast corner and missing truncated domes on all corners.

Rec. #	RECOMMENDATIONS LIST	Safety Benefit	Time Frame	Cost	Jurisdiction	Issue Ref. #
6.4 BROADWAY AND 3RD AVENUE						
Roadway Operations & Geometry						
1	Consider installing "No Turn on Red" signage for all approaches.	High	Short	\$	Essex Co.	58
2	Ensure that there is a signal head for each lane.	Medium	Medium	\$\$	Essex Co.	59
3	Conduct a road diet study on Broadway.	Medium	Medium	\$\$	Essex Co.	60
4	Coordinate with law enforcement to minimize illegal parking in the intersection.	Medium	Short	\$	Essex Co.	61
5	Paint edge lines to delineate the travel lane.	Medium	Short	\$	Essex Co.	60
Pedestrian/Bicyclist Behavior & Facilities						
6	Install high-visibility crosswalks.	Medium	Medium	\$\$	Essex Co.	64
7	Implement a Street Smart campaign.	Medium	Short	\$ / \$\$	Newark	62
8	Ensure that all countdown timers are operational.	Medium	Medium	\$\$	Essex Co.	63
9	Plan for full ADA compliance by scheduling upgrades of existing ramps and curbs at crosswalks.	Medium	Medium	\$\$	Essex Co.	65

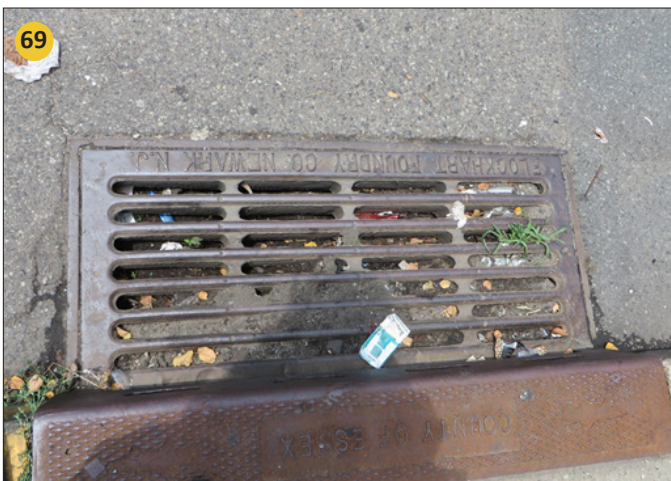
Drainage grate full of debris and is also not bicycle safe.

10	Consider pedestrian bulb-outs to shorten crosswalks.	Medium	Med. / Long	\$\$ / \$\$\$	Essex Co.	66
11	Consider installing a refuge island on Broadway.	Medium	Medium	\$\$	Essex Co.	66
Bus Facilities & Operations						
12	Install bus shelters and other amenities for waiting passengers.	Low	Medium	\$\$	Newark	67
13	Hatch bus stops.	Medium	Medium	\$\$	Essex Co.	68
Maintenance and Other						
14	Perform necessary drainage maintenance and trim overgrown foliage.	Low / Med.	Short	\$	Essex Co.	69
15	Replace inlet grates with bicycle-safe inlet grates.	Medium	Short	\$\$	Essex Co.	69

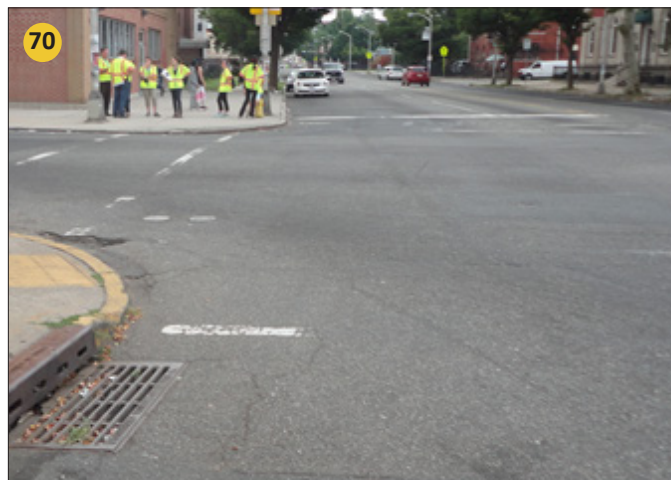
Faded pavement markings; crosswalks not high visibility.

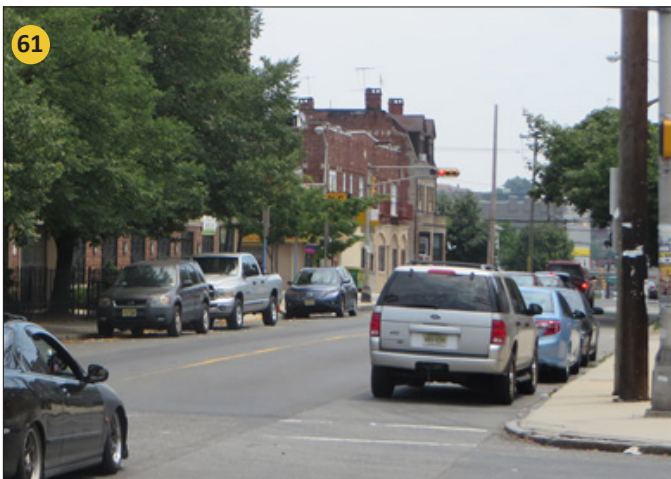
Motorists park too close to intersection, inhibiting sight distance.

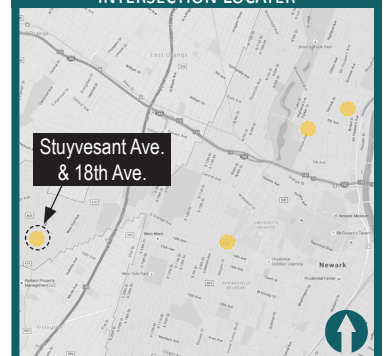
STUYVESANT AVENUE AND 18TH AVENUE—CRASH SUMMARY (2011–2013)

Crash Type	#
Same Direction – Rear End	6
Same Direction – Side Swipe	4
Right Angle	12
Opposite Direction – Head On/ Angular	6
Opposite Direction – Side Swipe	1
Struck Parked Vehicle	3
Left Turn / U-Turn	4
Backing	-
Encroachment	-
Overtaken	-
Fixed Object	-
Animal	-
Pedestrian	5
Pedalcyclist	-
Non-fixed Object	-
Railcar – Vehicle	-
Other	-
Total	41

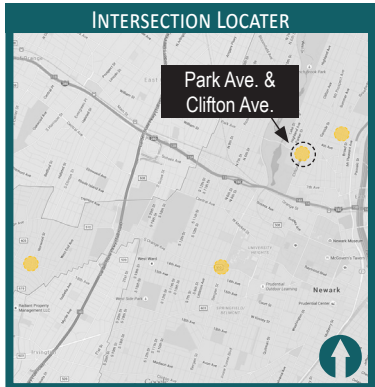
CLIFTON AVENUE AND PARK AVENUE—CRASH SUMMARY (2011–2013)

Crash Type	#
Same Direction – Rear End	7
Same Direction – Side Swipe	4
Right Angle	8
Opposite Direction – Head On/ Angular	-
Opposite Direction – Side Swipe	-
Struck Parked Vehicle	2
Left Turn / U-Turn	9
Backing	1
Encroachment	-
Overtuned	-
Fixed Object	-
Animal	-
Pedestrian	4
Pedalcyclist	-
Non-fixed Object	-
Railcar – Vehicle	-
Other	-
Total	35

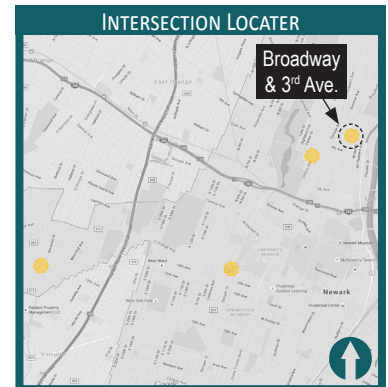
BROADWAY AND 3RD AVENUE—CRASH SUMMARY (2011–2013)

Crash Type	#
Same Direction – Rear End	7
Same Direction – Side Swipe	7
Right Angle	5
Opposite Direction – Head On/ Angular	-
Opposite Direction – Side Swipe	-
Struck Parked Vehicle	4
Left Turn / U-Turn	4
Backing	-
Encroachment	-
Overtaken	-
Fixed Object	-
Animal	-
Pedestrian	10
Pedalcyclist	-
Non-fixed Object	-
Railcar – Vehicle	-
Other	-
Total	37
