Freehold Borough Road Safety Audit

Intersection Safety at CR 24 (Manalapan Avenue) and Broad Street

Final Report August 2017

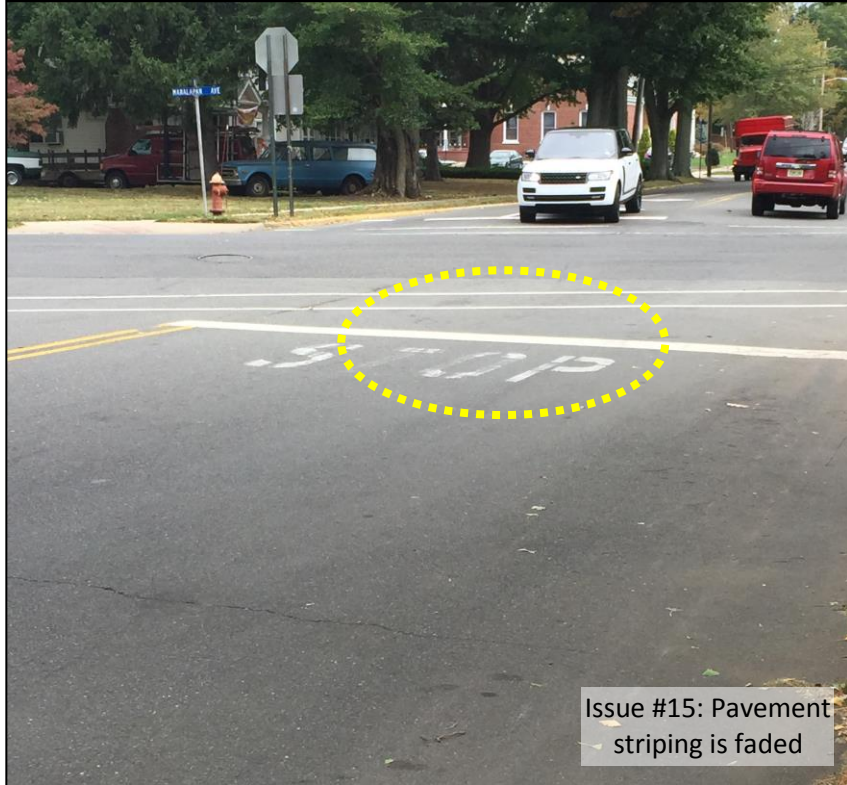
Broad Street Approaching the Intersection from the South

Issue #15: Pavement striping is faded

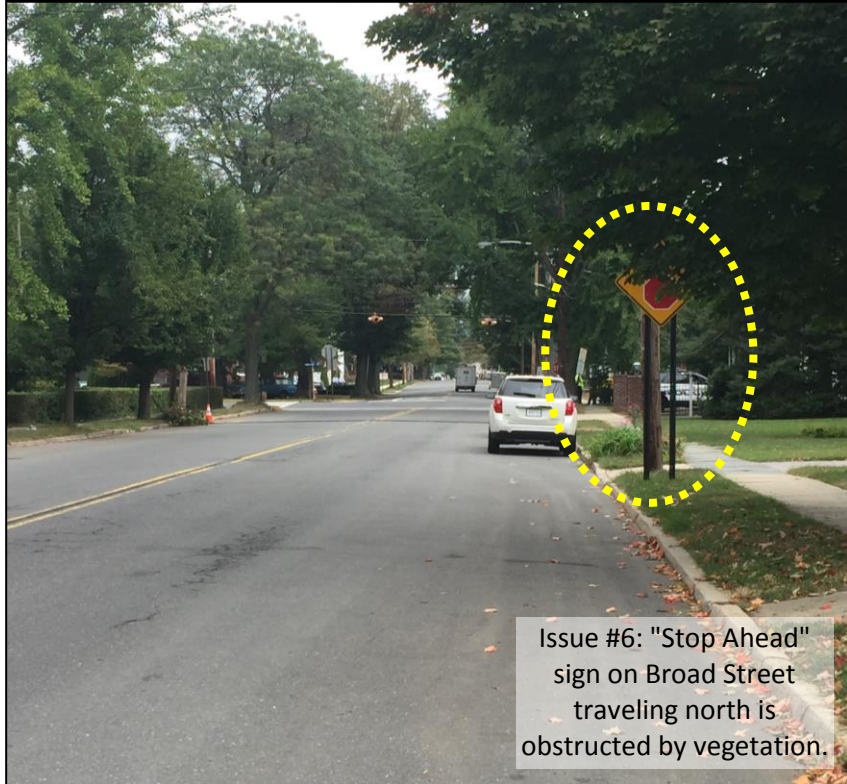
Broad Street Approaching the Intersection from the South

Issue #6: "Stop Ahead" sign on Broad Street traveling north is obstructed by vegetation.

10	Street lighting maintenance is needed.	Medium	Short	\$	10
11	Trim the vegetation on the south side of the intersection to improve sight distance.	High	Short	\$	9
12	Trim the vegetation obstructing the "Stop Ahead" sign on Broad Street traveling north.	Medium/High	Short	\$	6
13	Add retro reflective sheeting to sign posts.	Low	Short	\$	3, 8
Geometry and Infrastructure					
14	Consider a traffic calming treatment such as bump outs/curb extensions to increase pedestrian visibility and reduce their exposure to drivers.	Medium/High	Long	\$\$\$	4, 23, 13

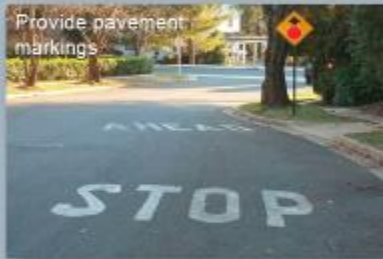
Recommended Safety Improvements at Unsignalized Intersections (by FHWA)

- Clear sight distance
- Larger regulatory and warning signs
- Supplementary stop signs mounted over the roadway
- Double stop signs and/or flashing beacons
- Pavement markings
- Traffic calming at the intersection approaches and intersection through a combination of geometrics and traffic control devices
- Signalization at intersections
- Roundabouts

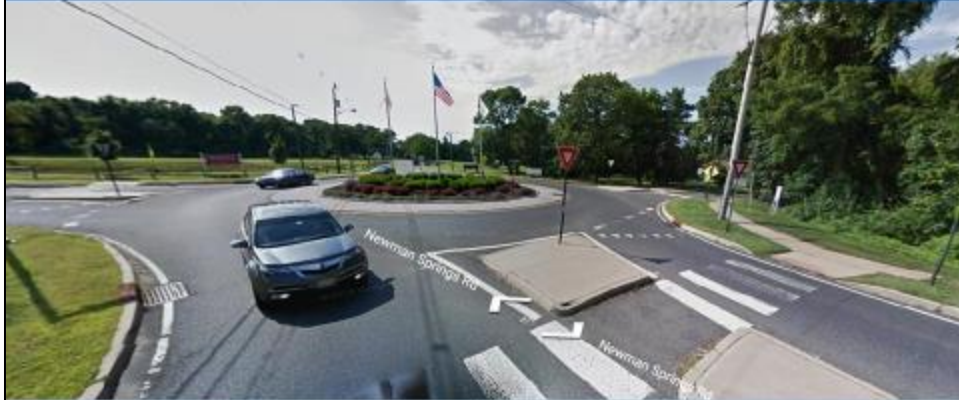
Proven Safety Countermeasure: Roundabouts

Yield at Entry:

- Entering traffic yields right-of-way to circulating traffic

Deflection:

- Entry and center island of roundabout deflects and slows entering traffic
