# MAIN STREET/CR 533

## ROAD SAFETY AUDIT

### Manville, Somerset County, New Jersey

>> August 2015

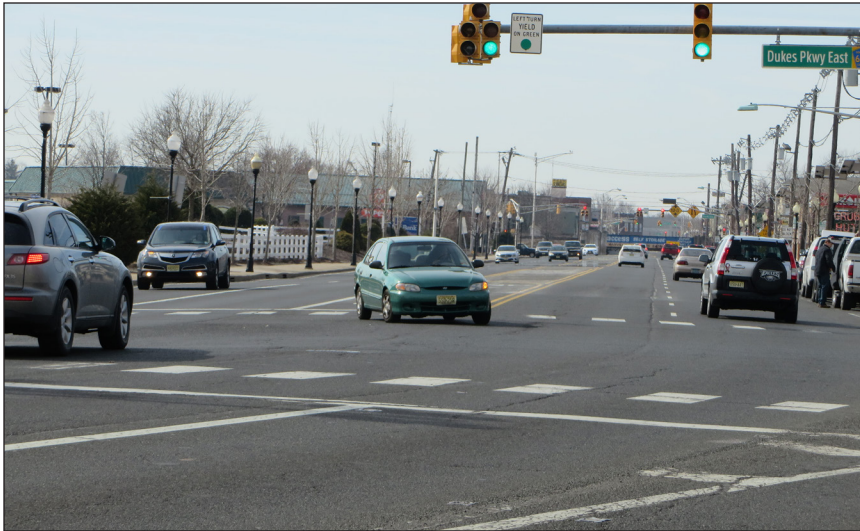
Figure 20 – Cross section north

The cross section between Dukes Parkway and Brooks Boulevard is approximately 70 feet wide. It has two lanes in each direction with left turn lanes or hatched median. There is parking on the west side of roadway.

The cross section north of Roosevelt Boulevard to the LVRR bridge is approximately 48 feet wide. It has one lane in each direction with left turn lanes or hatched median. There is parking on both sides of the roadway.

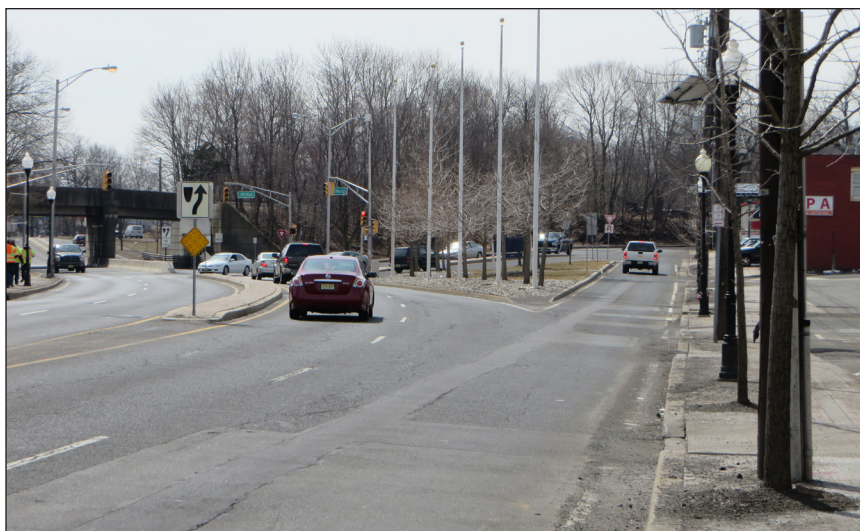
Figure 22 – Cross section south

The cross section in the southern part of the RSA corridor is approximately 48 feet wide, north of the jughandle, and 54 feet wide in the area of the jughandle, with a concrete median. It has two lanes in each direction. There is no parking.

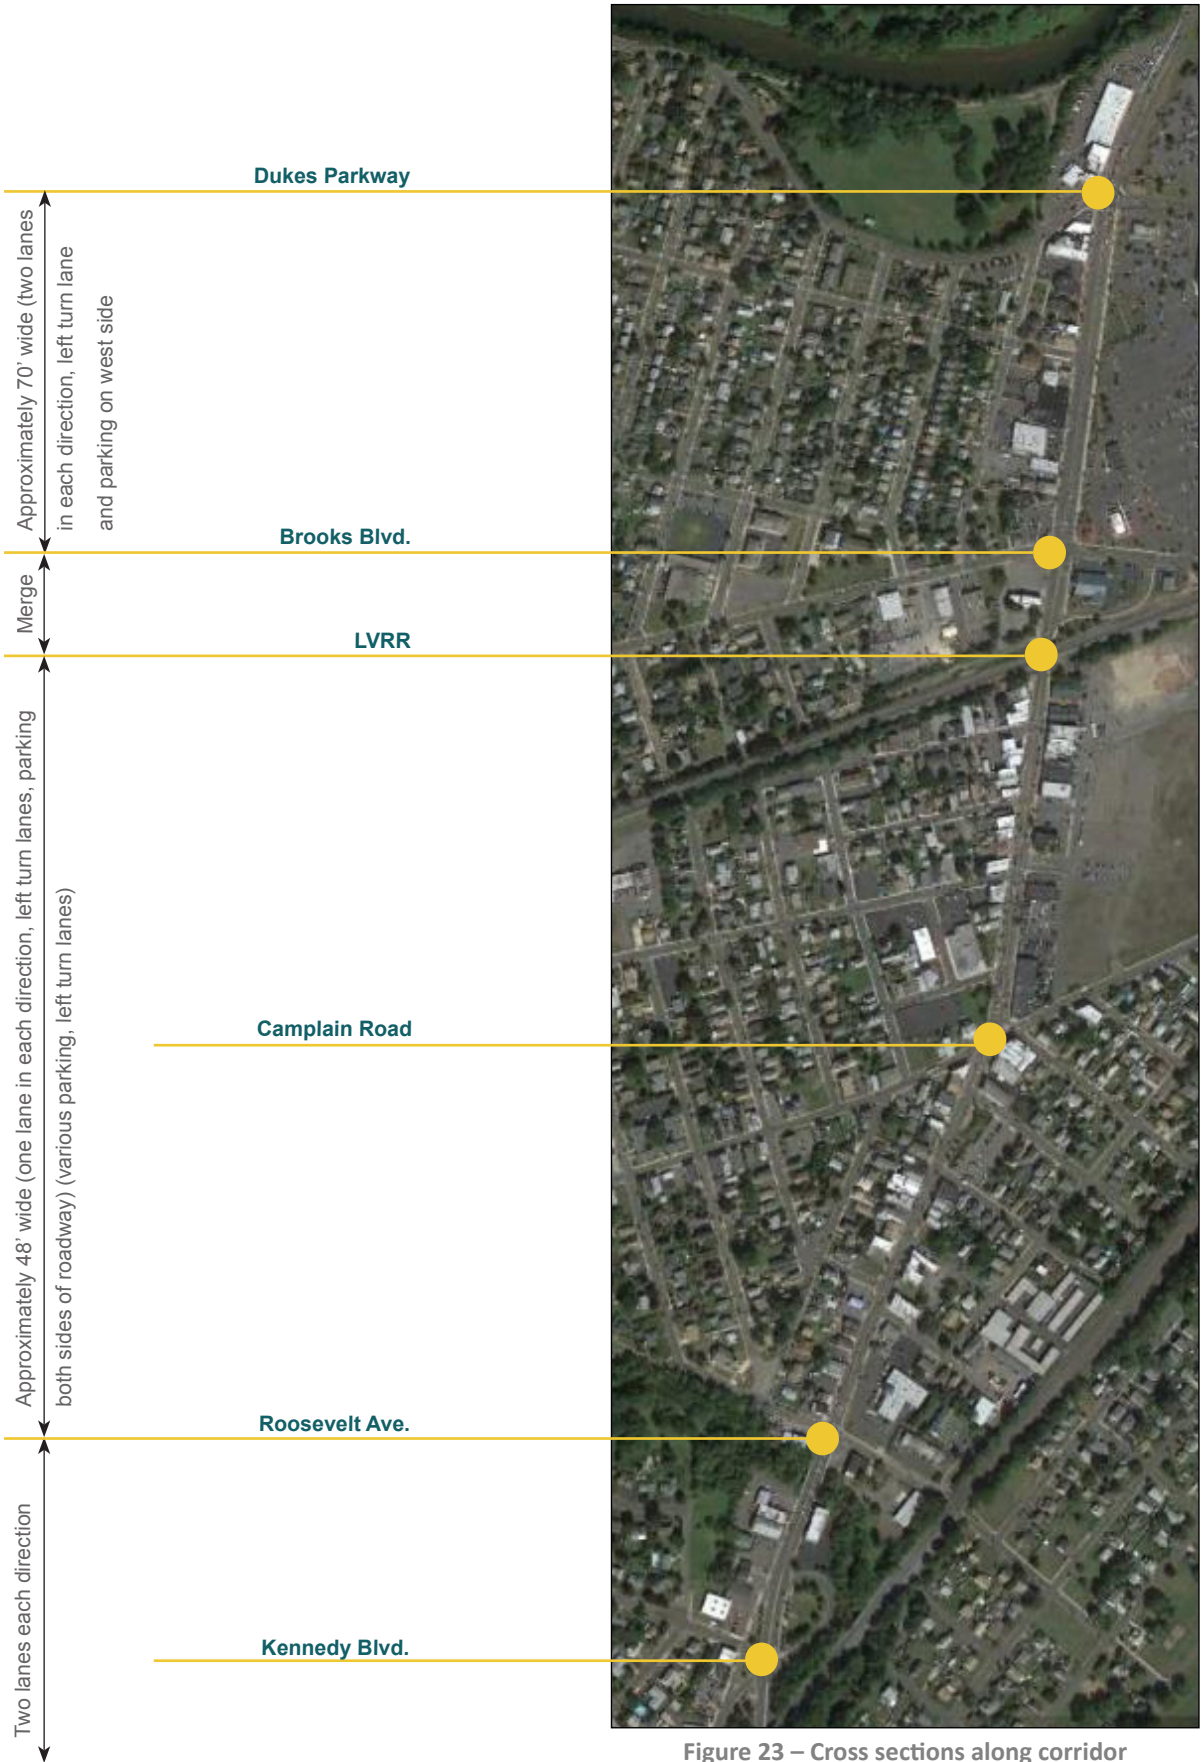
Figure 23 – Cross sections along corridor

# Cross Sections – RSA Corridor, Existing Conditions

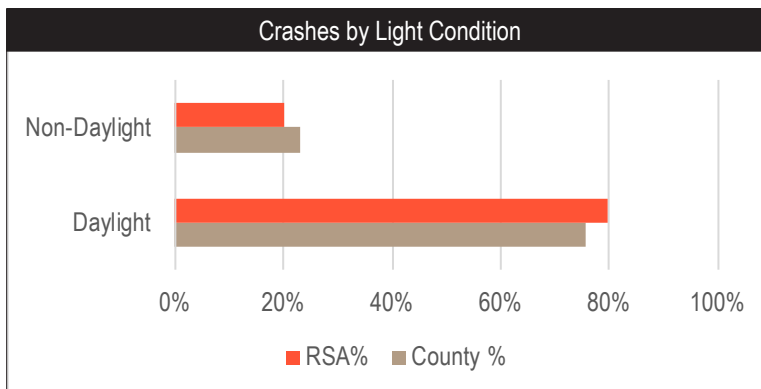
Figure 28 – Crashes by light condition

Light conditions do not appear to be a significant factor in the crash history.

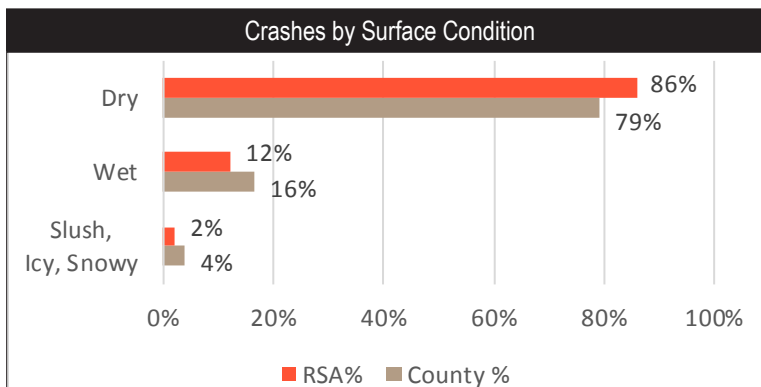
Figure 29 – Crashes by surface condition

The surface conditions do not appear to be a significant factor in the crash history.

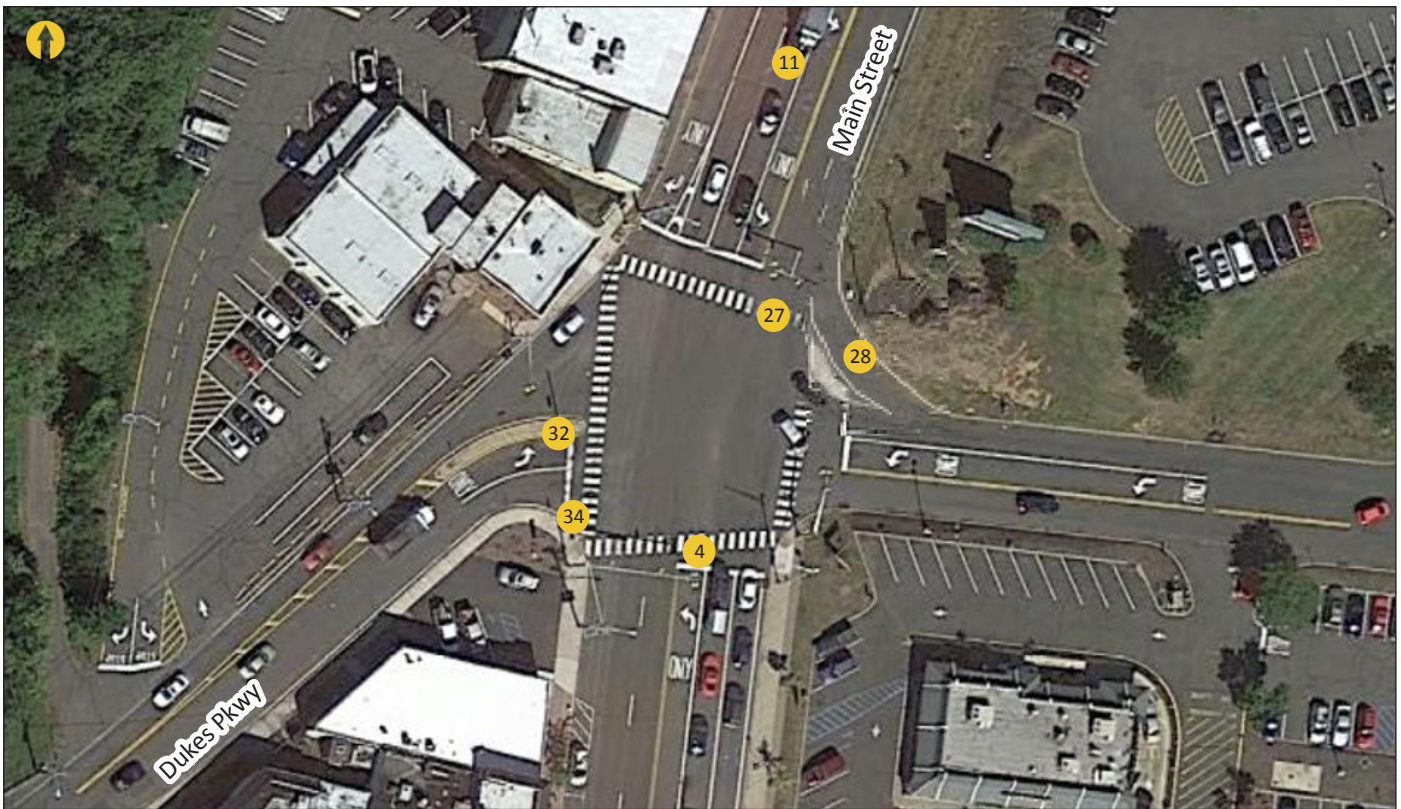
The median island on west leg is an obstacle for turning radius

Many trucks need a wide turning radius

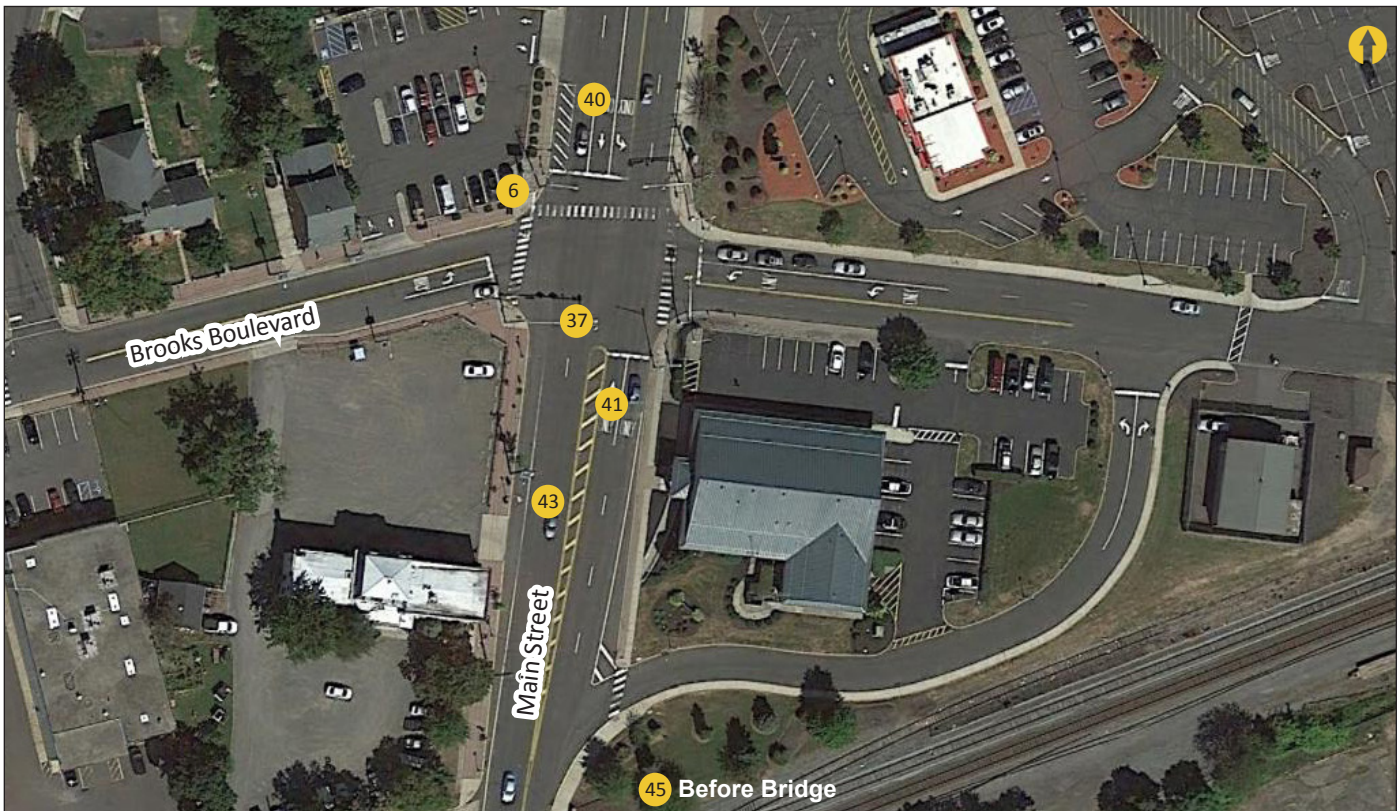
Some northbound drivers make prohibited left turn

Pedestrian push button located too far from crosswalk

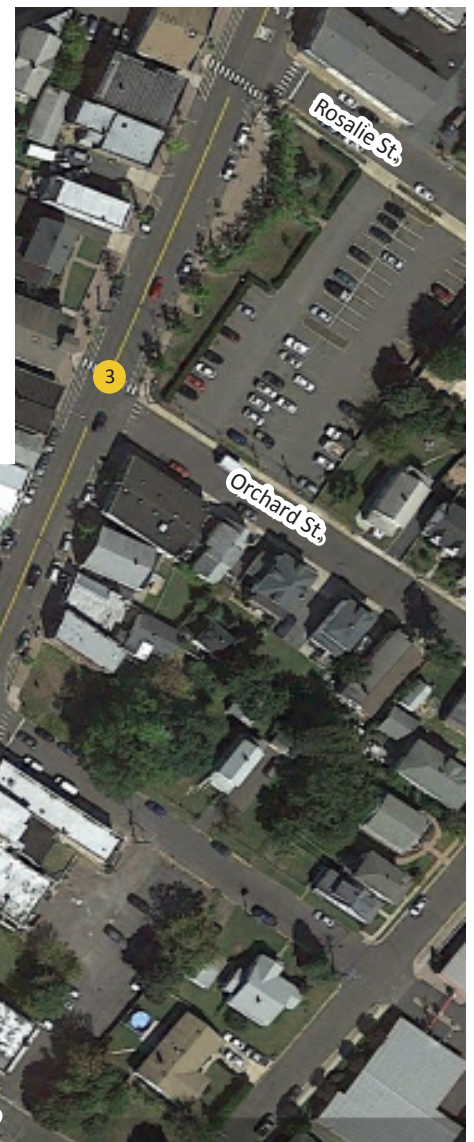
Difficult for pedestrians to cross at the unsignalized intersections

There were two pedcyclist crashes at North Street
