# **New Brunswick Train Station – Road Safety Audit**

## **FINAL REPORT**

October 2013

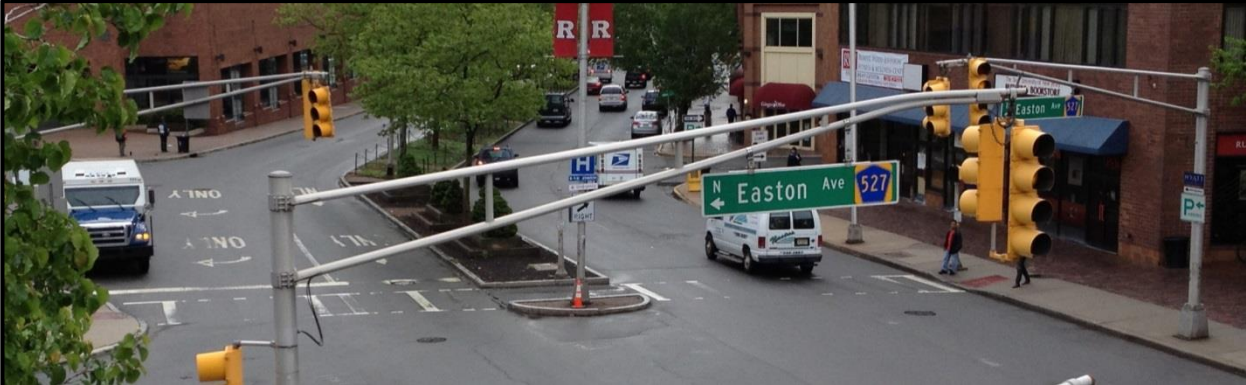
Issue: Roadway Markings	Safety Risk	
<p><b>Description:</b> Many of the roadway markings are either faded or weren't replaced when pavement repair was made.</p>	<p>Medium/High</p>

RSA Team's Recommendation	Cost	Potential Safety Benefit
<p>Regular maintenance should ensure that the roadway markings are clearly visible to pedestrians and vehicles. (1)</p>	<p>Low</p>	<p>Medium/High</p>
<p>Installation of retro-reflective pavement markings would significantly increase visibility. (2)</p>	<p>Low</p>	<p>Medium/High</p>

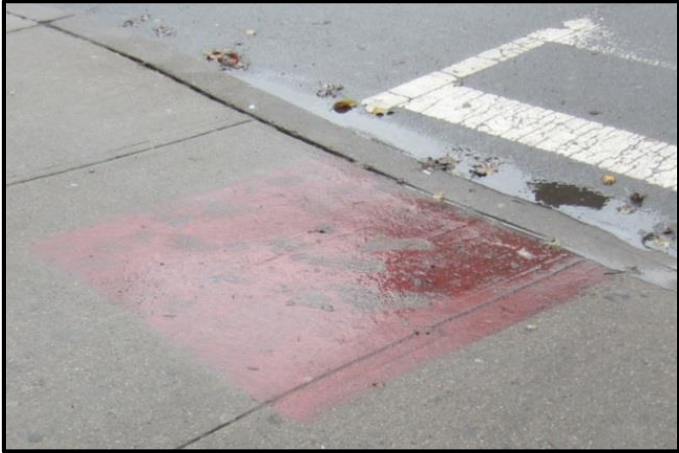
Issue: ADA Compliance	Safety Risk	
<b>Description:</b> Pedestrian accommodations, such as ramps and detectable warning surfaces, are not fully ADA compliant.	Medium

RSA Team's Recommendation	Cost	Potential Safety Benefit
Plan for full ADA compliance by scheduling upgrades of existing ramps and curbs at crosswalks. (3)	Medium	Medium

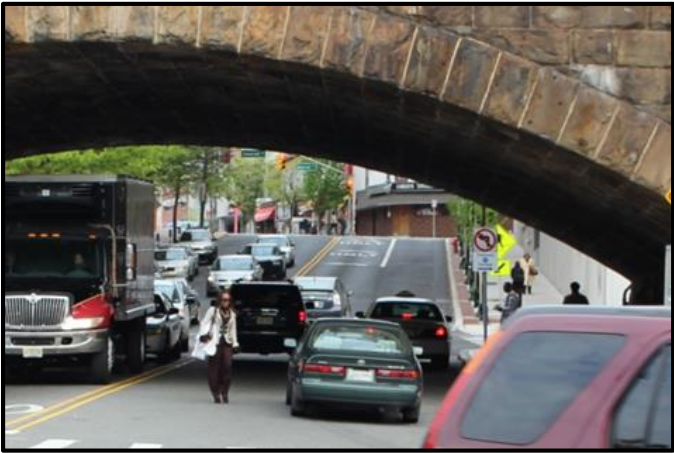
Issue: Pedestrian Behavior	Safety Risk	
<b>Description:</b> Pedestrians were observed not using the pedestrian facilities, sidewalks, and crosswalks.	High

RSA Team's Recommendation	Cost	Potential Safety Benefit
Improve pedestrian crossings to encourage pedestrians to cross in marked crosswalks. (4)	Medium/Low	Medium

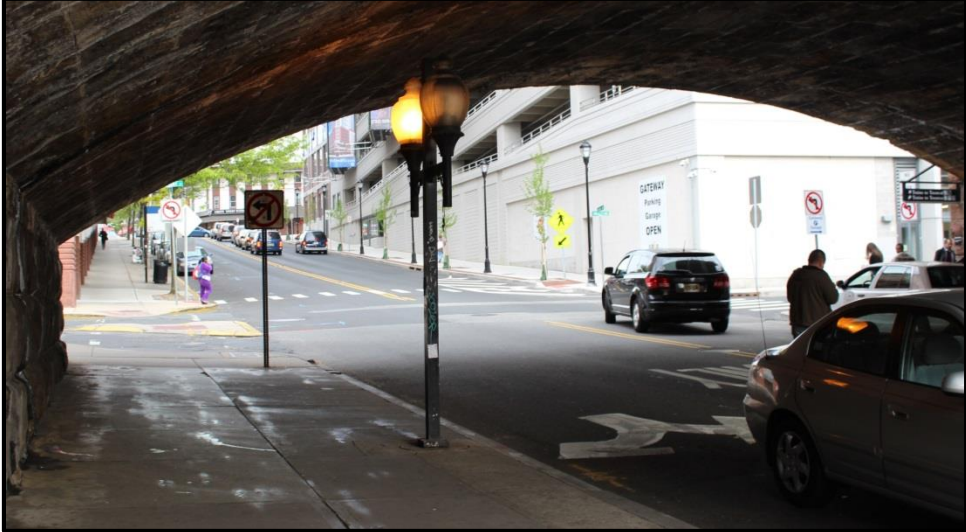
Issue: Lighting	Safety Risk	
<p><b>Description:</b> Lighting was inconsistent, not uniform, and may not address the nighttime visibility needs of both pedestrians and vehicles.</p>	<p>Medium/High</p>

RSA Team's Recommendation	Cost	Potential Safety Benefit
<p>Professional staff should conduct a formal engineering review of existing lighting conditions to evaluate where both vehicle and pedestrian level lighting can be enhanced. (5)</p>	<p>Medium</p>	<p>Medium/High</p>

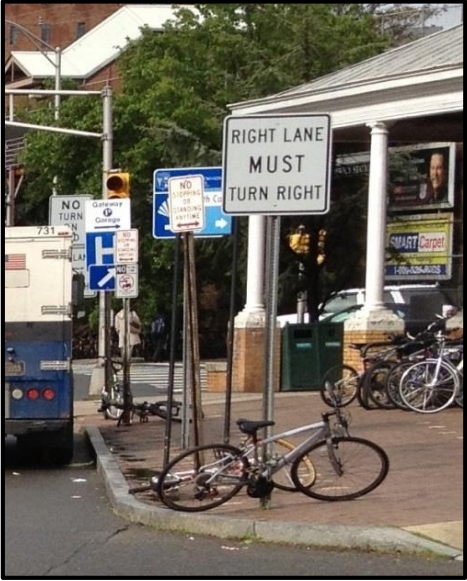
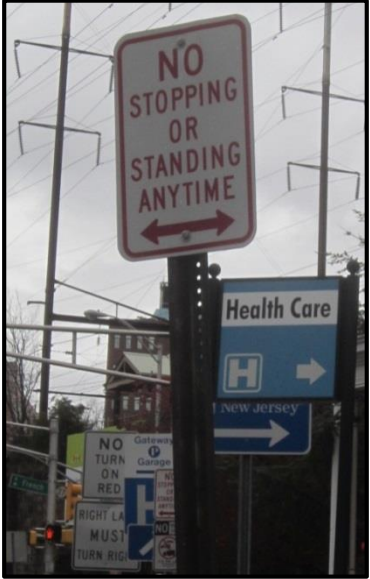
Issue: Signs	Safety Risk	
<p><b>Description:</b> The abundance of signs creates confusion for drivers and pedestrians.</p>	<p>Medium/High</p>

RSA Team's Recommendation	Cost	Potential Safety Benefit
<p>Professional engineering staff should conduct a thorough evaluation of existing and required signage to reduce the amount of signage in the intersection and decrease sign clutter. (6)</p>	<p>Low</p>	<p>Medium/High</p>

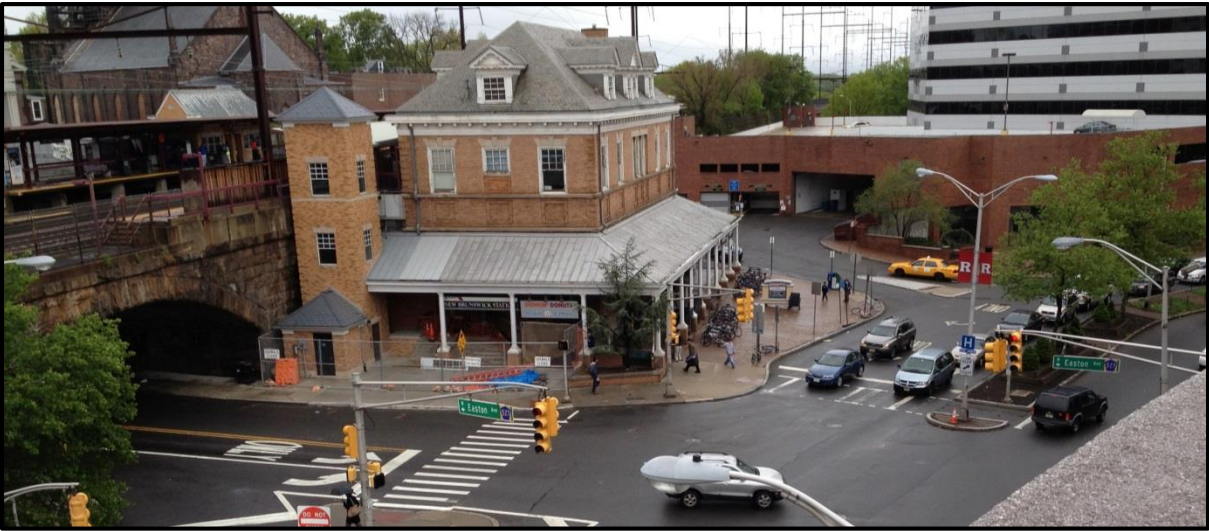
Issue: Train Station Drop-off and Pick-up	Safety Risk	
<p><b>Description:</b> There are a few unofficial “Kiss-and-Ride” drop-off/pick-up areas in the vicinity of the train station, under the bridge on Easton Avenue and in front of the station on Albany Street. None of these locations have signage or roadway markings to officially designate them for this purpose.</p>	Medium	
<p><b>Description:</b> The area in front of the train station on Albany Street has a “NO STOPPING” sign, yet it is unofficially being used as a pick-up and drop-off area.</p>	Medium

RSA Team’s Recommendation	Cost	Potential Safety Benefit
<p>Professional engineering staff should conduct a thorough evaluation of the train station traffic, including passenger pick-up and drop-off points and locations for taxi stands and private passenger vehicles. (7)</p>	Low	Medium
<p>Evaluate creating a dedicated taxi stand and installing signage in the area under the bridge at northbound Easton Avenue. (10)</p>	Low	Medium

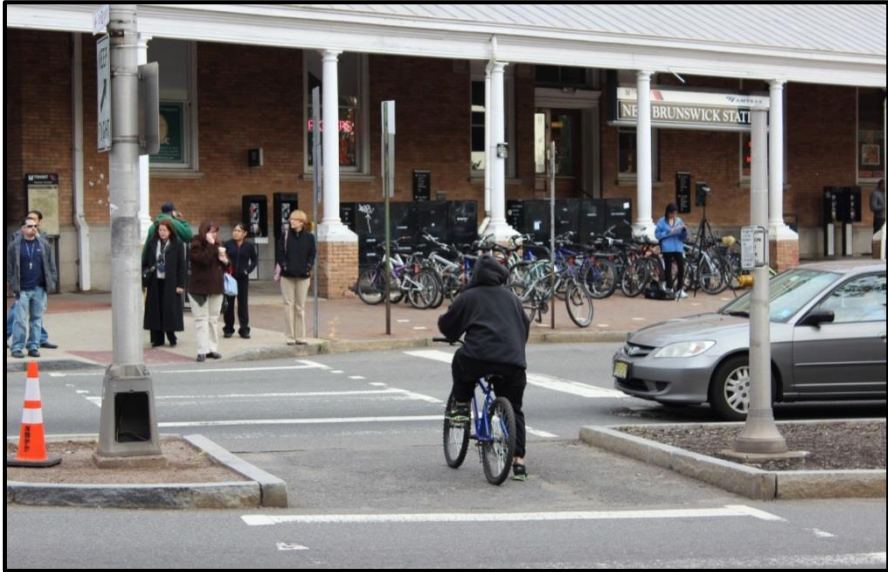
Issue: Bicycles	Safety Risk	
<b>Description:</b> There are no designated accommodations for bicycle travel in the area around the train station.	Medium/High

RSA Team's Recommendation	Cost	Potential Safety Benefit
Professional engineering staff should do a full evaluation of bicycle travel in the area around the train station to complement the New Brunswick Bike Lane project. (8) <b>See bikeway map:</b> <a href="http://thecityofnewbrunswick.org/planninganddevelopment/files/Bike-Lanes-2012-20131.pdf">http://thecityofnewbrunswick.org/planninganddevelopment/files/Bike-Lanes-2012-20131.pdf</a>	Low	Medium/High

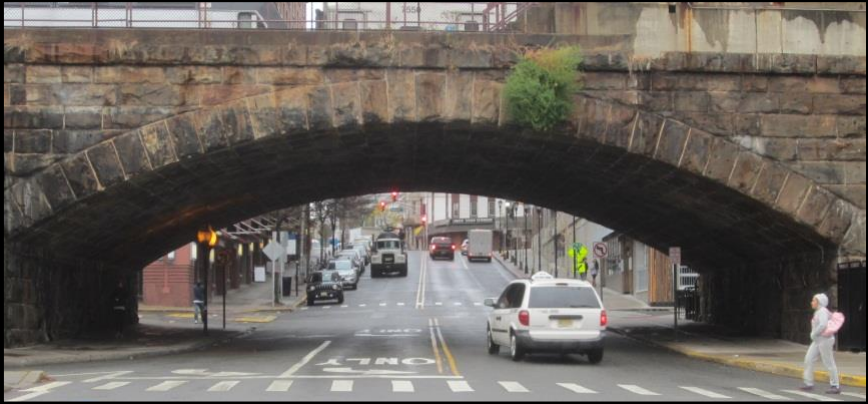
Issue: Lighting (Easton/Albany)	Safety Risk	
<p><b>Description:</b> Lighting is inconsistent and not uniform under the railroad bridge, and may not address the nighttime visibility needs of both pedestrians and vehicles.</p>	<p>Medium/High</p>

RSA Team's Recommendation	Cost	Potential Safety Benefit
<p>Professional staff should conduct a formal engineering review of existing lighting conditions to evaluate where both vehicle and pedestrian level lighting can be enhanced. (5)</p>	<p>Medium</p>	<p>Medium/High</p>

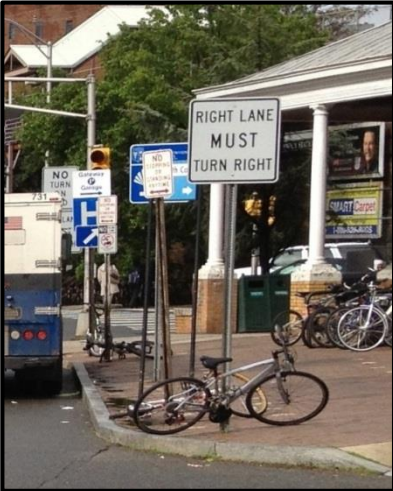
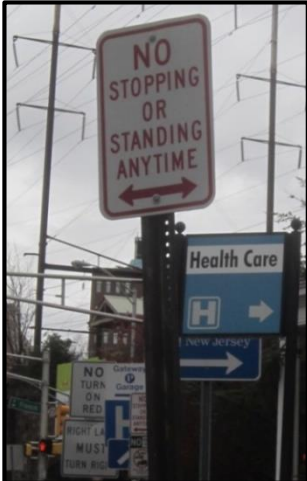
Issue: Signage (Easton/Albany)	Safety Risk	
<p><b>Description:</b> The abundance of signs in front of the train station creates confusion for drivers and pedestrians.</p>	<p>Medium/High</p>

RSA Team's Recommendation	Cost	Potential Safety Benefit
<p>Professional engineering staff should conduct a thorough evaluation of existing and required signage to reduce the amount of signage in the intersection and decrease sign clutter. (6)</p>	<p>Low</p>	<p>Medium/High</p>

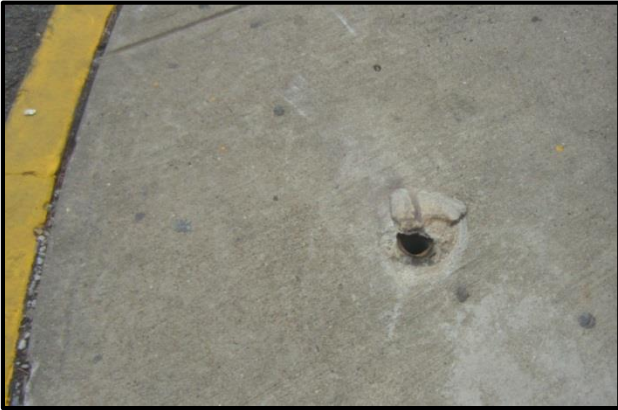
Issue: Pole (Easton/Albany)	Safety Risk	
<p><b>Description:</b> An unused broken pole is located in the island curb ramp (on right turn from Easton Avenue to southbound Albany Street).</p>	<p>Low</p>

RSA Team's Recommendation	Cost	Potential Safety Benefit
<p>Consider removing the unused broken pole in the island curb ramp (from Easton Avenue to southbound Albany Street). (9)</p>	<p>Low</p>	<p>Low</p>

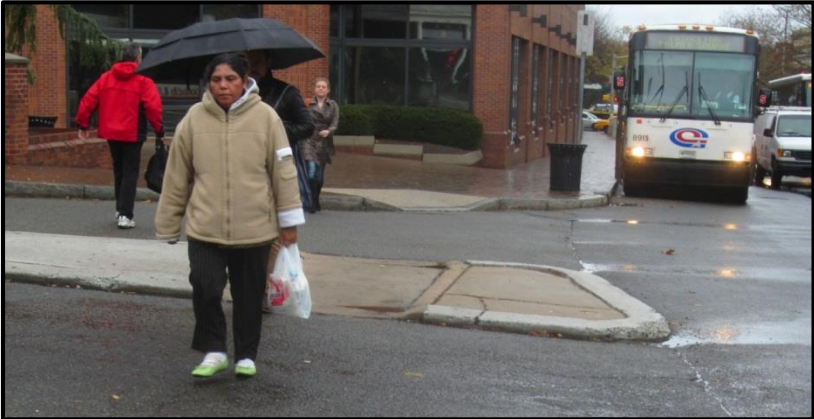
Issue: Crosswalk (Easton/Albany)	Safety Risk	
<b>Description:</b> There are many pedestrians crossing the "Kiss-and-Ride" driveway, on Albany Street southbound to and from the train station, but there is no marked crosswalk at that location.	Medium/High

RSA Team's Recommendation	Cost	Potential Safety Benefit
Consider installation of a marked crosswalk across the "Kiss-and-Ride" driveway on southbound Albany Street. (12)	Low	Medium/High

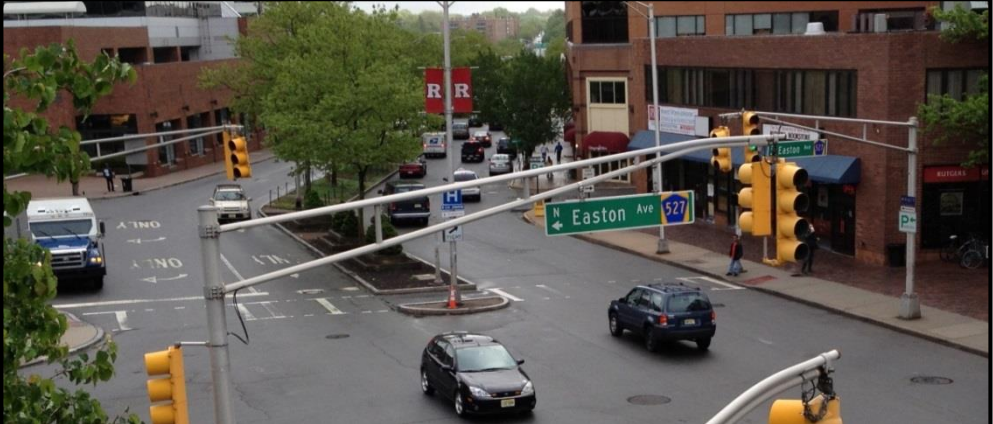
Issue: Roadway Markings (Easton/Albany)	Safety Risk	
<p><b>Description:</b> Many of the roadway markings and striped crosswalks on Albany Street and Easton Avenue are faded and not clearly visible to vehicles and pedestrians.</p>	<p>Medium/High</p>

RSA Team's Recommendation	Cost	Potential Safety Benefit
<p>Regular maintenance will ensure that the roadway markings are clearly visible to pedestrians and vehicles. (1)</p>	<p>Low</p>	<p>Medium/High</p>
<p>Installation of retro-reflective pavement markings would significantly increase visibility. (2)</p>	<p>Low</p>	<p>Medium/High</p>

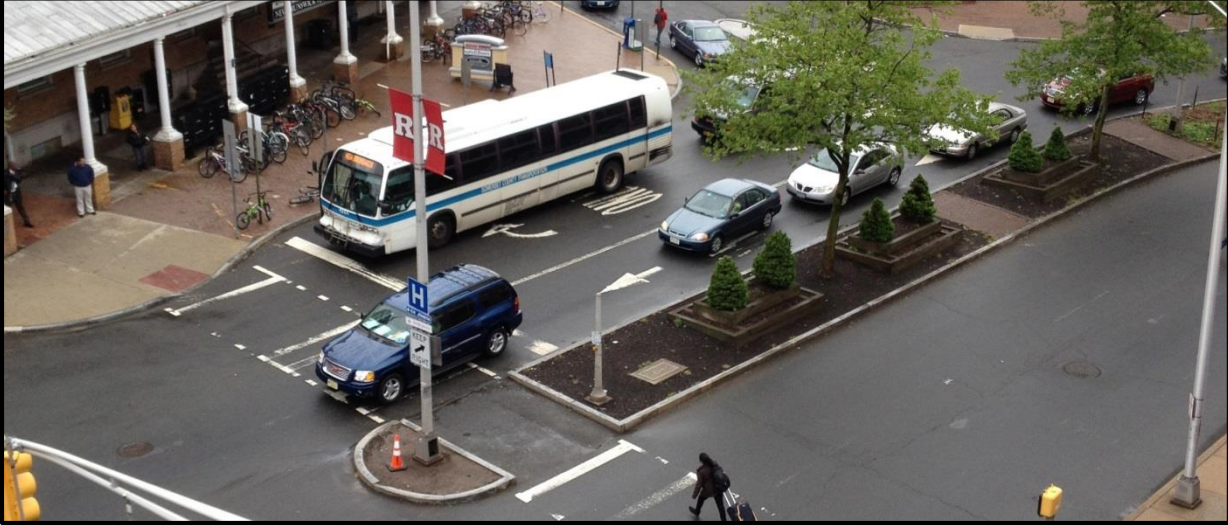
<b>Issue: Midblock Crossing (Easton/Albany)</b>	<b>Safety Risk</b>	
<b>Description:</b> Pedestrians were observed not using the pedestrian facilities, sidewalks, and crosswalks on both Albany Street and Easton Avenue.	Medium/High

<b>RSA Team's Recommendation</b>	<b>Cost</b>	<b>Potential Safety Benefit</b>
Improve pedestrian crossings to encourage pedestrians to cross in marked crosswalks. (4)	Medium/Low	Medium/High
Evaluate unofficial crossing locations in the median on Albany Street and consolidate or eliminate them, if possible.(13)	Low	Medium/High

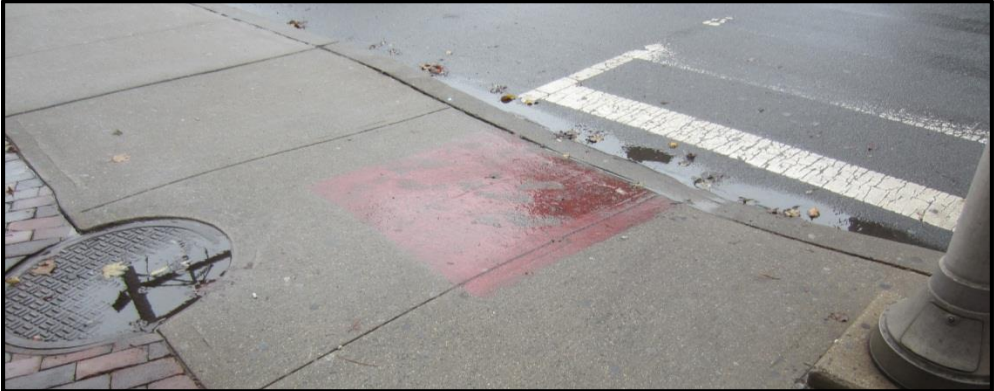
Issue: Pedestrian Accommodations (Easton/Albany)	Safety Risk	
<b>Description:</b> Pedestrian accommodations, such as ramps and detectable warning surfaces, are not fully ADA compliant.	Medium	
<b>Description:</b> There is a raised junction box in the northwest corner, adjacent to the ramp that poses a tripping hazard.	Medium/Low

RSA Team's Recommendation	Cost	Potential Safety Benefit
Plan for full ADA compliance by scheduling upgrades of existing ramps and curbs at crosswalks. (3)	Medium	Medium
Consider resetting or relocating the junction box. (14)	Low	Medium

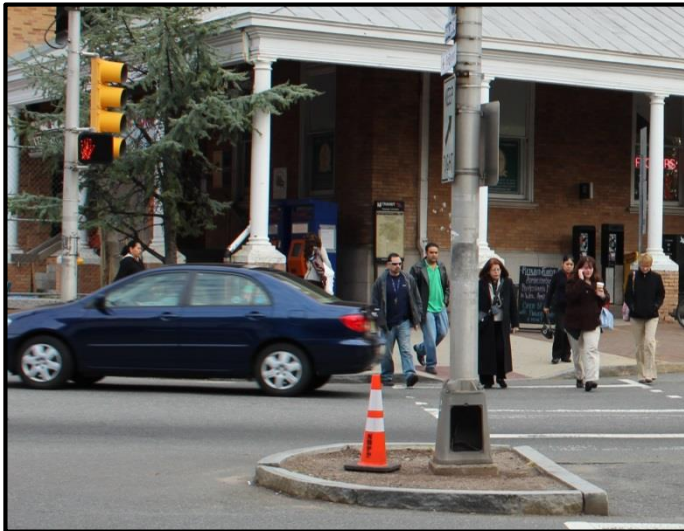
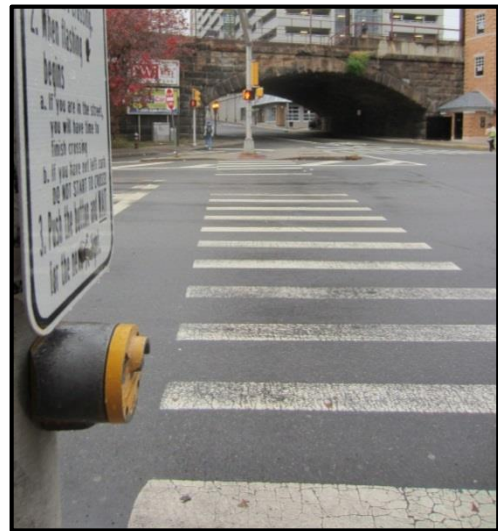
Issue: Pedestrian Buttons (Easton/Albany)	Safety Risk
<b>Description:</b> Pedestrians are required to press a button to activate a walk signal to cross Albany Street.	Medium/High
<b>Description:</b> There is a high volume of pedestrians at this intersection and many were not utilizing the buttons.	Medium/High
<b>Description:</b> Pedestrian buttons are not properly aligned in accordance with ADA requirements.	Medium

RSA Team's Recommendation	Cost	Potential Safety Benefit
To accommodate the high pedestrian volume, consider operating the signal in fixed time or utilizing pedestrian recall and removing pedestrian buttons. (19)	Low	Medium
Schedule realignment of the pedestrian buttons to conform to the 2009 MUTCD requirements. (20)	Low	Medium/Low

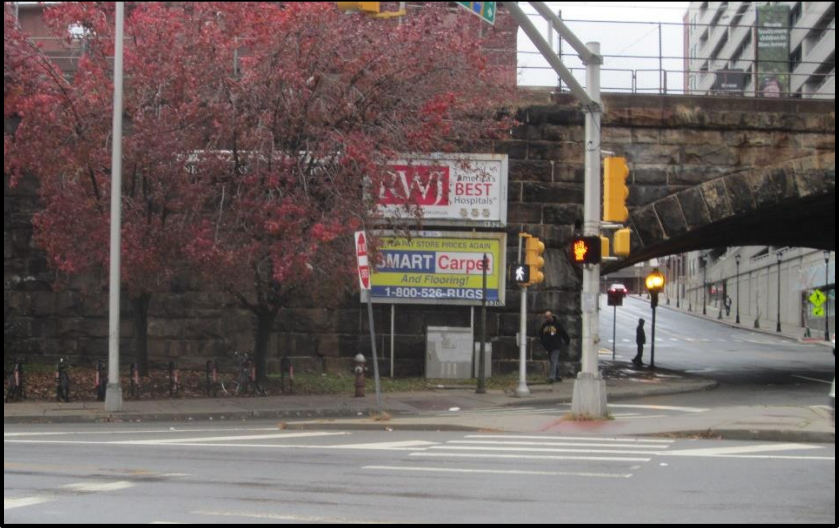
Issue: Pedestrian Heads (Easton/Albany)	Safety Risk	
<p><b>Description:</b> Pedestrians crossing Albany Street from the southwest corner, see a walk signal adjacent to the ramp, although the pedestrian head for their crosswalk displays “DON’T WALK.”</p>	Medium/High	
<p><b>Description:</b> Pedestrian heads are not located in the direct line of sight of pedestrians using the crosswalks.</p>	Medium

RSA Team’s Recommendation	Cost	Potential Safety Benefit
<p>Plan to realign and/or limit visibility of the walk signal so pedestrians do not receive conflicting information. (18)</p>	Low	Medium/High
<p>Review the alignment of the pedestrian heads with the crosswalks and sidewalks. (21)</p>	Low	Medium/Low

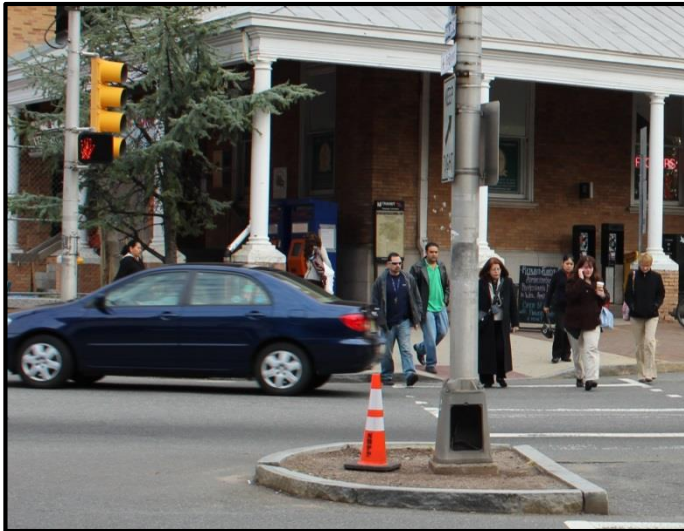
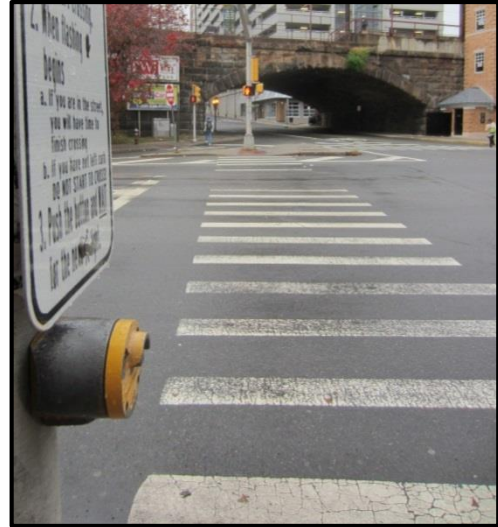
Issue: Pedestrian Timing/Phasing (Easton/Albany)	Safety Risk
<b>Description:</b> Crossing times may be inadequate under the 2009 edition of the MUTCD.	Medium/High
<b>Description:</b> The signal phasing for pedestrians crossing Albany Street is not intuitive and consequently, pedestrians frequently cross illegally against the left turning traffic from Easton Avenue to Albany Street northbound.	Medium/High

RSA Team's Recommendation	Cost	Potential Safety Benefit
Ensure crossing times are compliant with the 2009 edition of the MUTCD. (15)	Low	Medium/High
Consider rephasing signal timing so that the walk signal across the easterly Albany Street crosswalk comes before the left turn from Easton Avenue southbound to Albany Street northbound. (16)	Low	High
Evaluate adding an all-red, all-way pedestrian crossing at the intersection. (17)	Low	High
To accommodate pedestrian volume, consider operating the signal in fixed time or utilizing pedestrian recall and remove pedestrian buttons. (19)	Low	Medium

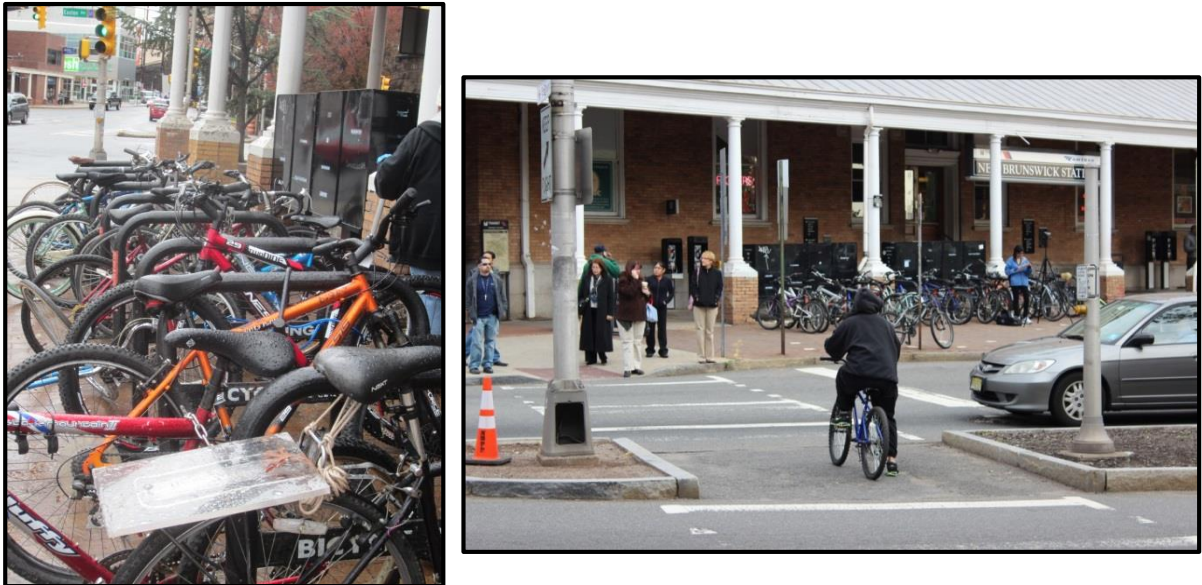
Issue: Bicycles (Easton/Albany)		Safety Risk
<b>Description:</b> There are no designated accommodations for bicycle travel in the area around the train station.		Medium/High
<b>Description:</b> There are insufficient accommodations for bicycle parking adjacent to the train station.		Low/Medium

RSA Team's Recommendation	Cost	Potential Safety Benefit
Professional engineering staff should do a full evaluation of bicycle travel in the area around the train station to complement the New Brunswick Bike Lane project.(8) <b>See bikeway map:</b> <a href="http://thecityofnewbrunswick.org/planninganddevelopment/files/Bike-Lanes-2012-20131.pdf">http://thecityofnewbrunswick.org/planninganddevelopment/files/Bike-Lanes-2012-20131.pdf</a>	Low	Medium/High
Consider the installation of additional bicycle parking. (22)	Low	Low/Medium

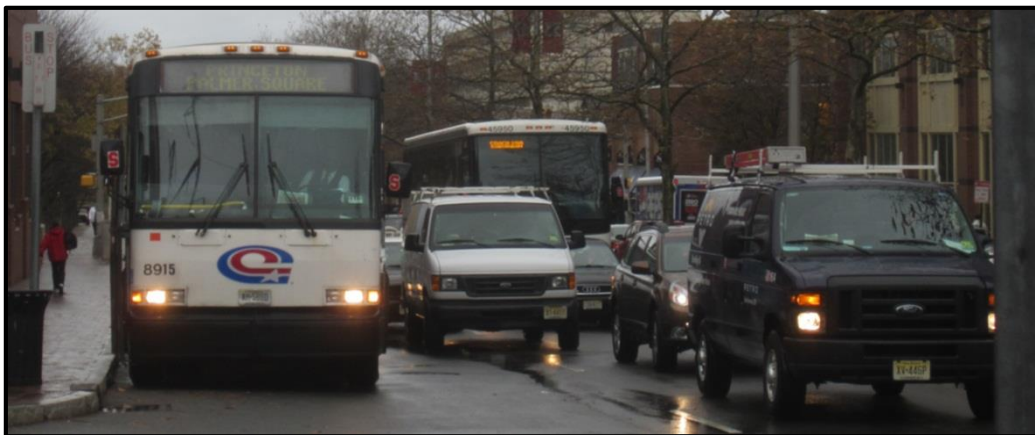
Issue: Merging Buses (Easton/Albany)	Safety Risk
<p><b>Description:</b> Buses have difficulty merging back into traffic from the bus stop just prior to the “Kiss-and-Ride” driveway on Albany Street southbound.</p>	<p>Medium/Low</p>

RSA Team’s Recommendation	Cost	Potential Safety Benefit
<p>Evaluate an alternative to the existing bus stop by revising (as conceptualized below) the striping on Albany Street northbound to increase the width on Albany Street southbound and allow the relocation of the bus stop just past the intersection, after the ramp from Easton Avenue southbound. (24) [See the diagram below.]</p>	<p>Low</p>	<p>Medium/High</p>

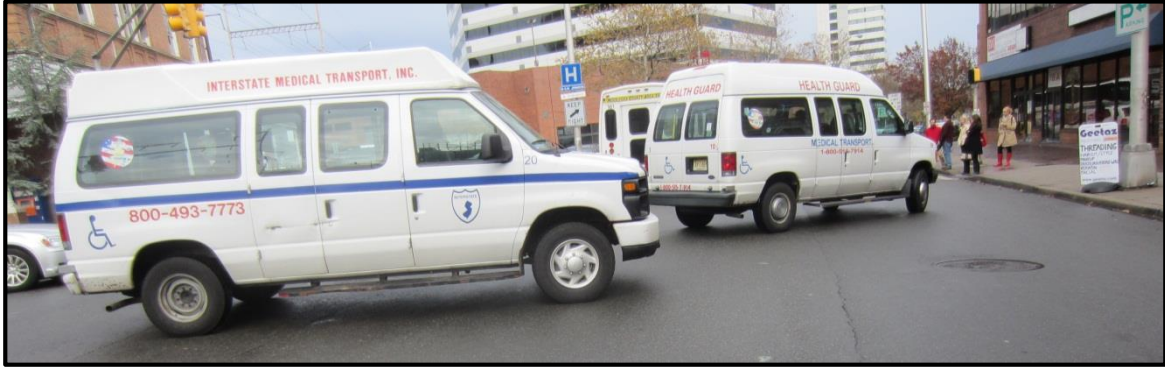
Issue: Left-Turn Crashes (Easton/Albany)	Safety Risk	
<b>Description:</b> Crash history indicates a significant number of left-turn crashes.	Medium/High

RSA Team's Recommendation	Cost	Potential Safety Benefit
Consider the addition of dotted lane line extension pavement markings, delineating the dual left-turning movement from Easton Avenue southbound to Albany Street northbound. (25)	Low	Medium/High

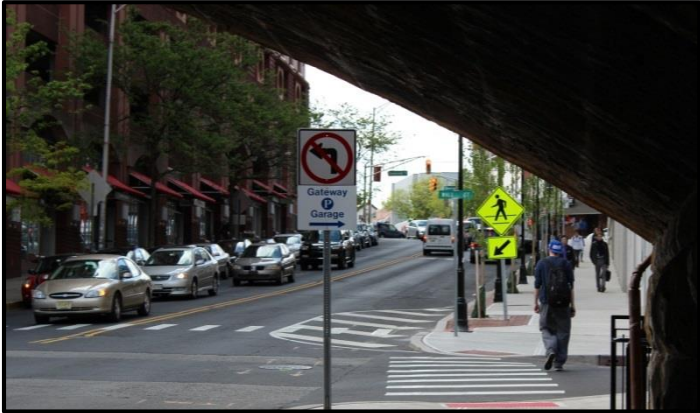
Issue: Lighting (Easton/Wall)	Safety Risk	
<b>Description:</b> Lighting was inconsistent and not uniform under the railroad bridge and may not address the nighttime visibility needs of both pedestrians and vehicles.	Medium/High

RSA Team's Recommendation	Cost	Potential Safety Benefit
Professional staff should conduct a formal engineering review of existing lighting conditions to evaluate where both vehicles and pedestrian level lighting can be enhanced. (5)	Medium	Medium/High

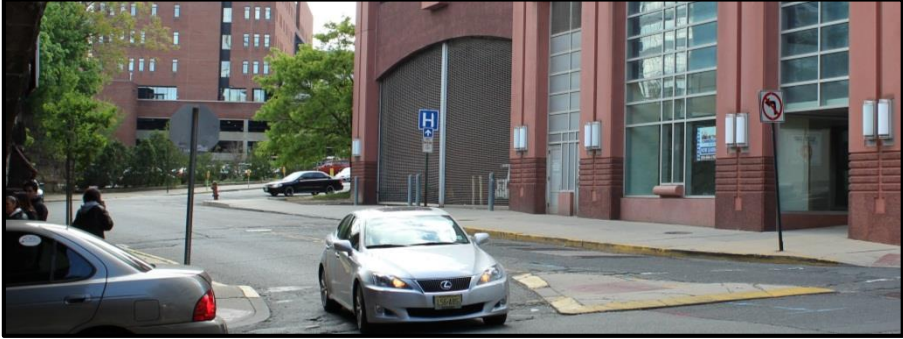
Issue: Signage (Easton/Wall)	Safety Risk	
<b>Description:</b> There is no “NO LEFT TURN” sign on far-left side when exiting from Wall Street onto Easton Avenue southbound.	Medium	
<b>Description:</b> There is an unused broken pole on Easton Avenue, just north of Little Albany Street.	Low

RSA Team’s Recommendation	Cost	Potential Safety Benefit
Consider installing a “NO LEFT TURN” sign in the far-left corner (for traffic exiting Wall Street onto Easton Avenue southbound) in conformance with the MUTCD. (31)	Low	Low
The broken pole on southbound Easton Avenue, north of Little Albany Street, should be removed. (32)	Low	Low

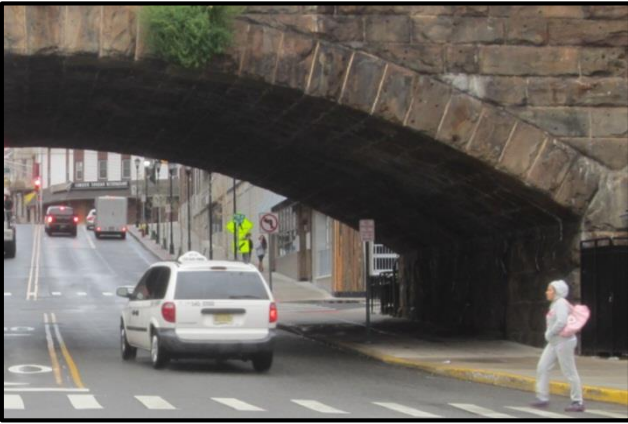
Issue: Taxi Stand (Easton/Wall)		Safety Risk	
<p><b>Description:</b> The area under the bridge on northbound Easton Avenue, south of Wall Street and adjacent to the train station stairway, is being used as an unmarked taxi stand for passengers disembarking from the train.</p>		Medium	
<p><b>Description:</b> There is an unofficial passenger drop-off and pick-up area along Little Albany Street west of the intersection.</p>		Low/Medium

RSA Team's Recommendation		Cost	Potential Safety Benefit
<p>Professional engineering staff should conduct a thorough evaluation of the train station traffic, including passenger pick-up and drop-off points and locations for taxi stands. (7)</p>		Low	Medium
<p>Evaluate creating a dedicated taxi stand and installing signage in the area under the bridge at northbound Easton Avenue. (10)</p>		Low	Medium

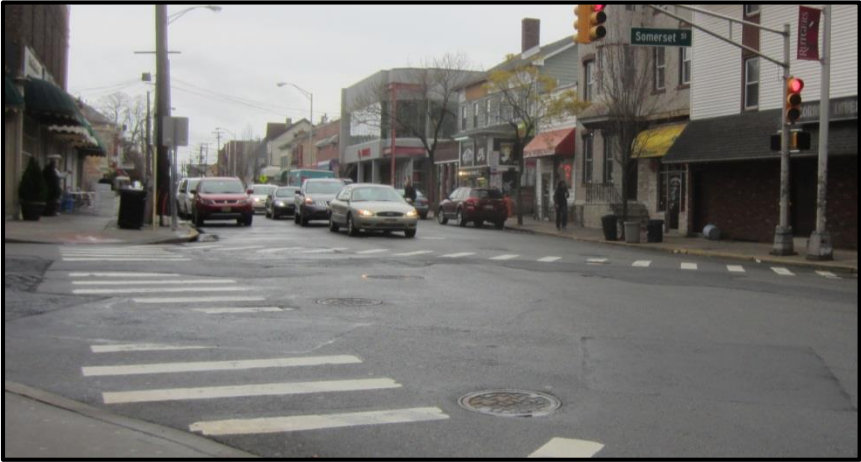
Issue: Right Turns (Easton/Somerset)	Safety Risk	
<p><b>Description:</b> Right turning vehicles from Easton Avenue, in both directions, may have difficulty making the maneuver due to the tight radius.</p>	<p>Medium/Low</p>

RSA Team's Recommendation	Cost	Potential Safety Benefit
<p>Conduct a turning analysis to evaluate turning movements and potentially revise intersection striping to include head-to-head left-turn lanes.(33)</p>	<p>Low</p>	<p>Medium</p>

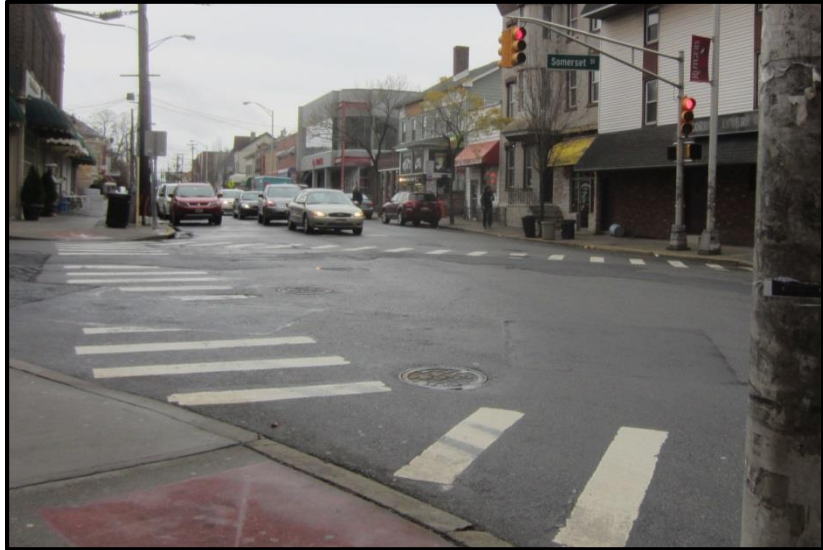
Issue: Crosswalks (Easton/Somerset)	Safety Risk
<b>Description:</b> The crosswalks do not accommodate pedestrian desire lines.	Medium/Low
<b>Description:</b> Pedestrian accommodations, such as ramps and detectable warning surfaces, are not fully ADA compliant.	Medium

RSA Team's Recommendation	Cost	Potential Safety Benefit
Plan for full ADA compliance by scheduling upgrades of existing ramps and curbs at crosswalks. (3)	Medium	Medium
Consider the installation of ergonomic crosswalks, to provide for natural pedestrian movements. (38) [See diagram below.]	Low	Medium

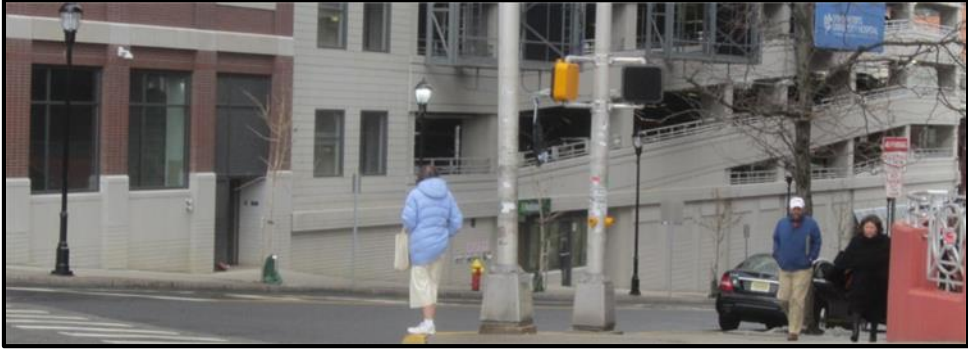
Issue: Pedestrian Accommodations (Easton/Somerset)	Safety Risk	
<b>Description:</b> Pedestrian buttons are not properly aligned in accordance with ADA requirements.	Medium	
<b>Description:</b> Pedestrian heads are not located in the direct line of sight of pedestrians using the crosswalks.	Low/Medium	
<b>Description:</b> There is a high pedestrian volume at this intersection and it was observed that pedestrians aren't utilizing buttons but crossing with the green light.	Medium/High	
<b>Description:</b> Pedestrian push signage is confusing.	Medium

RSA Team's Recommendation	Cost	Potential Safety Benefit
Schedule realignment of the pedestrian buttons to conform to 2009 MUTCD requirements. (20)	Low	Medium/Low
Review the alignment of the pedestrian heads with the crosswalks and sidewalks. (21)	Low	Medium/Low
Evaluate the benefit of revising signal timing to operate on fixed time or pedestrian recall, and adjust as feasible. (39)	Low	Medium/High

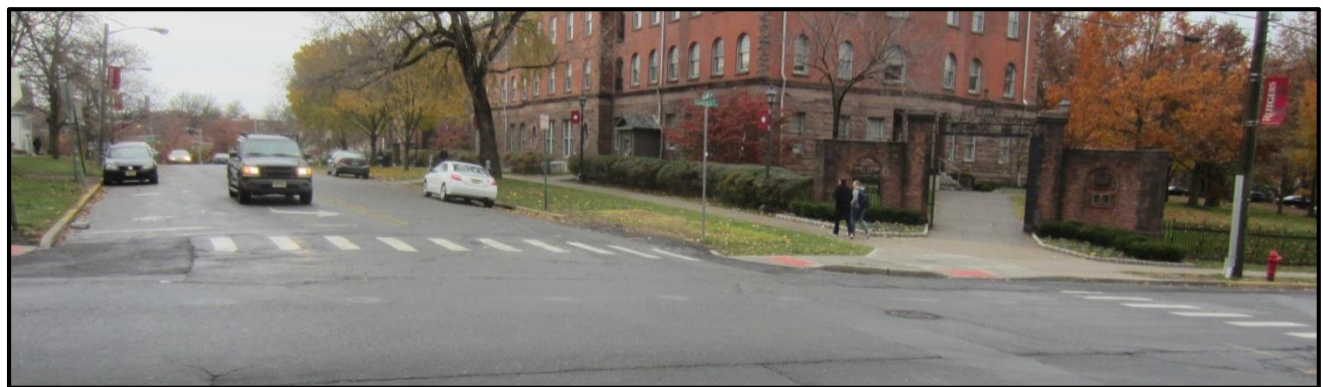
<b>Issue: Traffic Operations (Somerset/College)</b>	<b>Safety Risk</b>
<b>Description:</b> Buses making a left turn from College Avenue onto Somerset Street are forced into the “Right Turn Only” lane on College Avenue	Medium/Low

RSA Team’s Recommendation	Cost	Potential Safety Benefit
Removing the lane striping and providing a single lane allowing for both right and left turns would accommodate the wide left turns. (47) [See drawing below.]	Low	Medium
Consider the installation of (curbed or painted) bulb-outs at both corners of College Avenue and on Somerset Street (46) [See drawing below.]	Low-Painted; Medium-Curbed	Medium/High

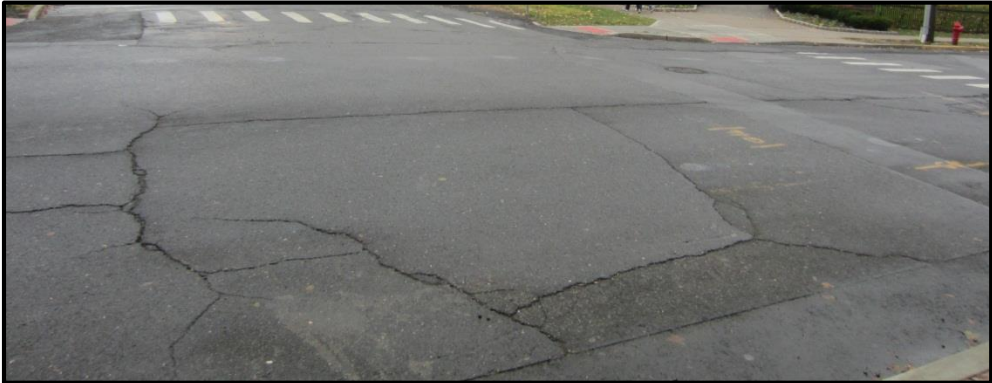
Issue: Pavement (Somerset/College)	Safety Risk	
<b>Description:</b> The pavement is in poor condition throughout the intersection.	Low

RSA Team's Recommendation	Cost	Potential Safety Benefit
Consider repaving the intersection. (49)	Medium	Medium/Low

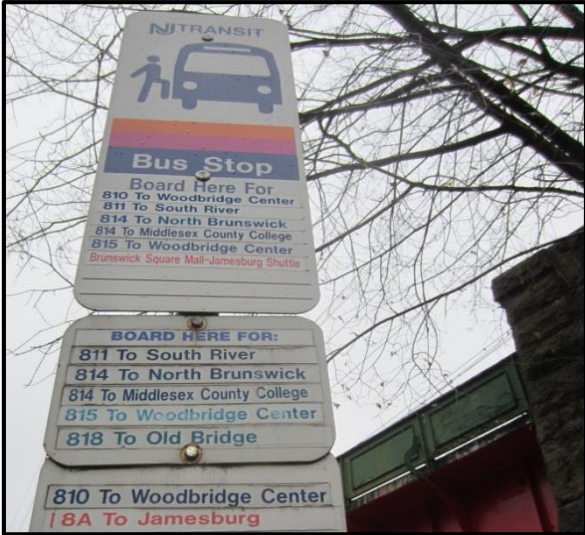
Issue: Bus Stop (Somerset/Wall)	Safety Risk	
<p><b>Description:</b> Because this is a bus stop for numerous routes for NJ Transit, Rutgers, County buses, and city shuttles, there is significant passenger confusion.</p>	<p>Low</p>

RSA Team's Recommendation	Cost	Potential Safety Benefit
<p>Consider adding signage that includes maps of the various bus routes bus schedule. (50)</p>	<p>Low</p>	<p>Low</p>

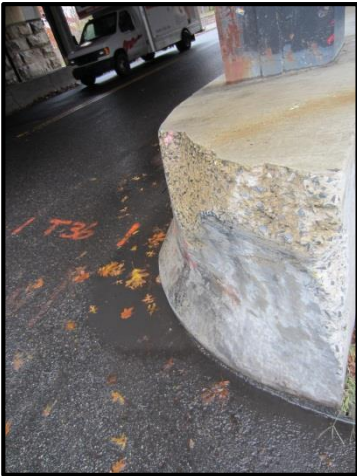
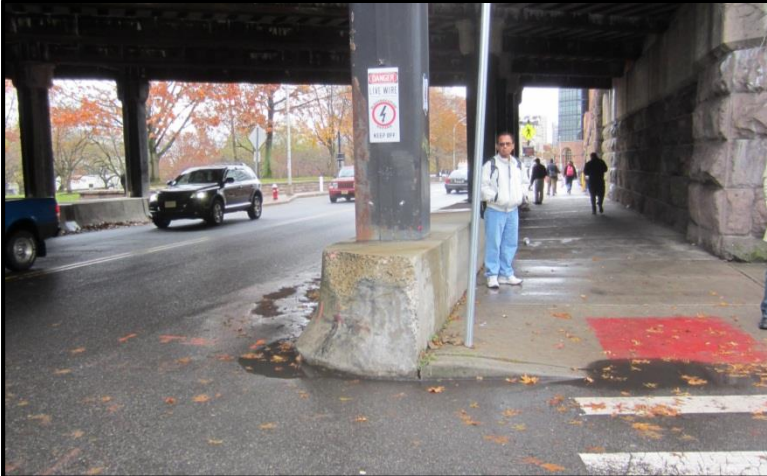
Issue: Turning Angle (Somerset/George)	Safety Risk	
<p><b>Description:</b> Some buses making a right turn from Somerset Street to George Street have difficulty, due to the sharp intersection between the two roadways.</p>	High	
<p>Vehicles use the bus stop area on Somerset Street as a right turn lane.</p>	Medium

RSA Team's Recommendation	Cost	Potential Safety Benefit
<p>Conduct a thorough evaluation to improve the geometry of the intersection, realigning Somerset Street so that it makes a right angle with George Street. (51)</p>	High	High
<p>Evaluate if installation of a traffic signal is warranted to better accommodate turning buses and vehicles into the parking deck. (52)</p>	High	High
<p>Consider hatching the bus stop area to prohibit vehicles from turning right at the same time that a bus is making a wide right turn. (53) [See diagram on page 62.]</p>	Low	Medium/High
<p>Consider installing a blinking yellow light on northbound George Street, prior to the intersection, alerting motorists to use caution. (54)</p>	High	High

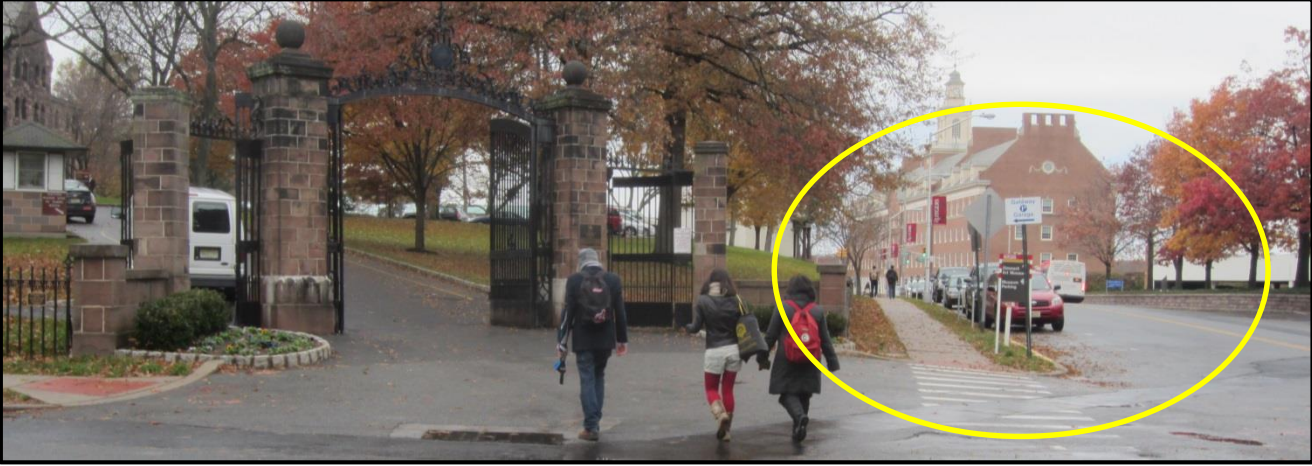
Issue: Sight Distance (Somerset/George)	Safety Risk	
<b>Description:</b> Parked vehicles on southbound George Street limit the sight distance of oncoming traffic from Somerset Street.	Medium/High

RSA Team's Recommendation	Cost	Potential Safety Benefit
Consider limiting parking on George Street, north of the intersection. (55)	Low	Medium/High

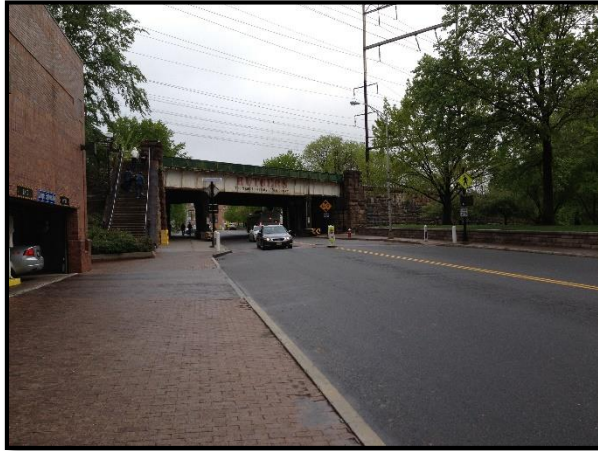
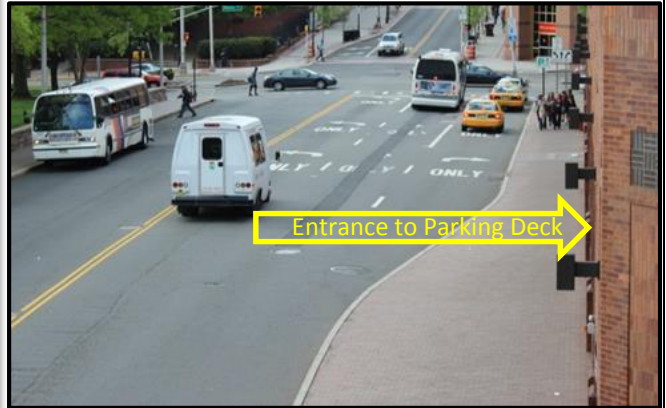
Issue: Parking Deck (Somerset/George)	Safety Risk
<b>Description:</b> Some drivers have difficulty making a left turn into the J & J parking deck at 410 George Street.	Medium-Low
<b>Description:</b> The existing crosswalk across George Street (south of the intersection and bridge) is very long.	Low

RSA Team's Recommendation	Cost	Potential Safety Benefit
Evaluate if installation of a traffic signal is warranted to better accommodate turning buses and vehicles turning into the parking deck. (52)	High	High
Consider adding a left-turn lane on George Street northbound (for the parking deck). (56)	Low	Medium
Northbound George Street (south of the railroad bridge) narrows to no shoulder just past the crosswalk. Consider revising the narrowing to a location prior to the crosswalk to shorten the crosswalk length. (63)	High	Low/Medium

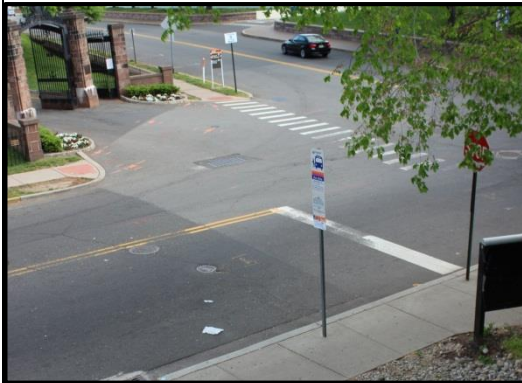
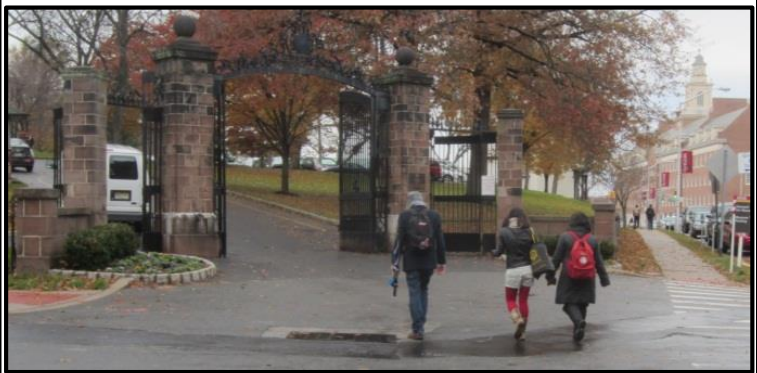
Issue: Crosswalk (Somerset/George)	Safety Risk
<b>Description:</b> The crosswalk in the northwest corner is not clearly delineated because of the wide driveway entrance to Rutgers University, nor is it ADA compliant.	Medium-Low
<b>Description:</b> Pedestrian accommodations, such as ramps and detectable warning surfaces, are not fully ADA compliant at the intersection of Somerset and George Streets.	Medium
<b>Description:</b> There is no marked crosswalk across George Street north of the intersection.	Medium
<b>Description:</b> The crosswalk across Somerset Street is very long.	Medium/High

RSA Team's Recommendation	Cost	Potential Safety Benefit
The northwest corner could be improved for pedestrians, possibly with additional striping and continuation of the sidewalk from Somerset Street across the Rutgers driveway. (58) [See diagram on page 62.]	Low	Medium
Plan for full ADA compliance by scheduling upgrades to existing ramps and curbs at crosswalks. (3)	Medium	Medium
Consider the installation of bulb-outs (curbed or painted) at the intersection in addition to a crosswalk across the Rutgers driveway. (59) [See diagram on page 62.]	Low-Painted; Medium-Curbed	Medium/High
The addition of a marked crosswalk at George Street north of the intersection would alert drivers to possible pedestrian activity. (60) [See diagram on page 62.]	Low	Medium/High

Consider the installation of bulb-outs (curbed or painted) at a proposed crosswalk across George Street. (61) [See diagram below.]	Low-Painted; Medium-Curbed	Medium/High
Consider the installation of a visibly differentiated mountable refuge island across Somerset Street. (62) [See diagram below.]	Low-Painted; Medium-Mountable	Medium/High

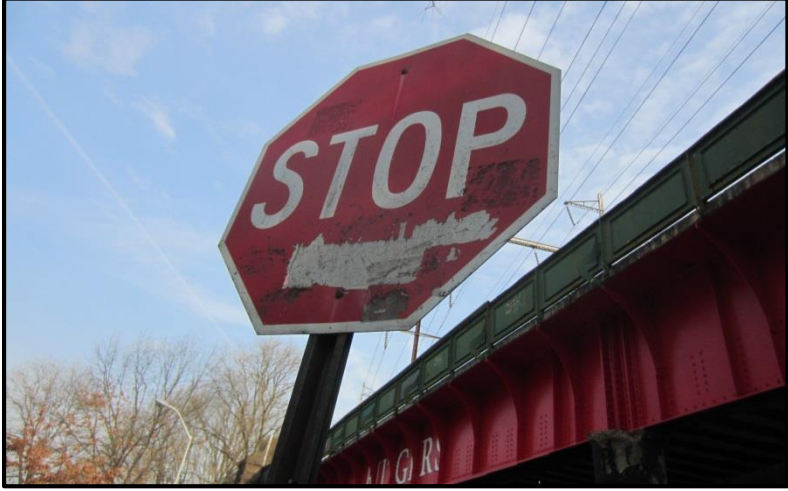
Issue: Signage (Somerset/George)	Safety Risk	
<b>Description:</b> The stop sign lacks retro-reflectivity.	Medium

RSA Team's Recommendation	Cost	Potential Safety Benefit
Plan on replacing the stop sign to conform to MUTCD standards. (64)	Low	Medium/High

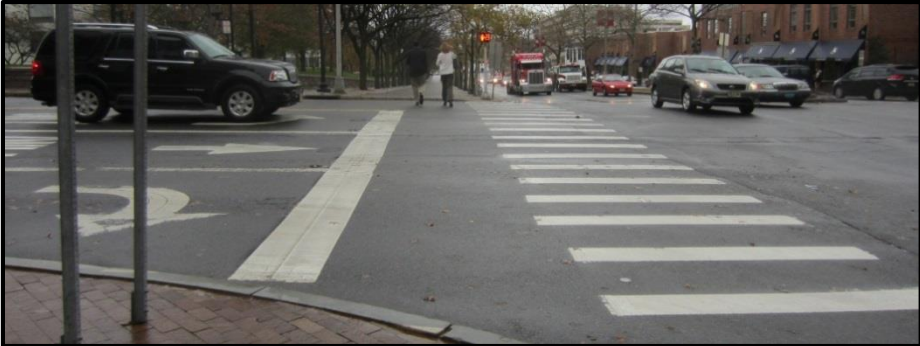
Issue: Pedestrian Accommodations (George/Albany)	Safety Risk	
<b>Description:</b> Pedestrians were observed crossing George Street in line with the sidewalk, which is not aligned with the crosswalk.	Low	
<b>Description:</b> Pedestrian accommodations, such as ramps and detectable warning surfaces, are not fully ADA compliant.	Medium/Low	
<b>Description:</b> Some of the bricks in the sidewalk have settled and may cause a tripping hazard.	Medium/Low	
<b>Description:</b> A significant number of people utilize the bus stops.	Medium

RSA Team's Recommendation	Cost	Potential Safety Benefit
Pedestrians could be better accommodated by aligning the crosswalks with the sidewalks. (67)	Low	Medium
Plan for full ADA compliance by scheduling upgrades to existing ramps and curbs at crosswalks. (3)	Medium/Low	Medium
Regular maintenance should include repairing the bricks where they have settled. (68)	Low	Medium/High

Consider the installation of bus shelters. (69)	<b>Note:</b> NJ Transit will install bus shelters at no cost, conditional with the city maintenance and J&J easement.	Medium

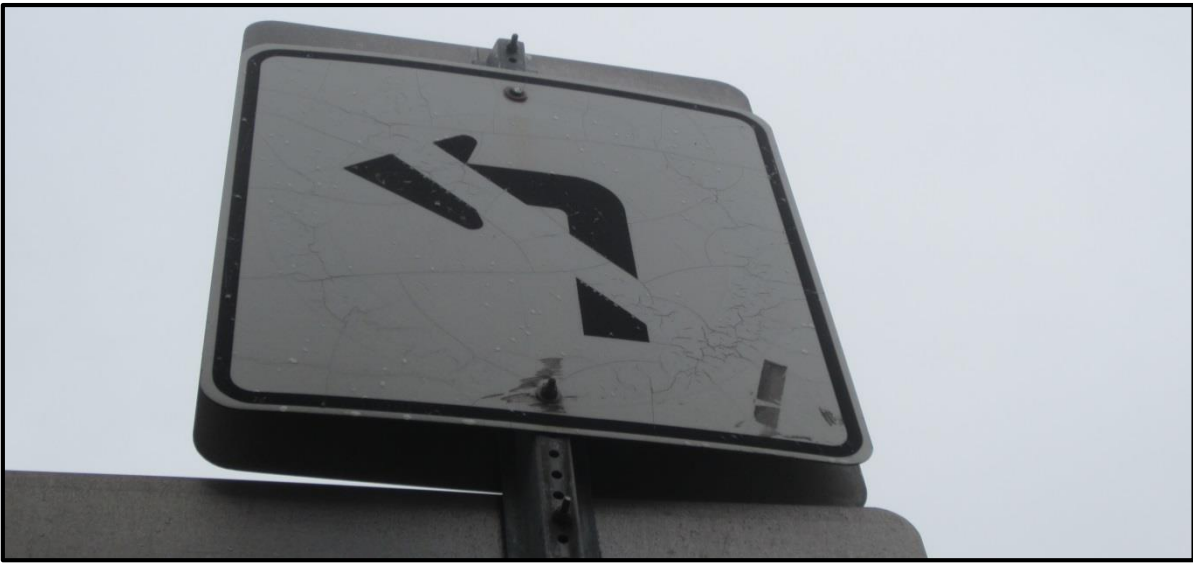
Issue: Signage (George/Albany)	Safety Risk	
<b>Description:</b> Left-turn prohibition is not clear to drivers because of missing and faded signage.	Medium/High	
<b>Description:</b> There is an unused broken pole in the southeast corner of the intersection.	Low

RSA Team's Recommendation	Cost	Potential Safety Benefit
Replace all "NO LEFT TURN" signage where necessary. (70)	Low	High
Remove the unused broken pole at the southeast corner. (71)	Low	Low/Medium
